DOT HS 800 624

# **AN ASSESSMENT OF AUTOMOTIVE FUEL SYSTEM FIRE HAZARDS**

**Dynamic Science  
A Division of Marshall Industries  
1800 West Deer Valley Drive  
Phoenix, Arizona 85027**

**Contract No. DOT FH 11 7579  
December 1971  
Final Report**

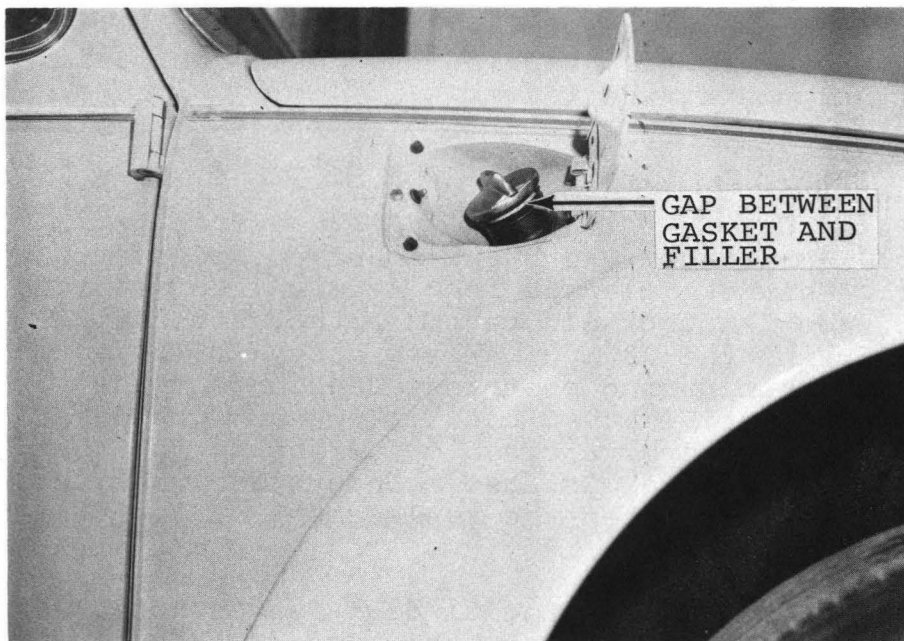
design is such that the filler cap cannot be screwed tightly into the fuel tank, as shown in Figure 5-3. Thus, the filler cap gasket is not seated firmly against the tank opening and leakage occurred around this gasket when the Super Beetle was subjected to severe cornering with a full tank of fuel.

Figure 5-3. Filler Cap Installation in 1971 VW Super Beetle.

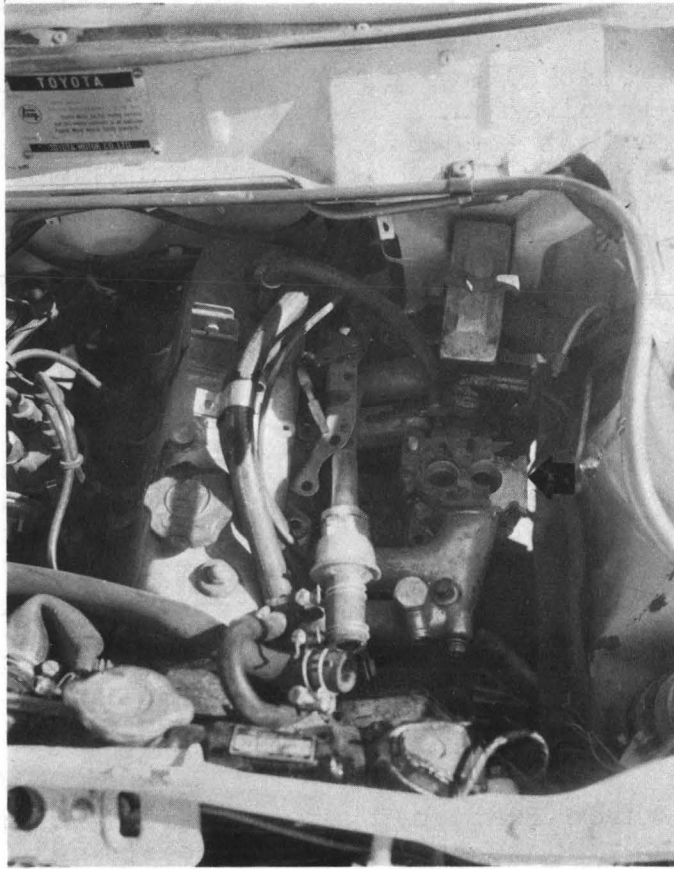
The Toyota carburetor was pushed back into the brake fluid reservoir, breaking both the carburetor base mounting on the intake manifold and the base of the carburetor itself, as shown in Figure 5-19. This failure graphically illustrates the hazards of fuel system component damage resulting from direct impacts on other vehicle components as the carburetor withstood the extremely high acceleration of 295G during the drop test with no damage. Again, a minor amount of fuel leakage must have occurred during impact although there was no post-test leakage. It should be noted that the intake manifold and carburetor in the 1971 Toyota Corollas are now located on the right side of the engine where there is adequate space behind the carburetor to prevent the recurrence of such a failure.

Figure 5-19. Broken Carburetor Mounting in Barrier-Crashed Toyota Corolla.

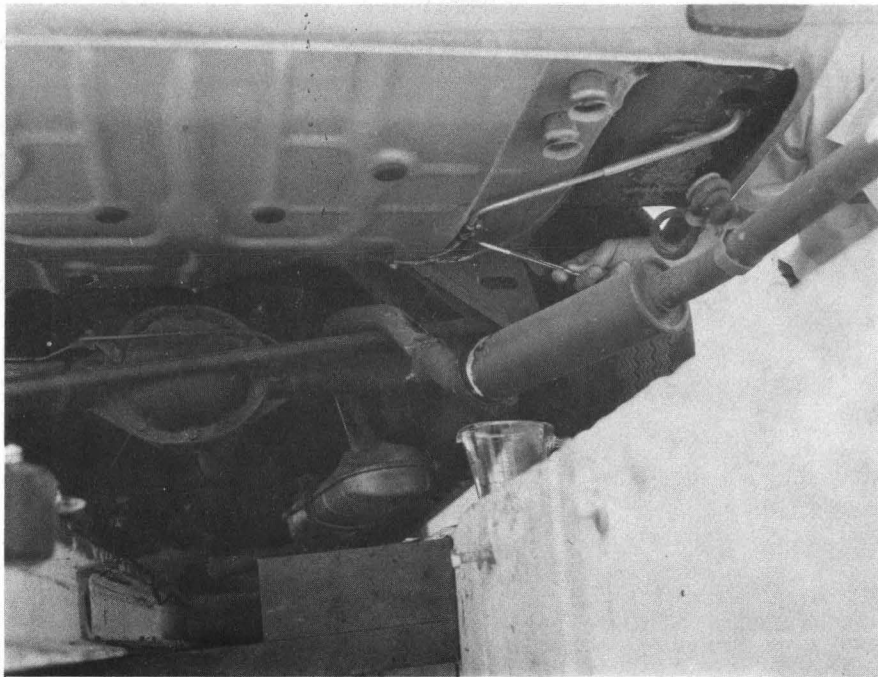
Figure 5-20. Opel Kadett Fuel Line Following Front Barrier Impact (Pencil indicates point of fuel loss).

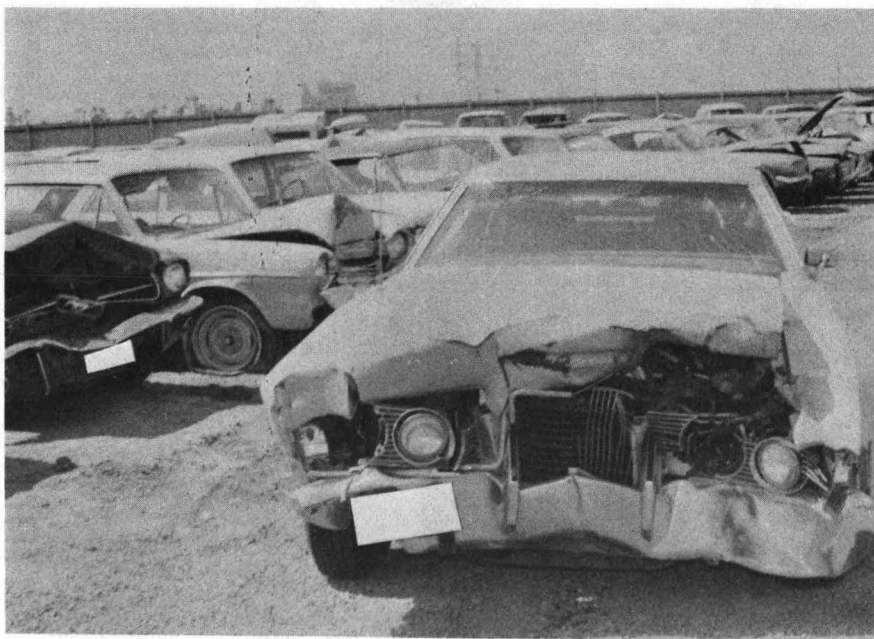
Figure 5-21. 1971 Cougar Involved in a Moderate Front End Collision.

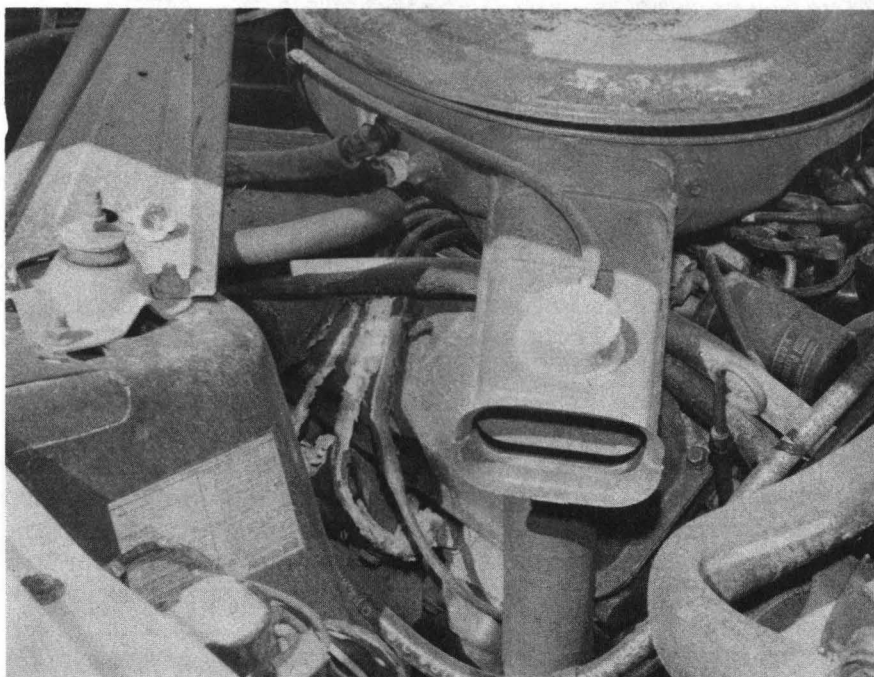
Figure 5-22. Engine Compartment Fire Damage in Crashed 1971 Cougar.

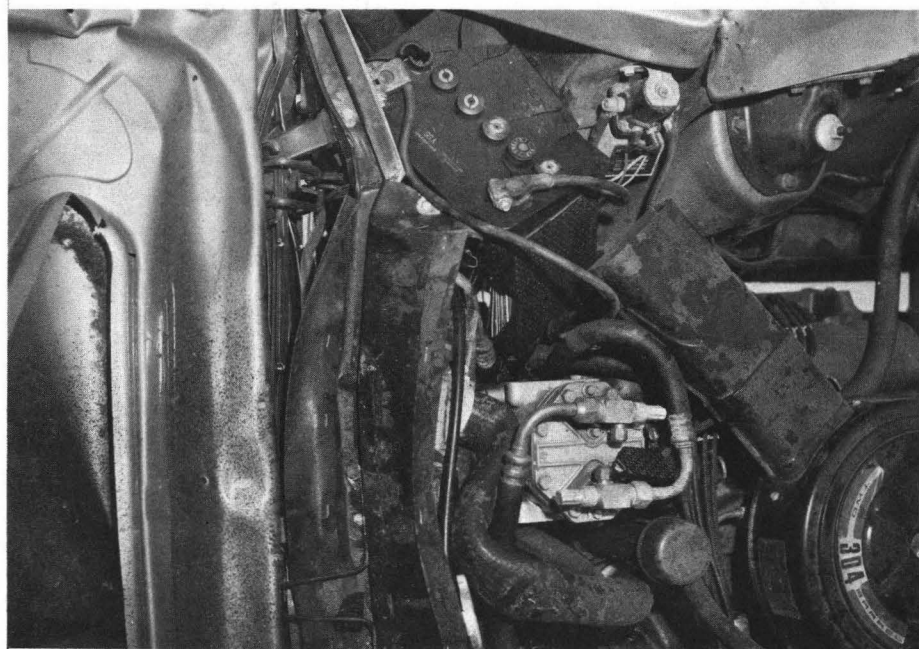
Catastrophic damage to the battery was generally experienced in those vehicles with the battery located in the front of the engine compartment when impacted into the barrier at 30 mph. Typical battery damage is illustrated in the Ambassador engine compartment shown in Figure 5-23. Sparks generated during impact as the battery is broken are potential ignition sources. The capacity of the battery to act as an ignition source may exist even when it is almost totally destroyed, e.g., although only one cell in the 1971 Fiat battery was not destroyed, the passenger compartment light functioned when the doors were opened after the impact. Thus, destruction of the battery does not eliminate it as an ignition source.

Figure 5-23. Battery Damage in Barrier-Tested Ambassador.

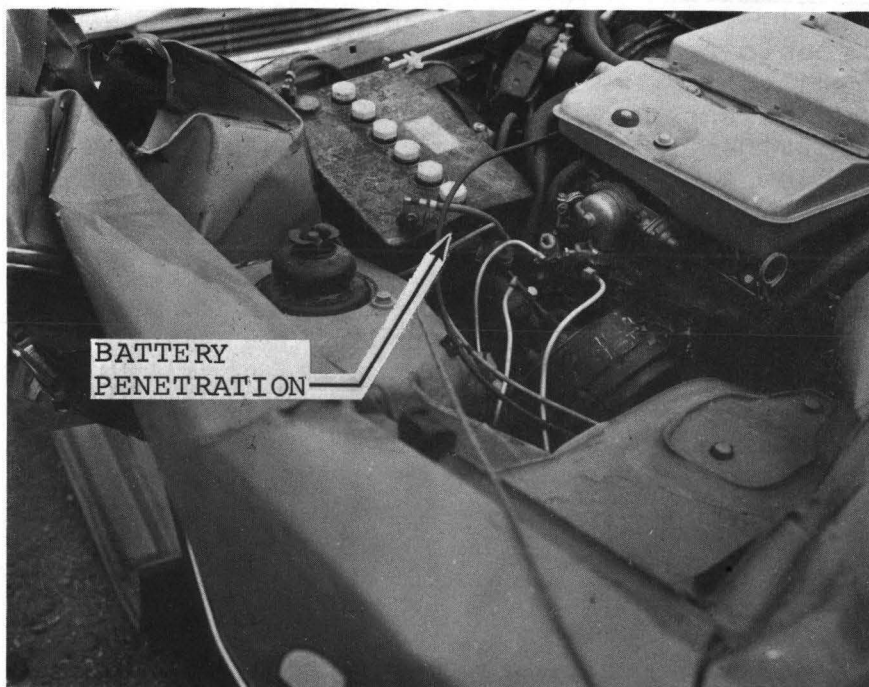
Figure 5-24. Battery Damage in Barrier-Tested Capri.

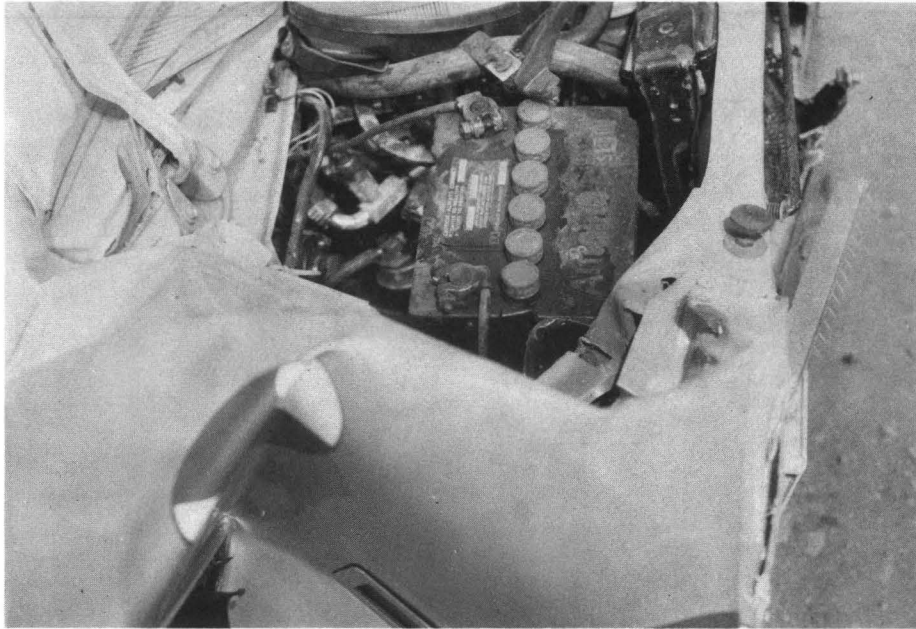
Figure 5-25. Battery Damage in Barrier-Crashed Pinto.

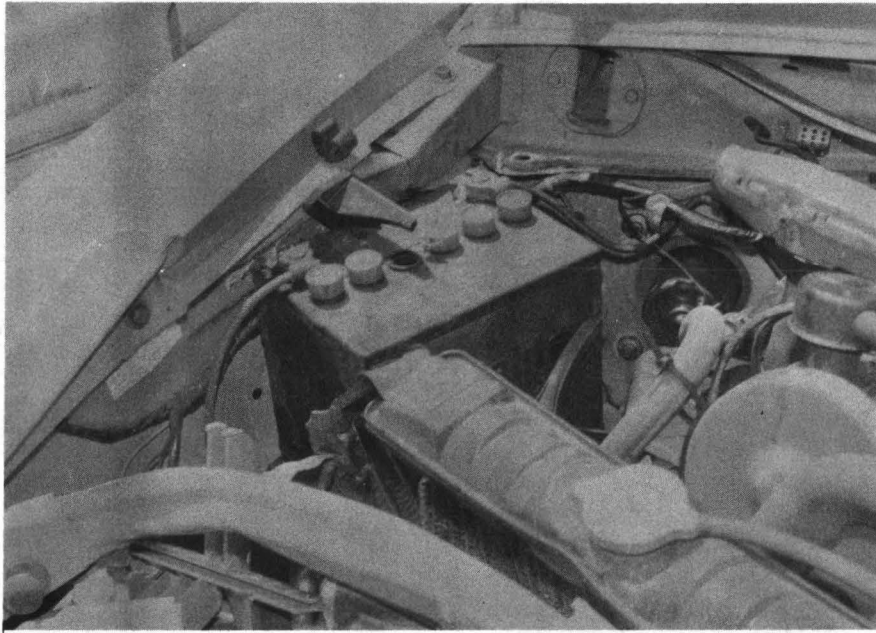
Figure 5-26. Displaced Battery in Pinto Involved in Minor Front End Collision.

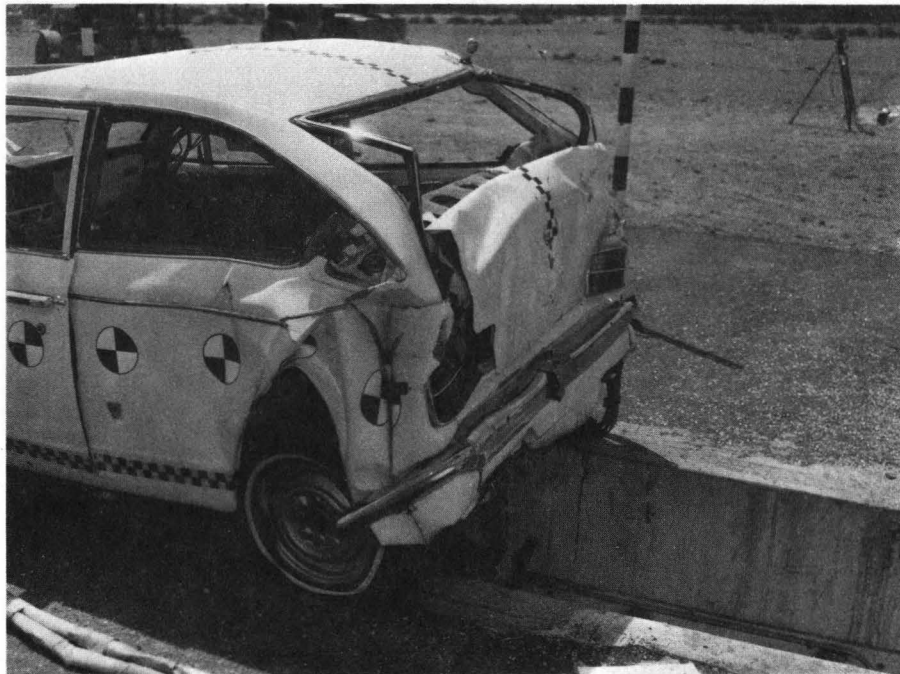
Figure 5-27. Toyota Impact Damage From 30.2-mph Barrier Test.

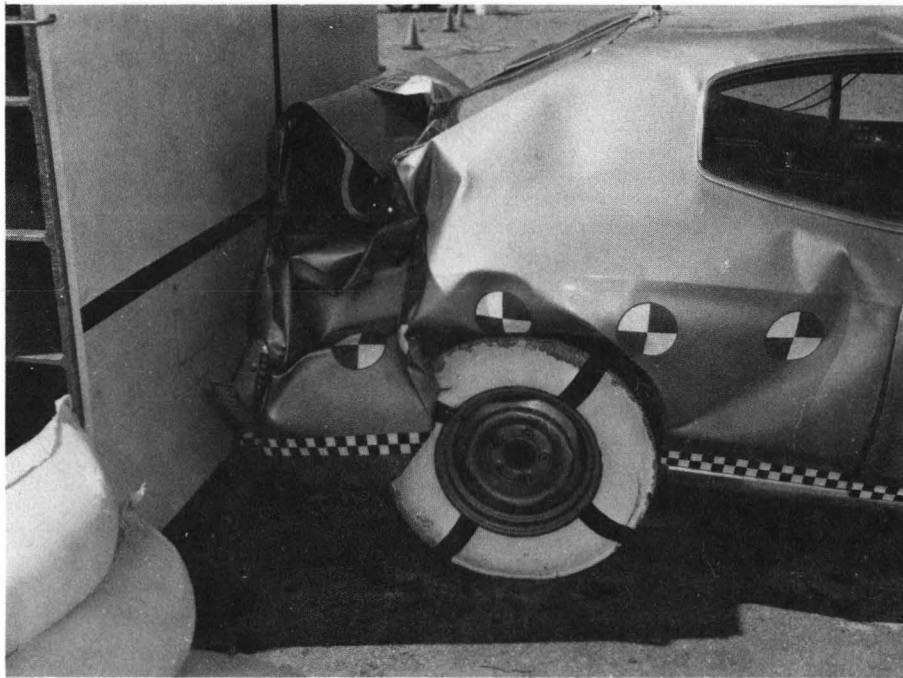
Figure 5-28. Chevelle Impact Damage From 21.8-mph Barrier Test.

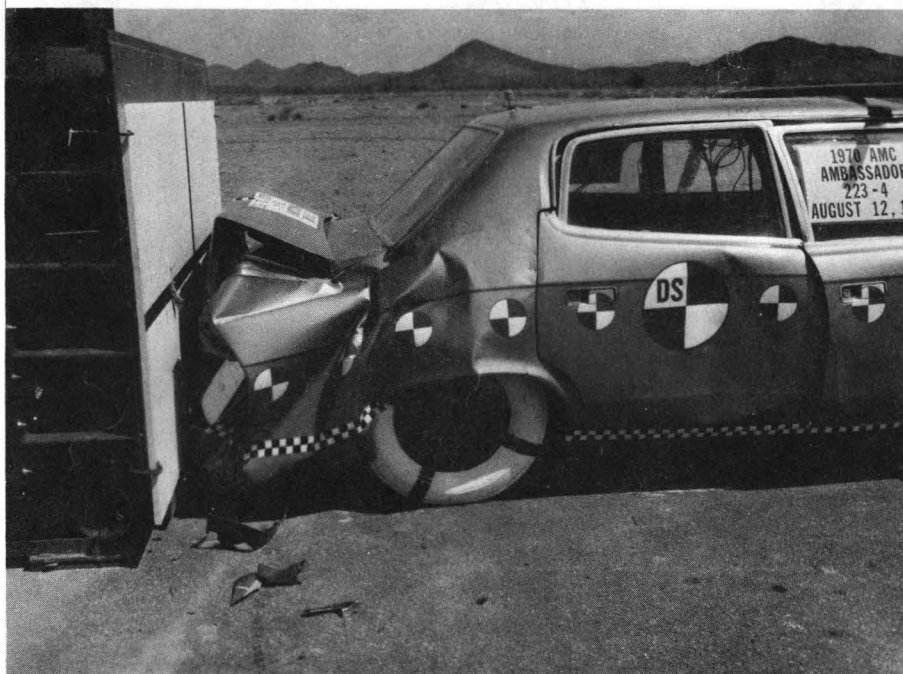
Figure 5-29. Ambassador Impact Damage From 20.2-mph Barrier Test.

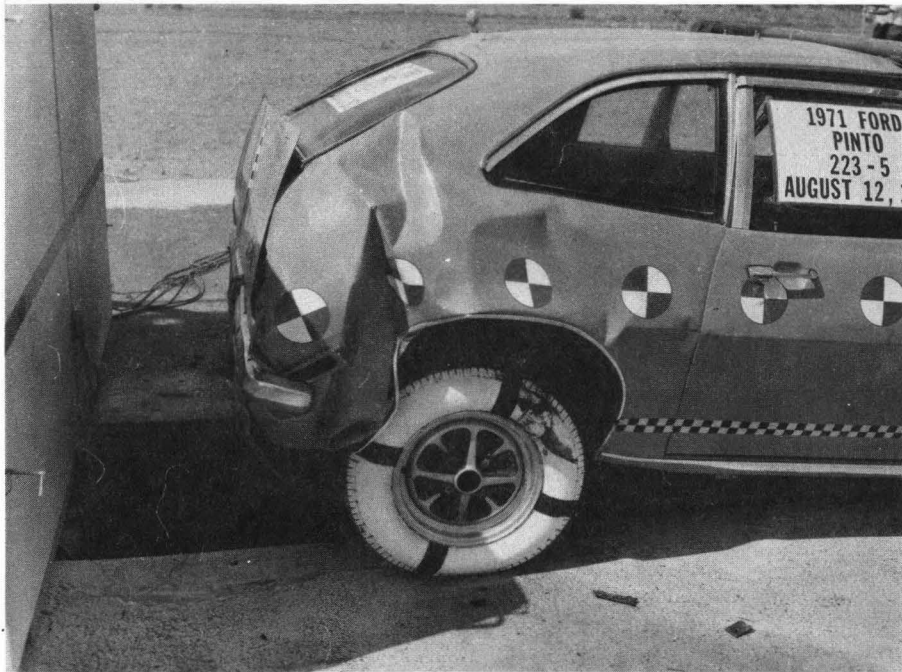
Figure 5-30. Pinto Impact Damage From 20.1-mph Barrier Test.

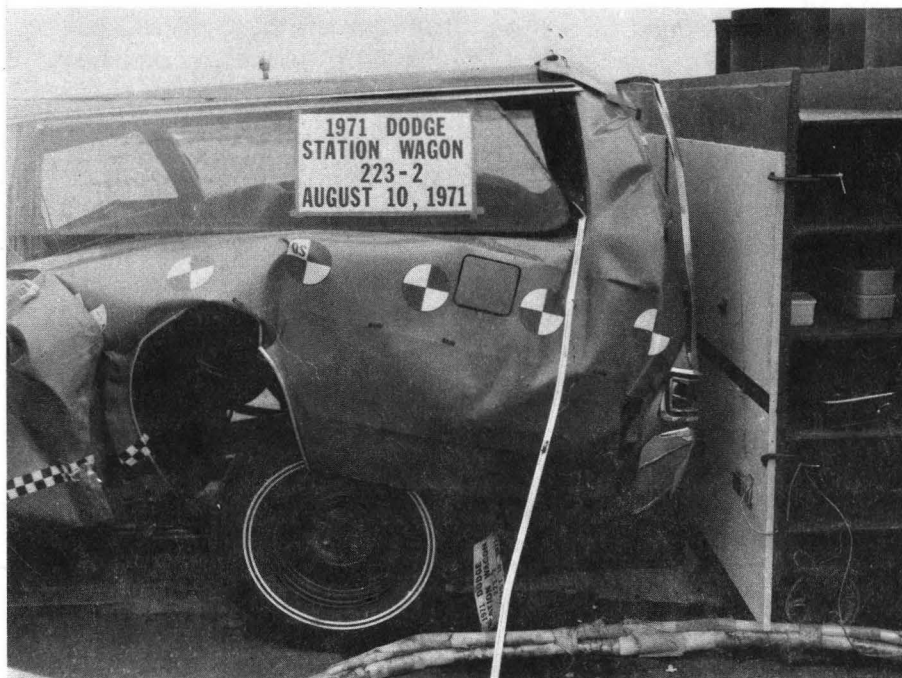
Figure 5-31. Dodge Station Wagon Impact Damage From 27.6-mph Barrier Test.

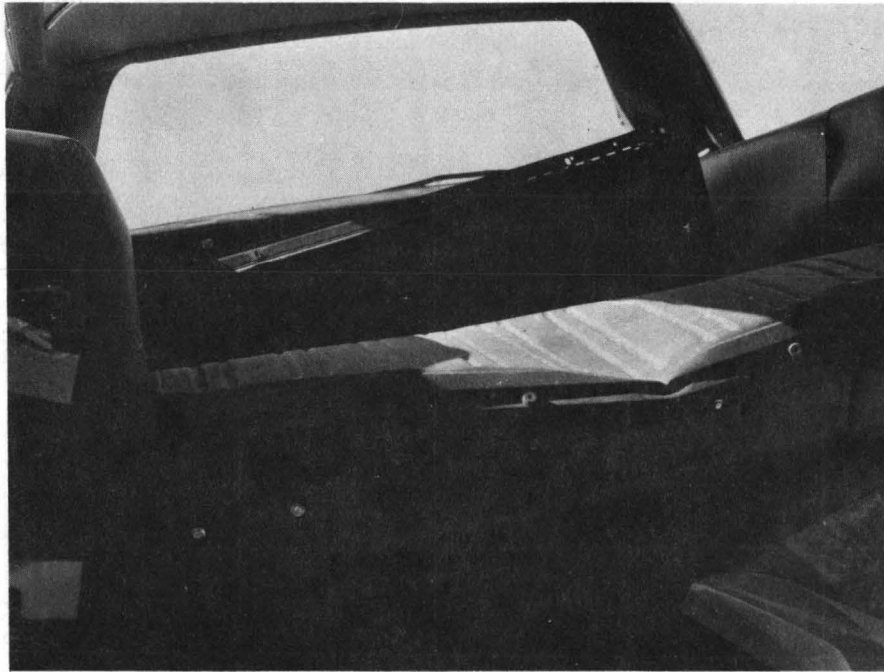
Figure 5-32. Interior Damage in Rear of Dodge Station Wagon.

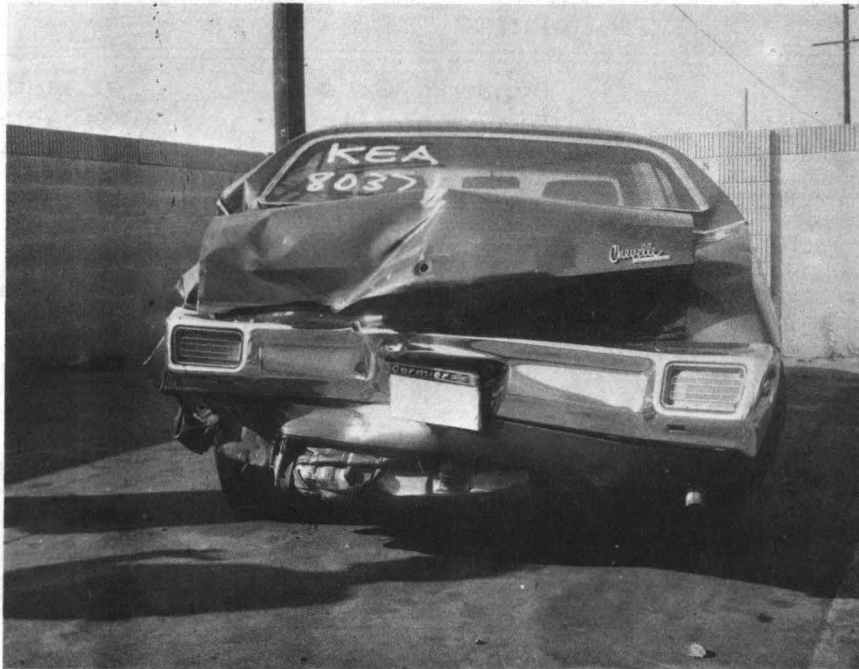
Figure 5-40. Rear End Collision Damage to 1970 Chevelle.

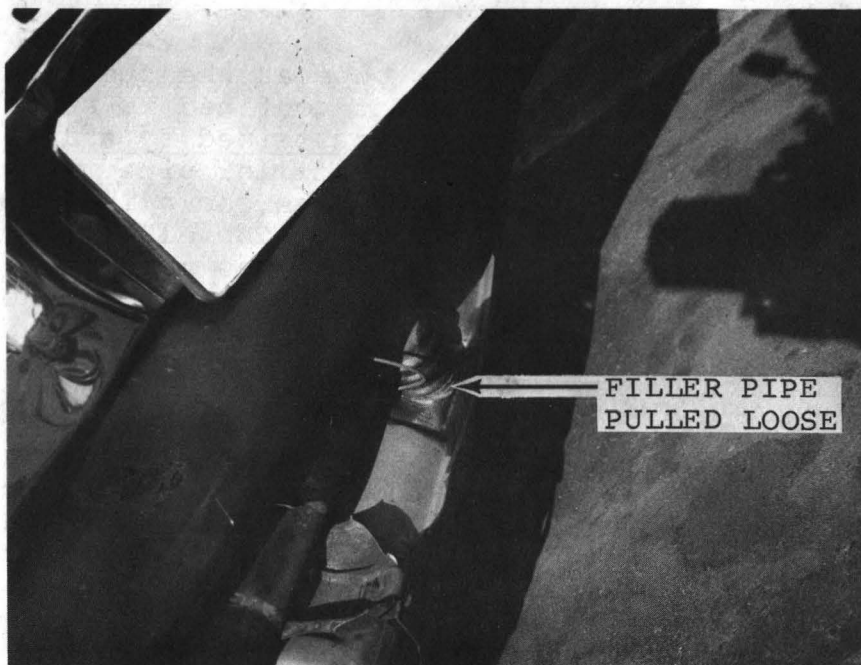
Figure 5-41. Filler-Tank Failure in Moderate Rear End Collision.

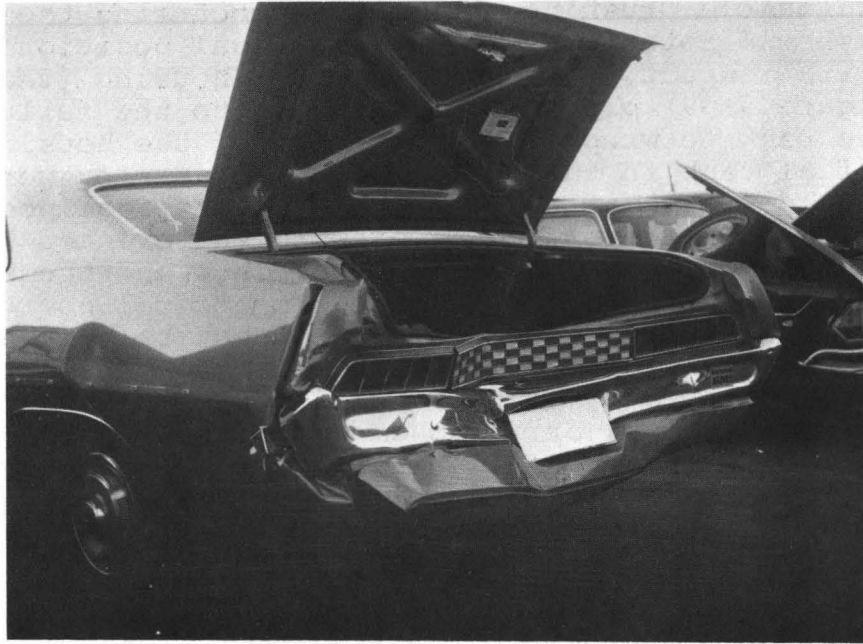
Figure 5-42. Rear End Collision Damage to 1970 Ford Torino.

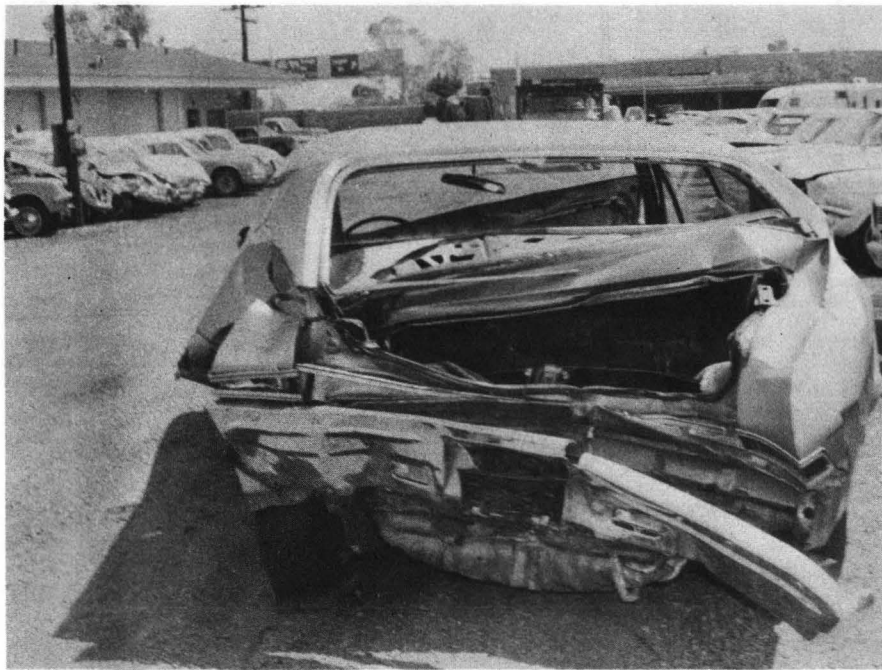
Figure 5-44. Severe Rear End Collision Damage in 1971 Chevelle Malibu.

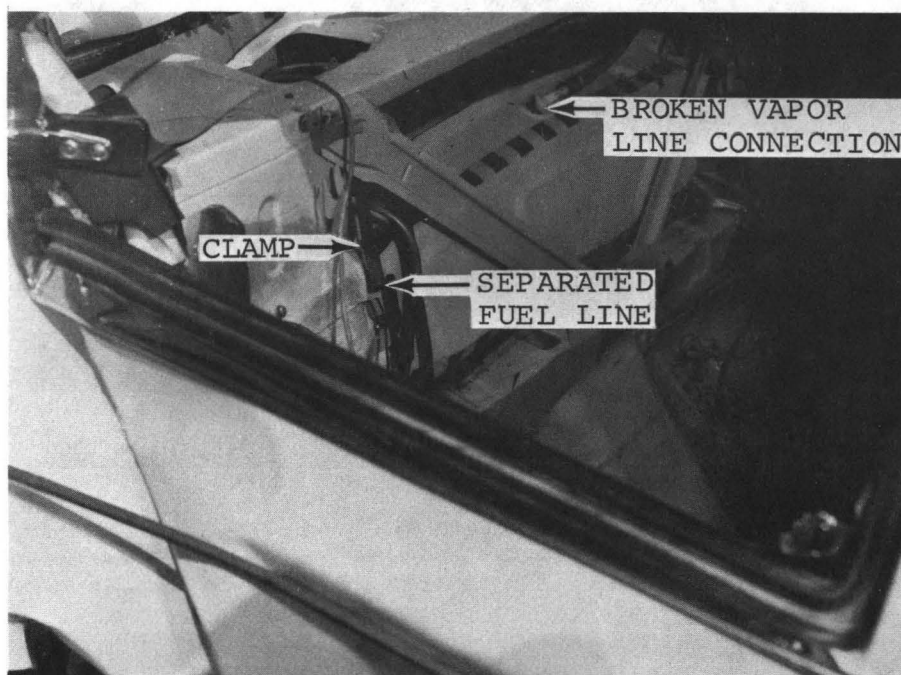
Figure 5-48. Broken Fuel and Vapor Lines in Barrier-Tested Toyota.

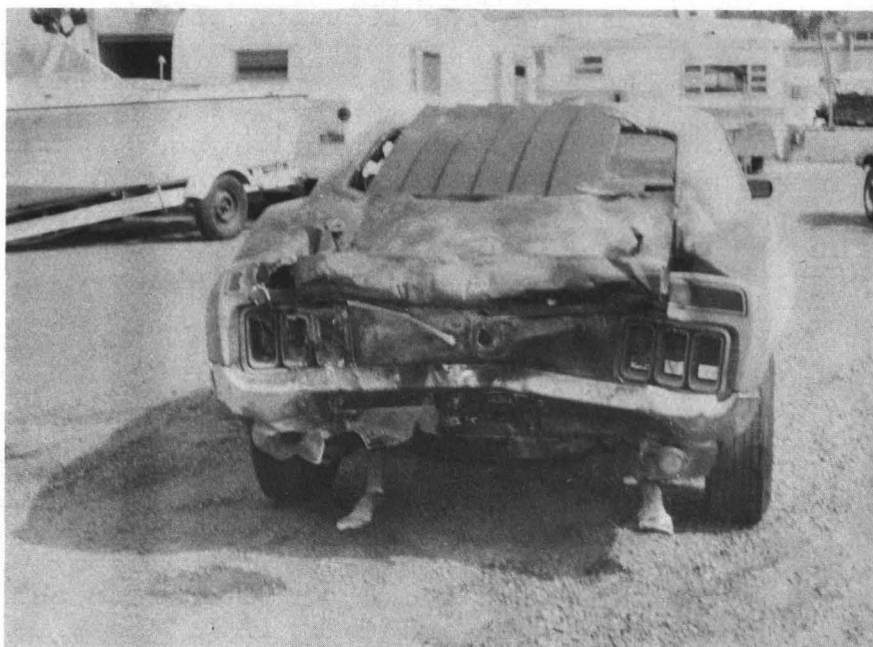
Figure 5-51. Fire Damage in 1970 Mustang Involved in Moderate Rear End Collision.

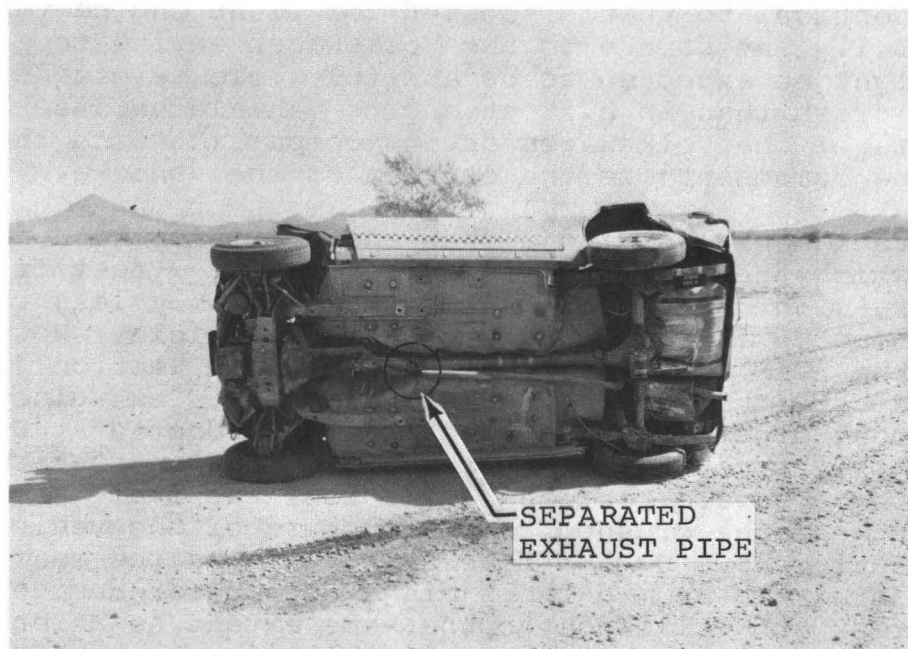
Figure 5-52. Exhaust Pipe Separation in Barrier-Tested Pinto.

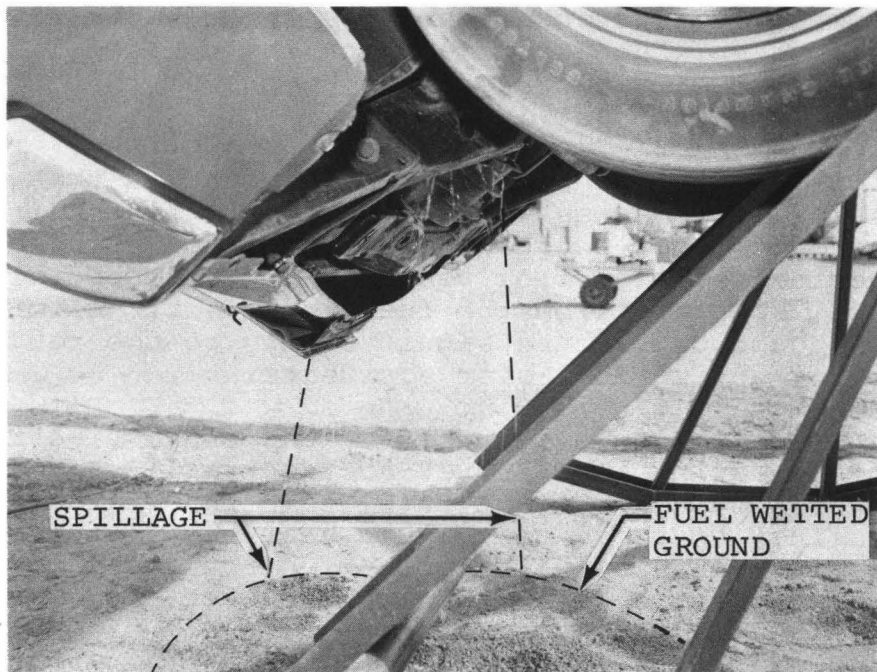
Figure 5-56. Fuel Spillage From Chevelle Canister With Vehicle in 45-Degree Nose-Down Position.

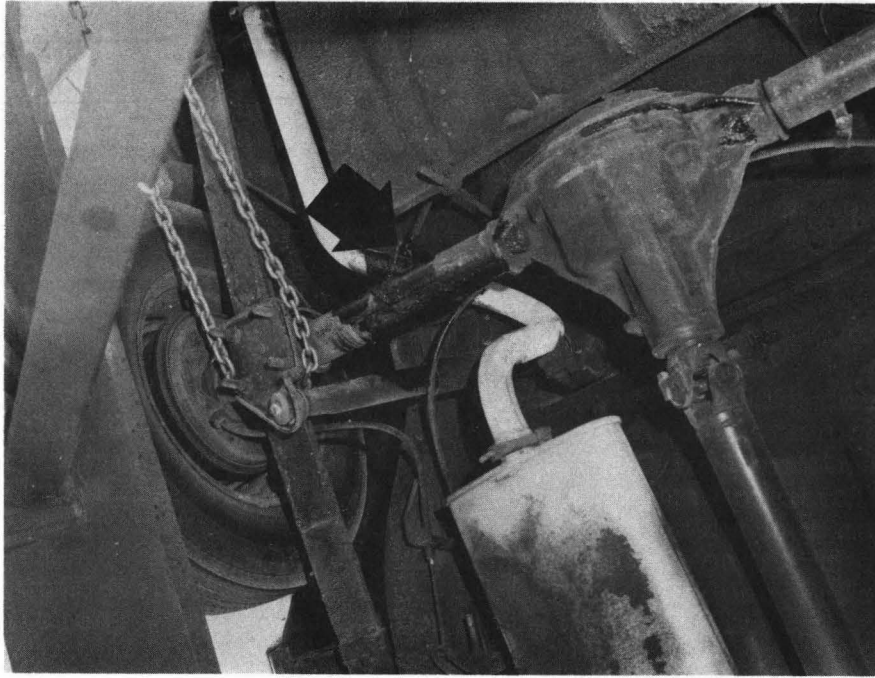
Figure 5-57. Fuel Spillage From Damaged Vapor Hose in AMC Hornet.

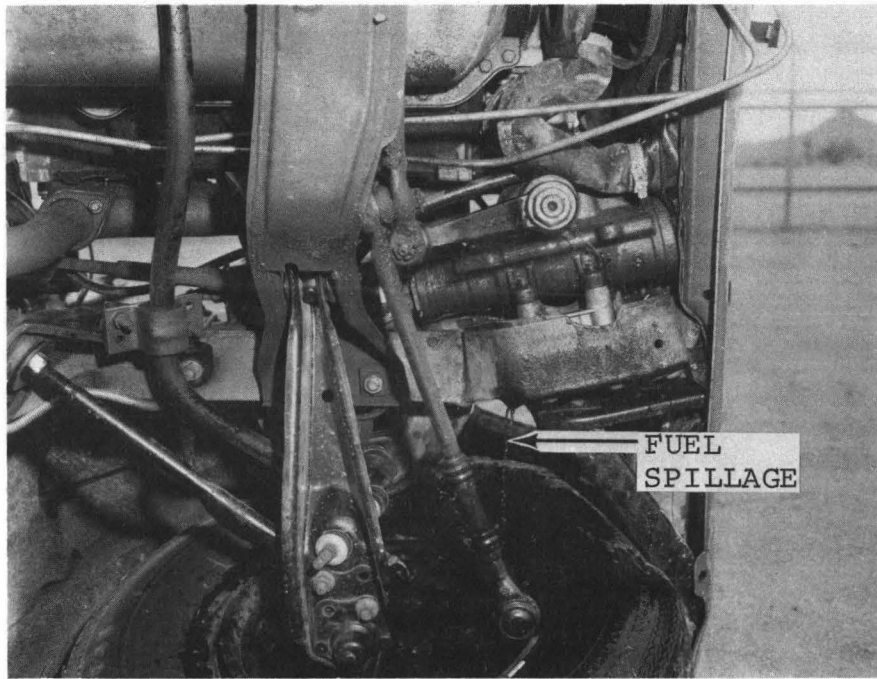
Figure 5-58. Fuel Spillage From Broken Fuel Line in AMC Ambassador.

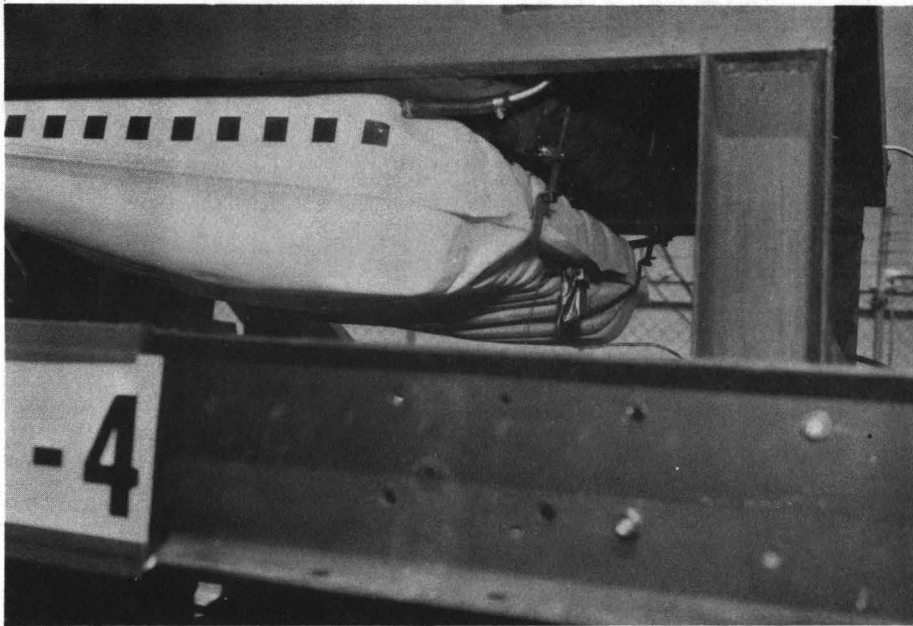
(2) Fuel tank broke loose from attachments.

Figure F-12. Chevelle Fuel Tank Damage - Rear Impact Sled Test (Test 4).

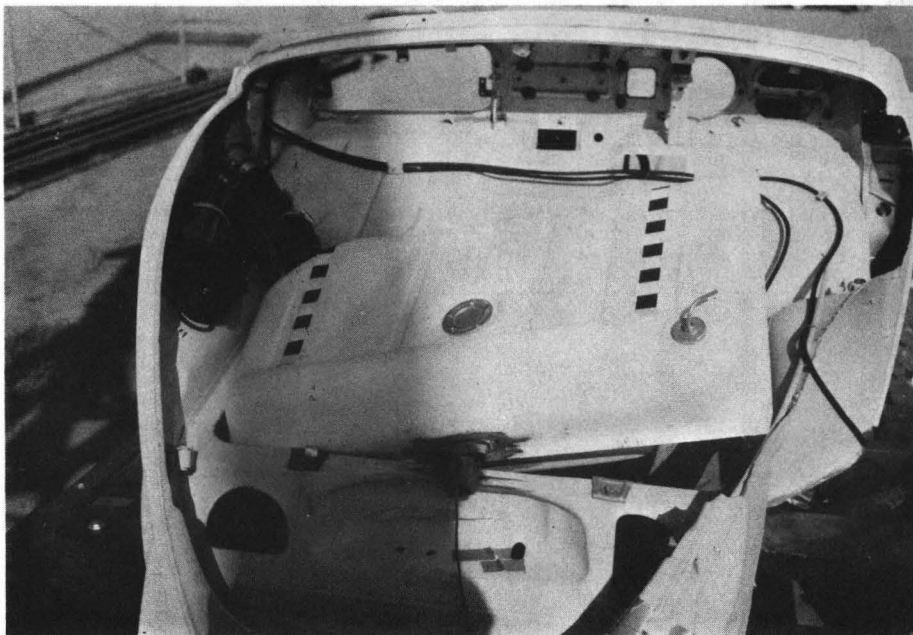
Figure F-13. Displaced Volkswagen Fuel Tank - Front Impact Sled Test (Test 5).
