# Accident Data Analysis and Investigation Tools

## NASS Case Summaries (1998)

*FHWA/NHTSA National Crash Analysis Center  
The George Washington University*

*Motor Vehicle Fire Research Institute*

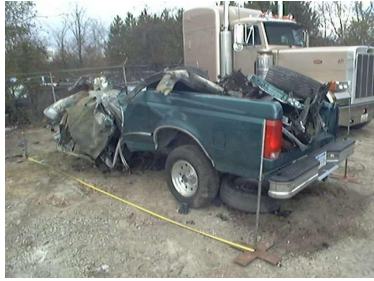
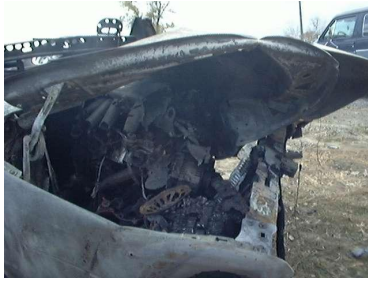
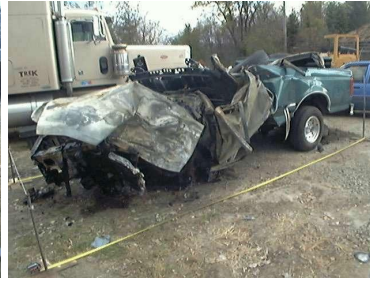
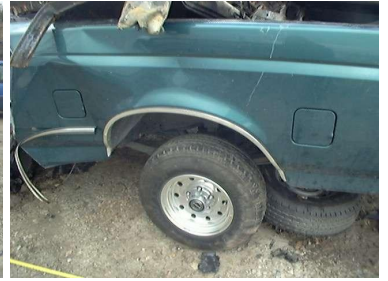
**Occupant: 1998-11-196-1-1**

| Fire Occurrence | Major fire |
| Location of Fuel Leakage | No fuel leakage |
| Fuel Tank Damage | No damage |

| Damage (C1-C6) | 12 F D E W 4 |

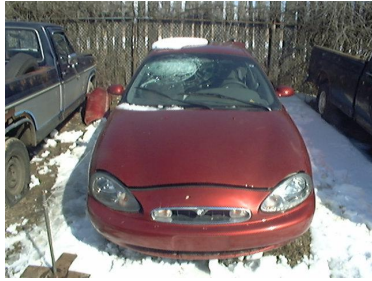
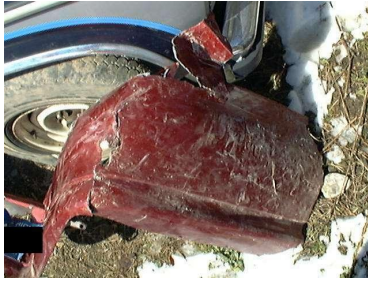
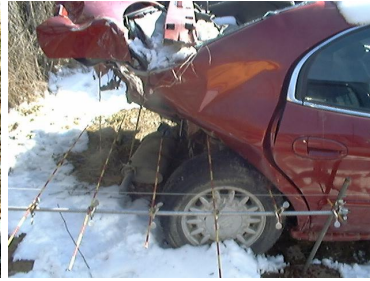
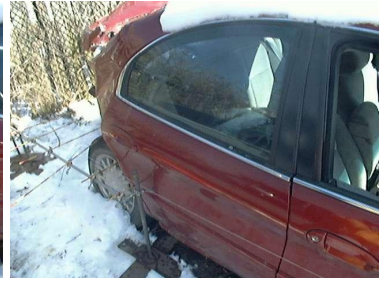
**Occupant: 1998-11-29-1-1**

| Fire Occurrence | No fire |
| Location of Fuel Leakage | Other |
| Fuel Tank Damage | Other damage |

| Damage (C1-C6) | 82 86 63 42 14 7 |

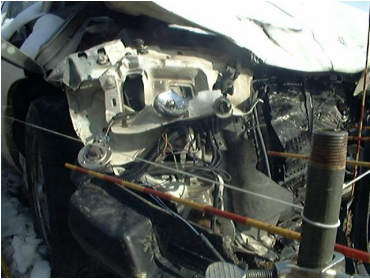
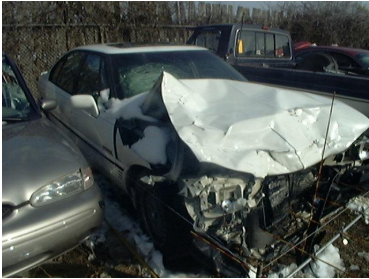
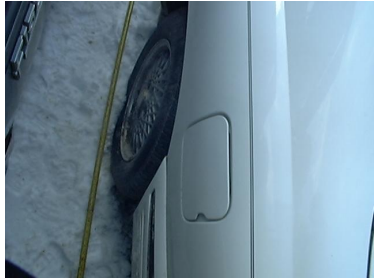
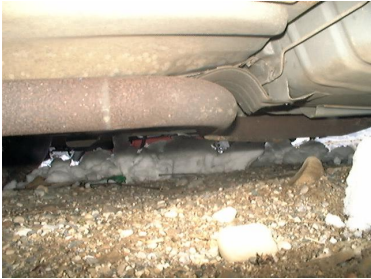
Occupant: 1998-11-29-2-1

| Fire Occurence | No fire |
| Location of Fuel Leakage | No fuel leakage |
| Fuel Tank Damage | No damage |

| Damage (C1-C6) | 0 33 38 37 30 44 |

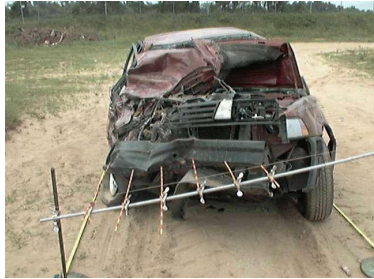
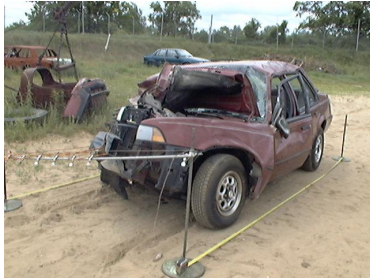
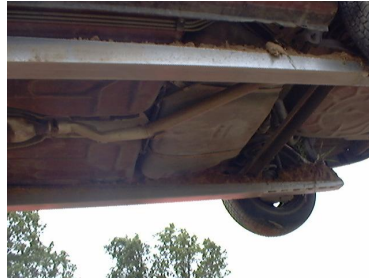
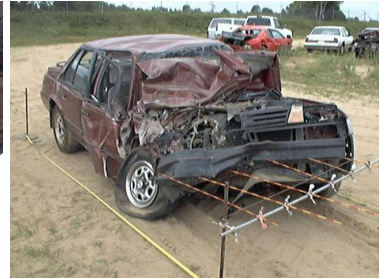
**Occupant: 1998-12-100-1-1**

| Fire Occurrence | No fire |
| Location of Fuel Leakage | No fuel leakage |
| Fuel Tank Damage | No damage |

| Damage (C1-C6) | 0 23 48 66 72 86 |

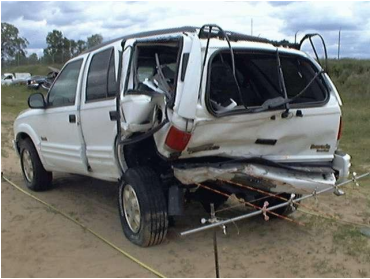
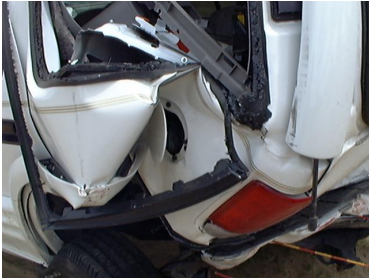
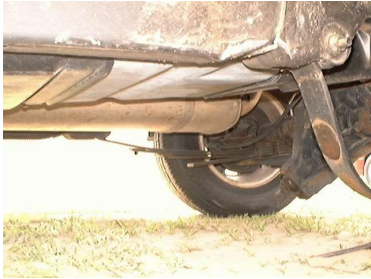
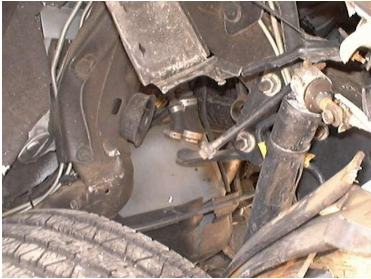
Occupant: 1998-12-100-2-1

| Fire Occurence | No fire |
| Location of Fuel Leakage | Other |
| Fuel Tank Damage | Deform+seam fail |

| Damage (C1-C6) | 81 74 53 27 6 12 |

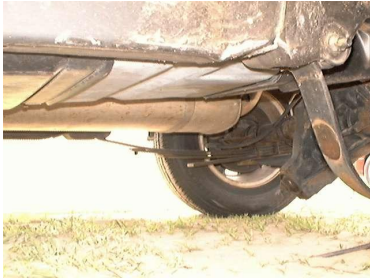
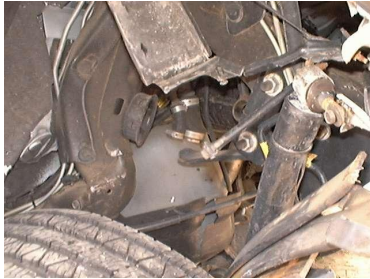
Occupant: 1998-12-100-2-2

| Fire Occurence | No fire |
| Location of Fuel Leakage | Other |
| Fuel Tank Damage | Deform+seam fail |

| Damage (C1-C6) | 81 74 53 27 6 12 |

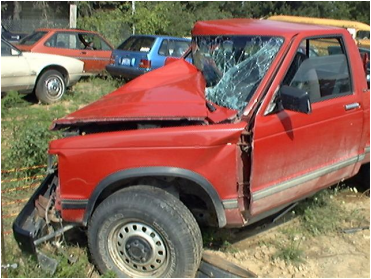
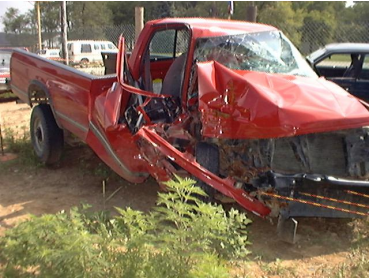
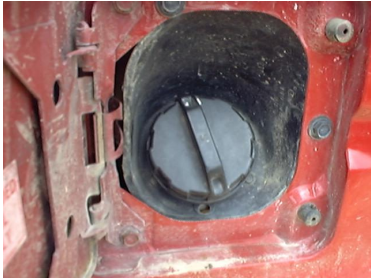
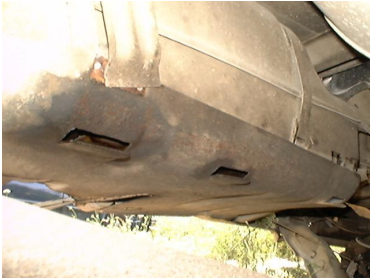
Occupant: 1998-12-134-1-1

| Fire Occurence | No fire |
| Location of Fuel Leakage | Tank |
| Fuel Tank Damage | Deform+seam fail |

| Damage (C1-C6) | 19 31 44 72 88 130 |

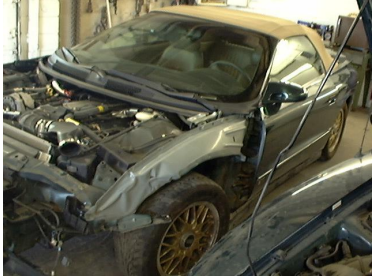
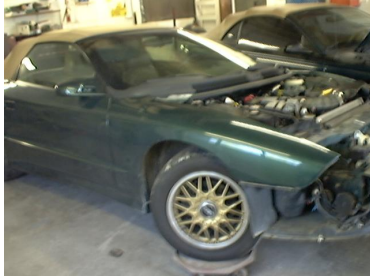
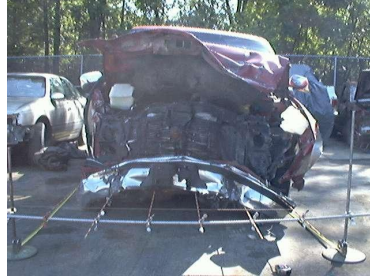
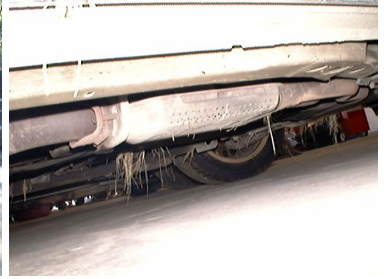
**Occupant: 1998-12-160-2-1**

| Fire Occurrence | No fire |
| Location of Fuel Leakage | No fuel leakage |
| Fuel Tank Damage | No damage |

| Damage (C1-C6) | 49 71 69 68 72 91 |

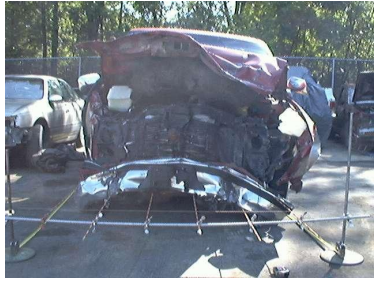
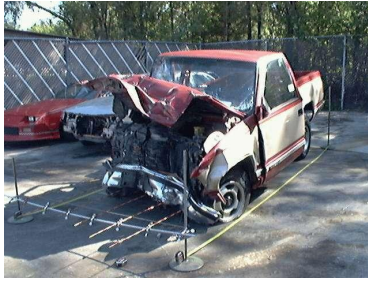
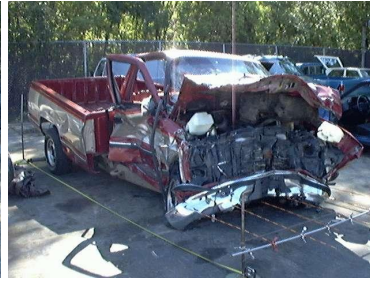
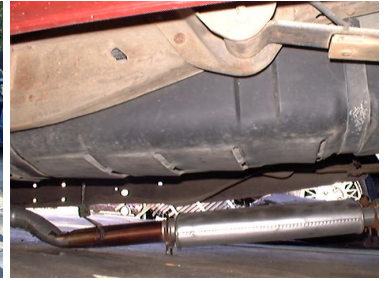
**Occupant: 1998-12-160-3-1**

| Fire Occurrence | Major fire |
| Location of Fuel Leakage | No fuel leakage |
| Fuel Tank Damage | No damage |

| Damage (C1-C6) | 0 1 41 43 55 25 |

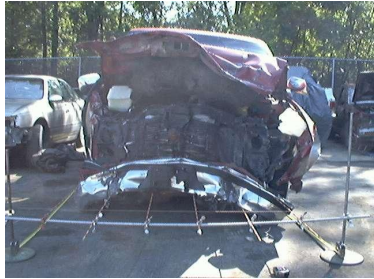
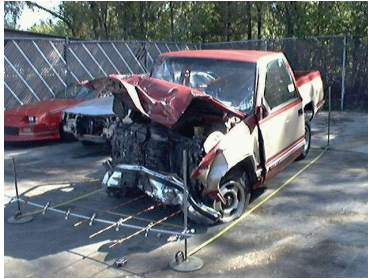
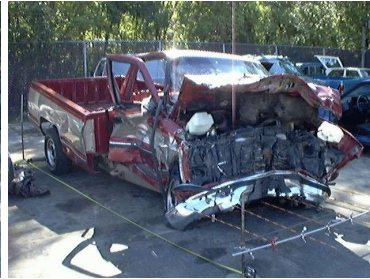
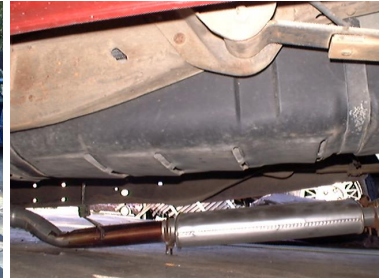
**Occupant: 1998-12-160-3-2**

| Fire Occurrence | Major fire |
| Location of Fuel Leakage | No fuel leakage |
| Fuel Tank Damage | No damage |

| Damage (C1-C6) | 0 1 41 43 55 25 |

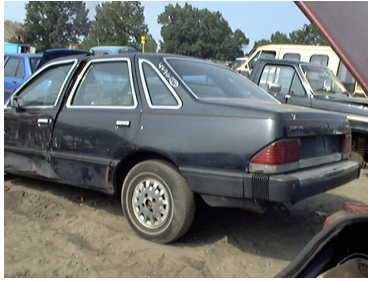
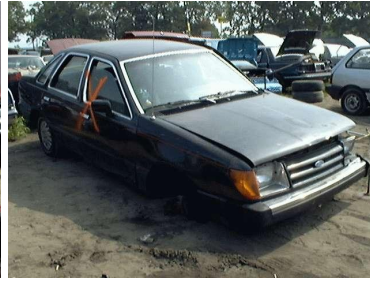
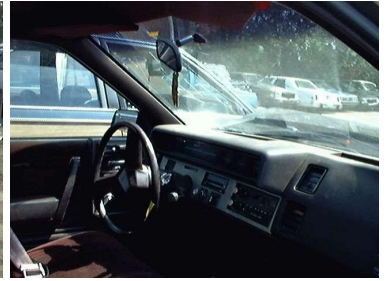
**Occupant: 1998-13-139-1-2**

| Fire Occurrence | No fire |
| Location of Fuel Leakage | No fuel leakage |
| Fuel Tank Damage | No damage |

| Damage (C1-C6) | 1 4 6 12 18 3 |

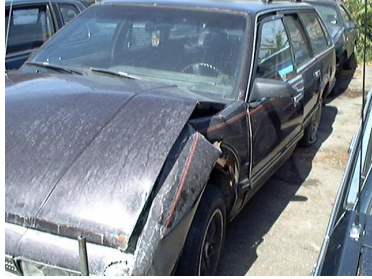
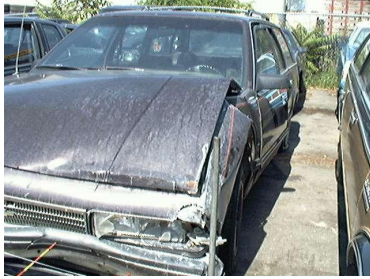
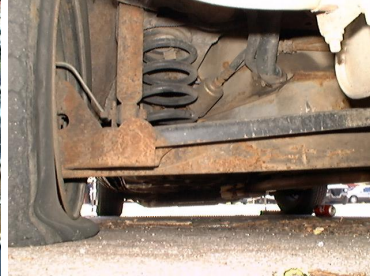
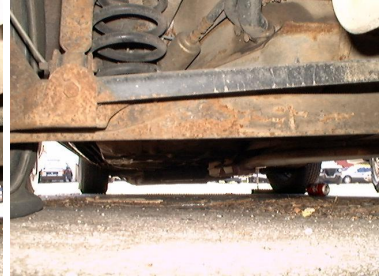
## Occupant: 1998-13-139-2-1

| Fire Occurrence | Minor fire |
| Location of Fuel Leakage | No fuel leakage |
| Fuel Tank Damage | No damage |

| Damage (C1-C6) | 35 31 28 19 10 8 |

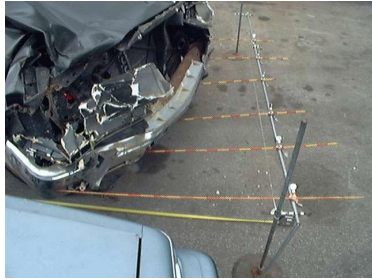
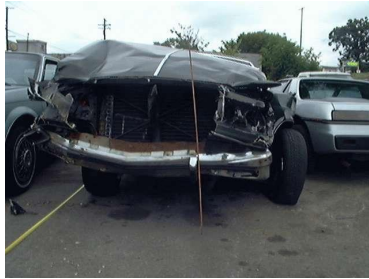
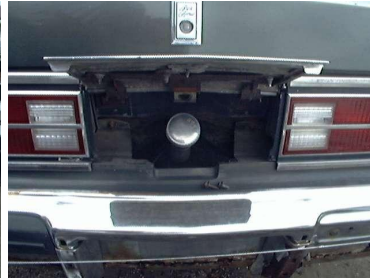
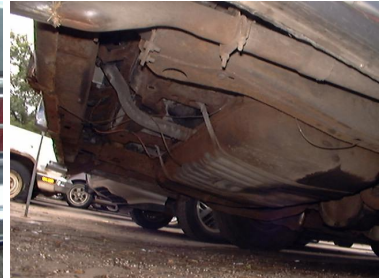
**Occupant: 1998-13-147-1-1**

| Fire Occurrence | No fire |
| Location of Fuel Leakage | No fuel leakage |
| Fuel Tank Damage | No damage |

| Damage (C1-C6) | 24 22 34 42 47 75 |

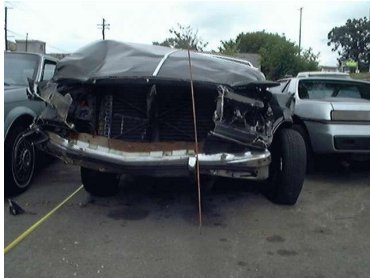
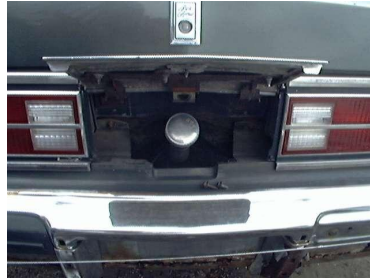
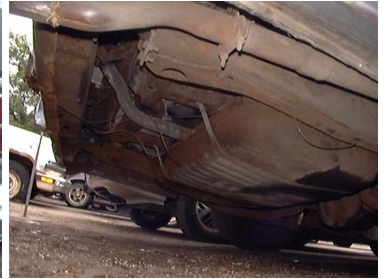
**Occupant: 1998-13-147-1-2**

| Fire Occurrence | No fire |
| Location of Fuel Leakage | No fuel leakage |
| Fuel Tank Damage | No damage |

| Damage (C1-C6) | 24 22 34 42 47 75 |

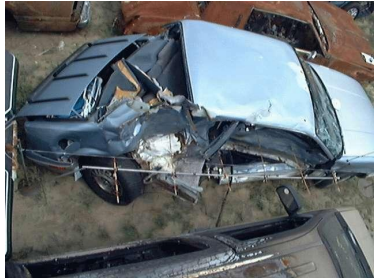
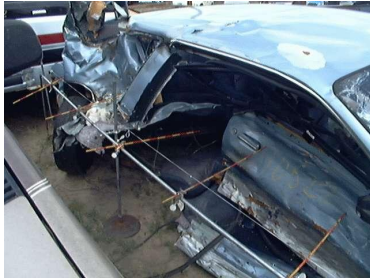
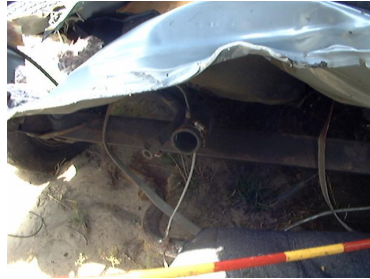
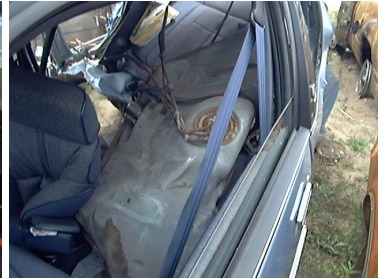
**Occupant: 1998-13-147-2-1**

| Fire Occurrence | No fire |
| Location of Fuel Leakage | Filler neck |
| Fuel Tank Damage | Deformed |

| Damage (C1-C6) | 0 28 44 44 31 0 |

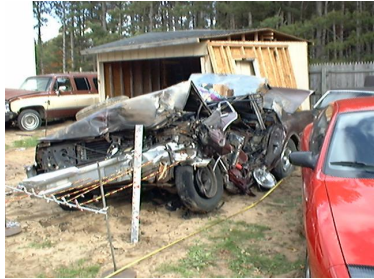
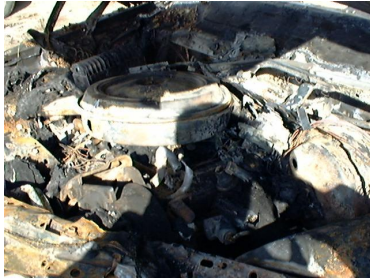
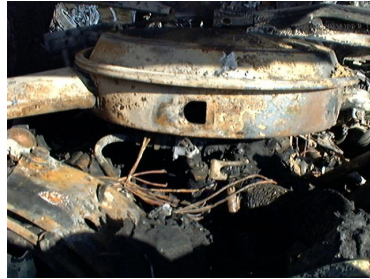
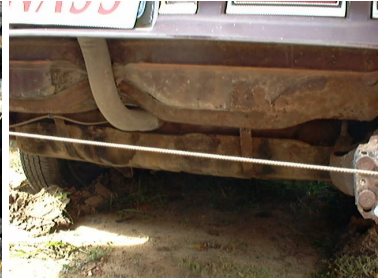
**Occupant: 1998-13-199-1-1**

| Fire Occurrence | Major fire |
| Location of Fuel Leakage | Line/pump/filter |
| Fuel Tank Damage | No damage |

| Damage (C1-C6) | 142 135 109 106 51 0 |

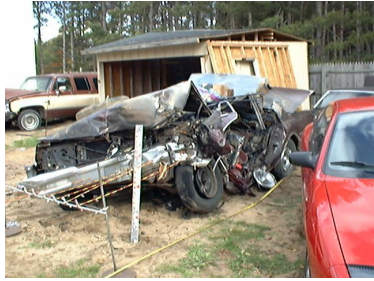
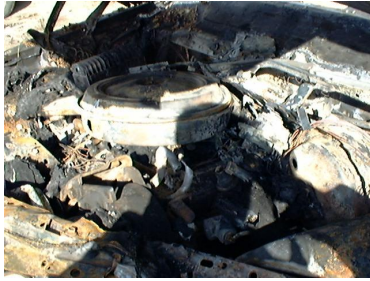
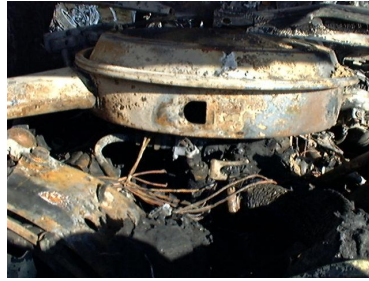
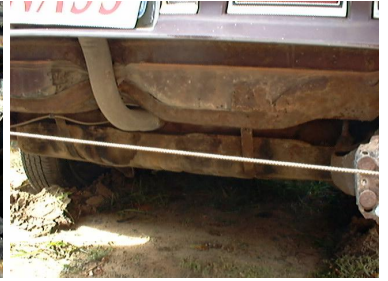
**Occupant: 1998-13-199-1-2**

| Fire Occurrence | Major fire |
| Location of Fuel Leakage | Line/pump/filter |
| Fuel Tank Damage | No damage |

| Damage (C1-C6) | 142 135 109 106 51 0 |

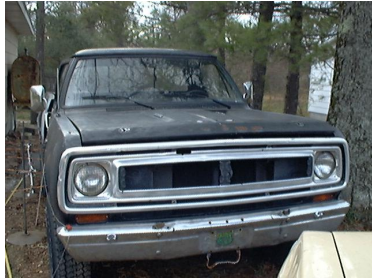
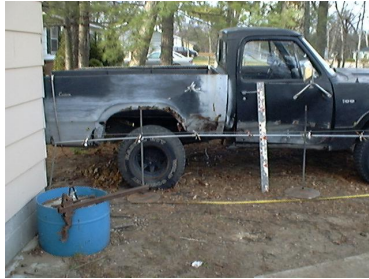
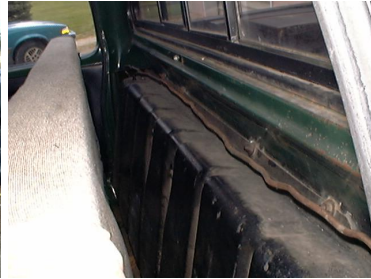
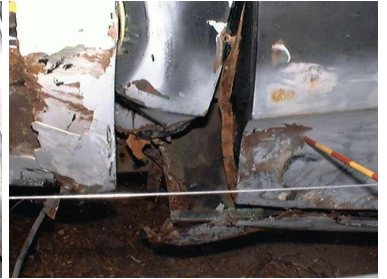
**Occupant: 1998-13-213-1-1**

| Fire Occurrence | No fire |
| Location of Fuel Leakage | Tank |
| Fuel Tank Damage | Deform+seam fail |

| Damage (C1-C6) | 0 0 17 31 18 3 |

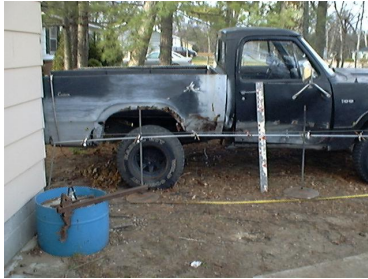
**Occupant: 1998-13-213-1-2**

| Fire Occurrence | No fire |
| Location of Fuel Leakage | Tank |
| Fuel Tank Damage | Deform+seam fail |

| Damage (C1-C6) | 0 0 17 31 18 3 |

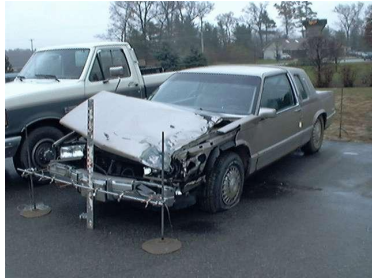
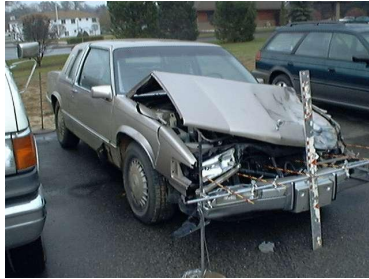
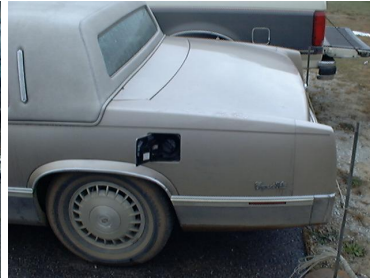
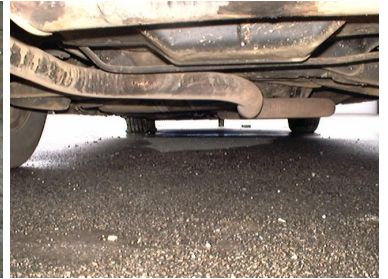
**Occupant: 1998-13-213-2-1**

| Fire Occurrence | No fire |
| Location of Fuel Leakage | No fuel leakage |

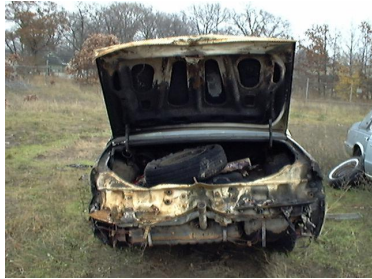
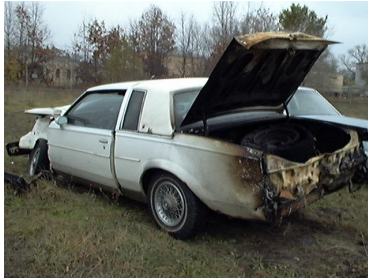
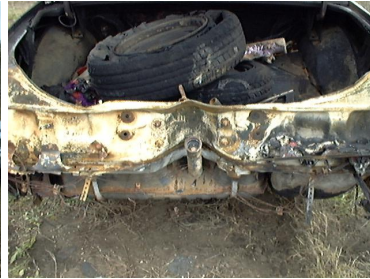
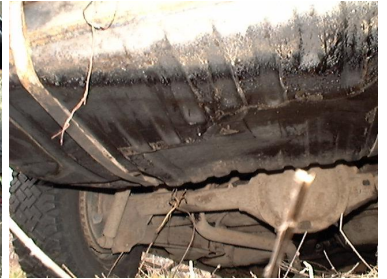
**Occupant: 1998-13-215-1-1**

| Fire Occurrence | Minor fire |

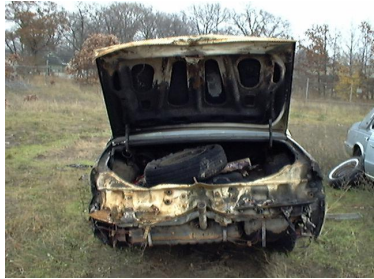
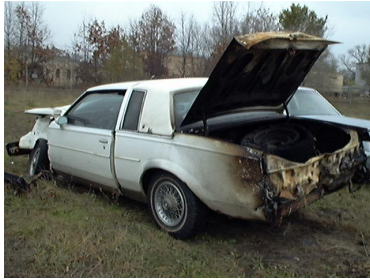
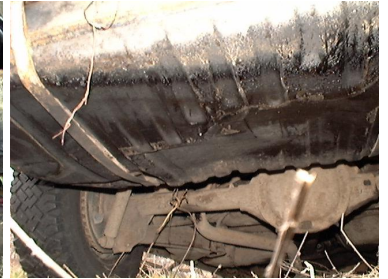
**Occupant: 1998-13-215-1-4**

| Fire Occurrence | Minor fire |
| Location of Fuel Leakage | Tank |
| Fuel Tank Damage | Punctured |

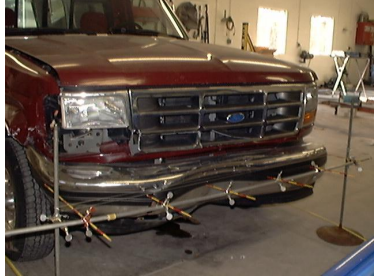
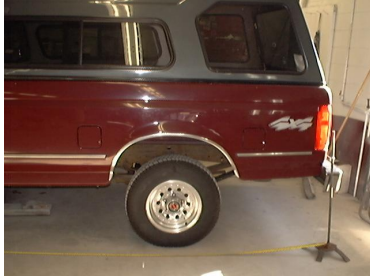
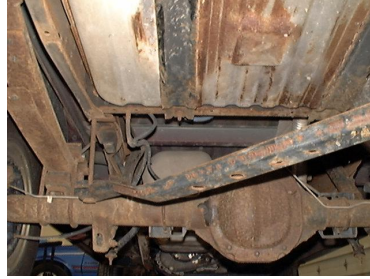
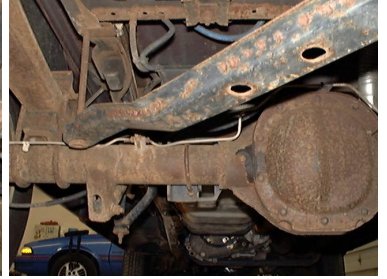
**Occupant: 1998-13-215-2-1**

| Fire Occurrence | No fire |
| Location of Fuel Leakage | No fuel leakage |
| Fuel Tank Damage | No damage |

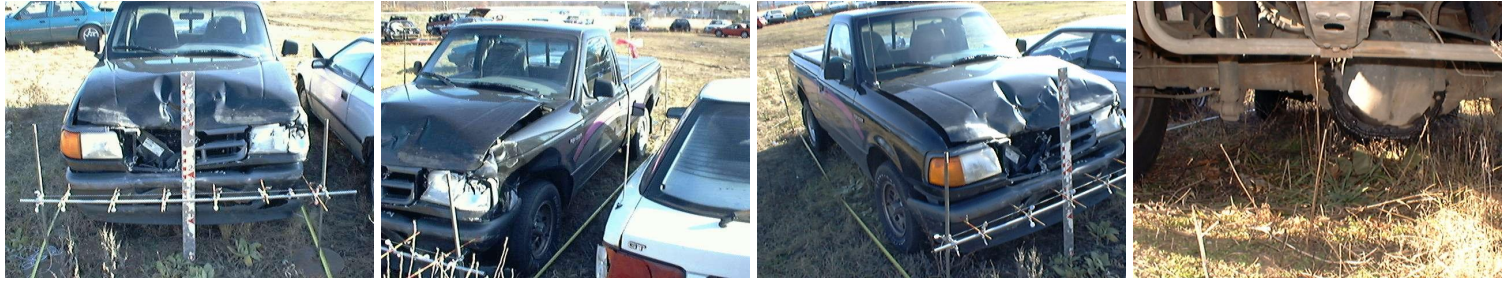
**Occupant: 1998-13-223-1-1**

| Fire Occurrence | No fire |
| Fuel Tank Damage | No damage |

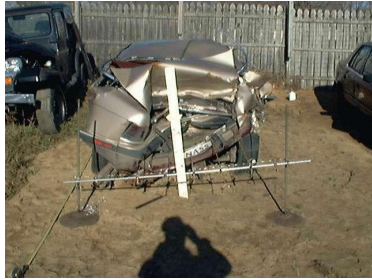
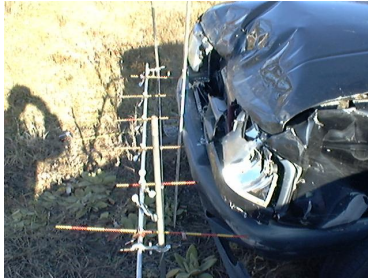
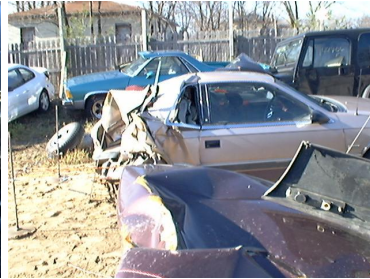
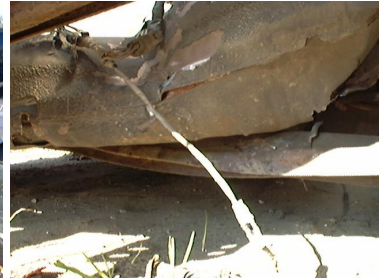
**Occupant: 1998-13-223-2-1**

| Fire Occurrence | No fire |
| Location of Fuel Leakage | Tank |
| Fuel Tank Damage | Deform+seam fail |

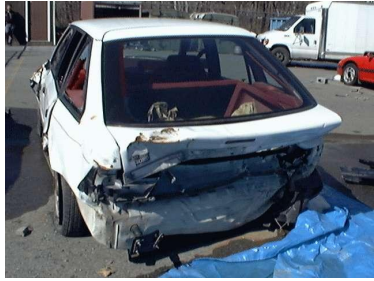
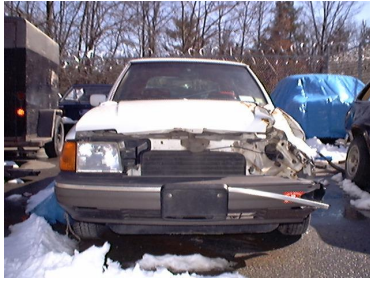
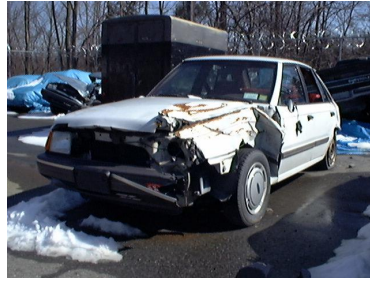
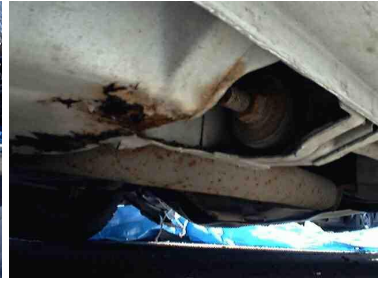
**Occupant: 1998-2-10-1-1**

| Fire Occurrence | No fire |

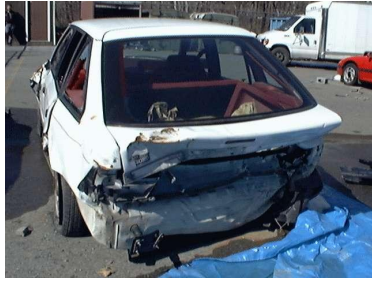
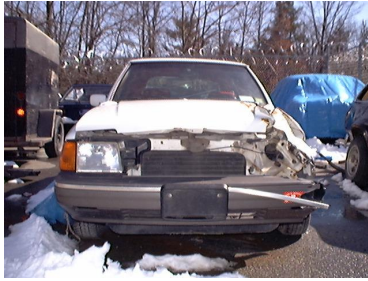
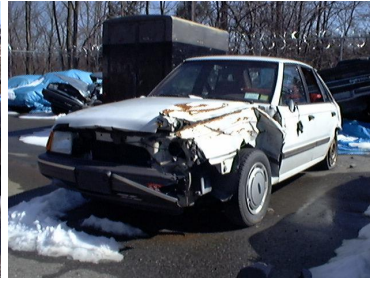
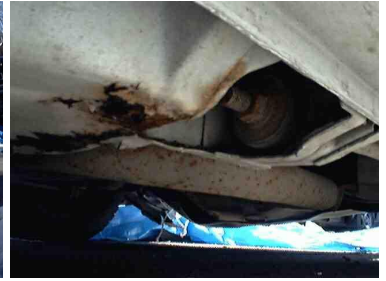
**Occupant: 1998-2-10-1-2**

| Fire Occurrence | No fire |

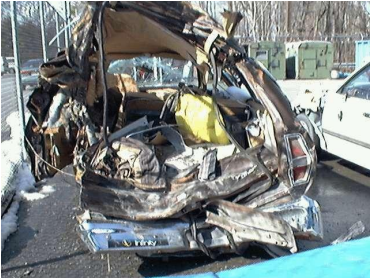
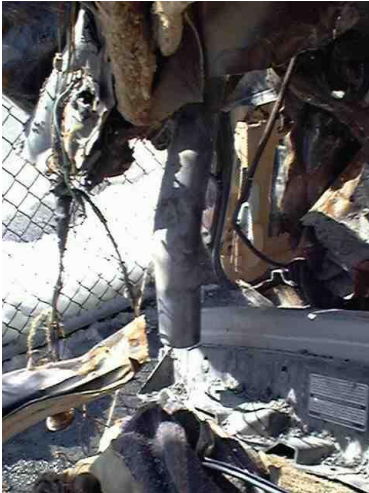
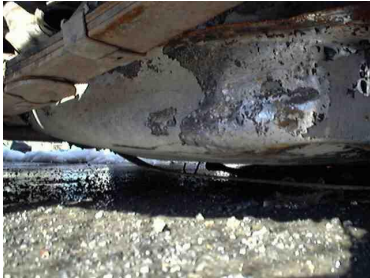
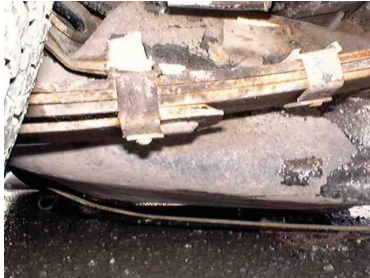
Occupant: 1998-2-10-2-1

| Fire Occurence | No fire |
| Location of Fuel Leakage | Filler neck |
| Fuel Tank Damage | Deformed |

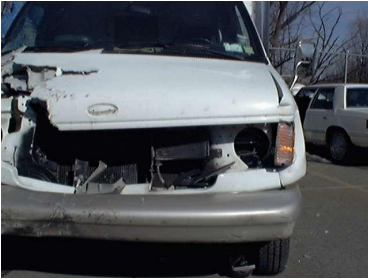
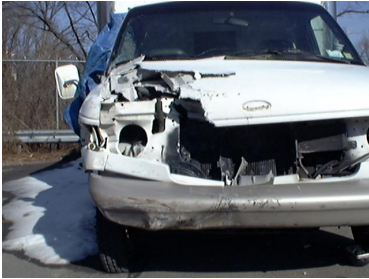
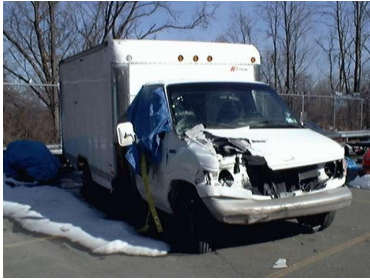
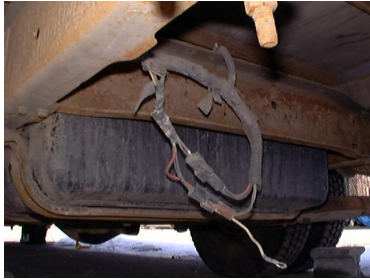
Occupant: 1998-2-10-3-1

| Fire Occurence | No fire |
| Location of Fuel Leakage | No fuel leakage |
| Fuel Tank Damage | No damage |

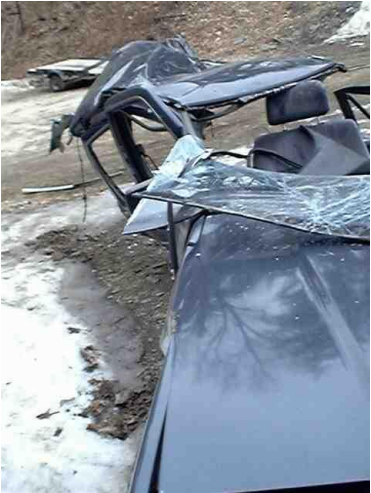
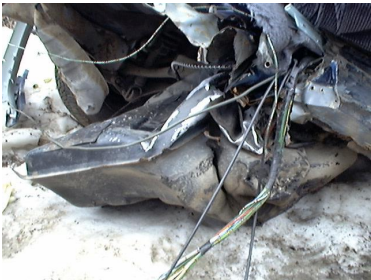
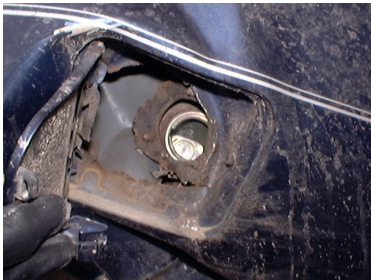
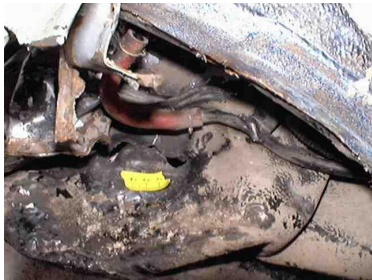
Occupant: 1998-2-11-1-1

| Fire Occurence | No fire |
| Location of Fuel Leakage | Tank |
| Fuel Tank Damage | Punctured |

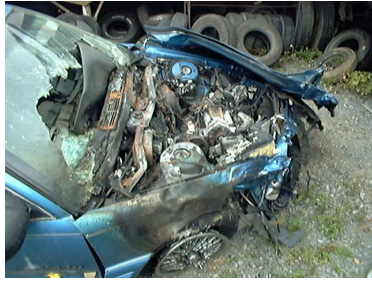
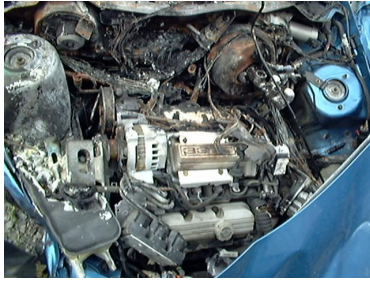
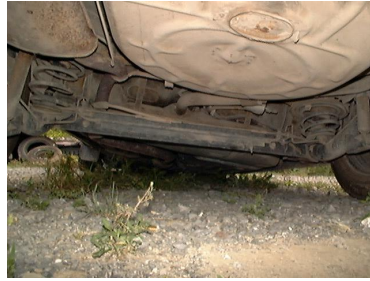
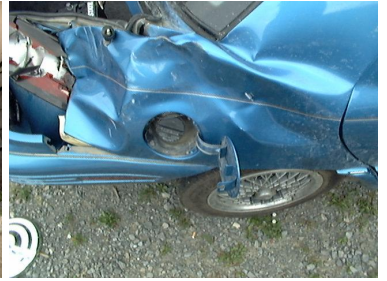
**Occupant: 1998-2-123-1-1**

| Fire Occurrence | Major fire |

| Damage (C1-C6) | 6 13 18 21 23 32 |

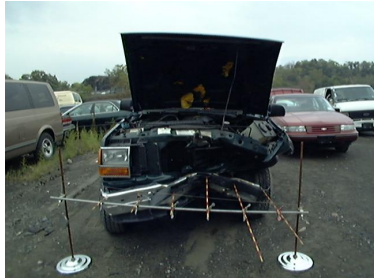
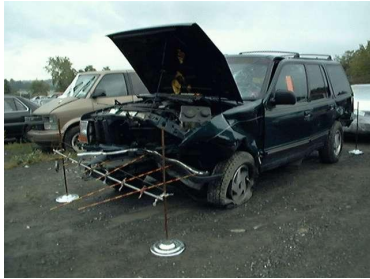
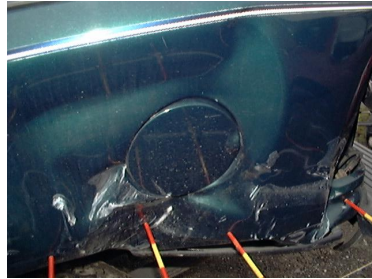
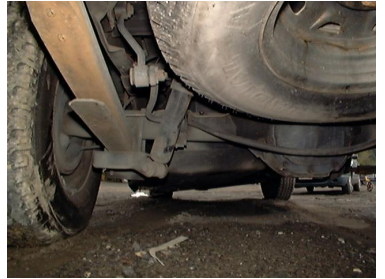
**Occupant: 1998-2-123-2-1**

| Damage (C1-C6) | 53 48 40 11 3 0 |

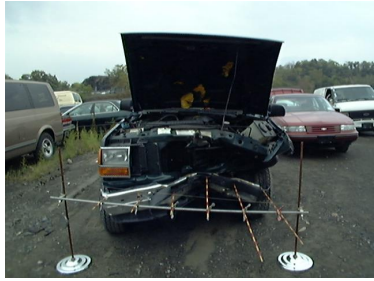
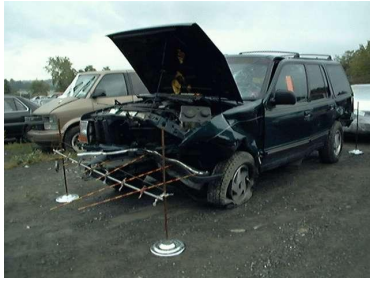
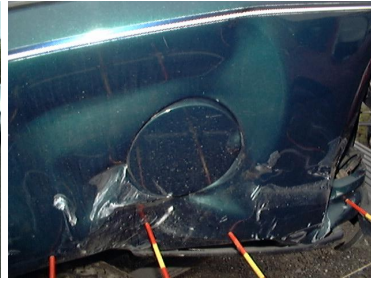
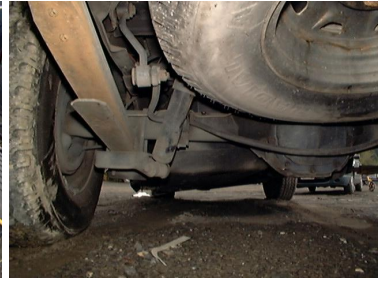
**Occupant: 1998-2-123-2-2**

| Damage (C1-C6) | 53 48 40 11 3 0 |

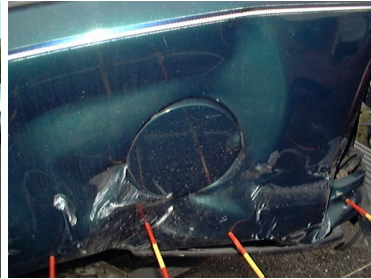
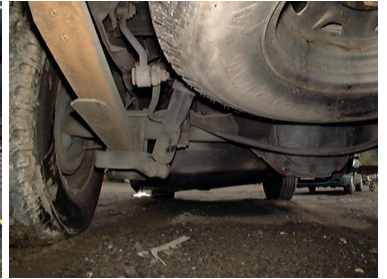
**Occupant: 1998-2-123-2-3**

| Damage (C1-C6) | 53 48 40 11 3 0 |

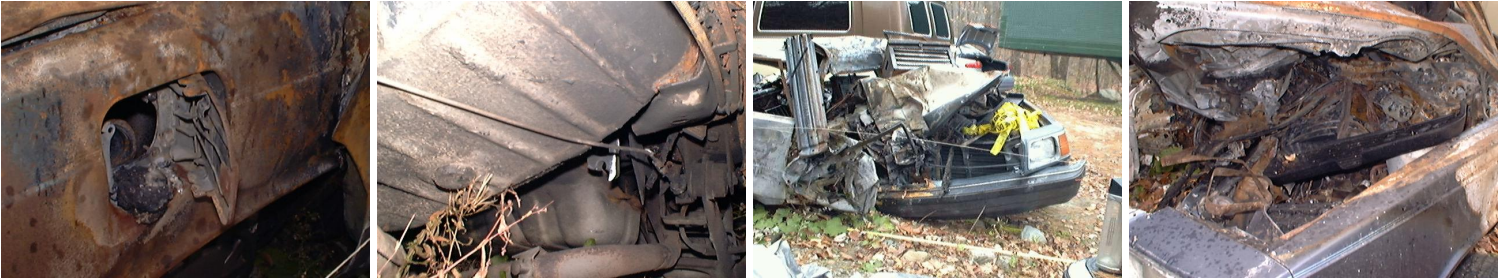
Occupant: 1998-2-142-1-1

Vehicle #1 traveling west on two lane undivided roadway negotiating a curve to the left. Vehicle #1 runs off right side of roadway rotating counterclockwise and strikes a tree with front. Vehicle #1 rotates counterclockwise, catches fire and comes to rest facing in a westerly direction. The weather was clear, the roadway dry and it was dark, but lighted at the time of the crash. Vehicle #1 was towed due to damage. Operator was transported and expired at a local hospital.

| Fire Occurence | Major fire |

| Damage (C1-C6) | 68 132 177 202 0 0 |

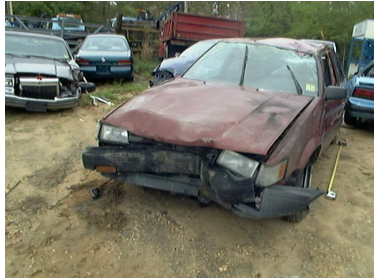
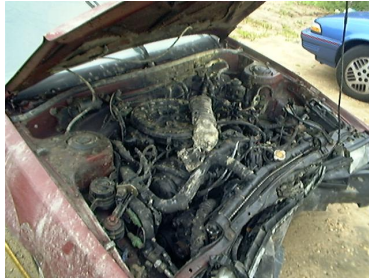
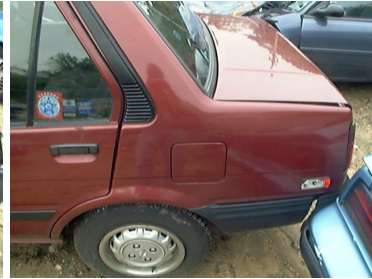
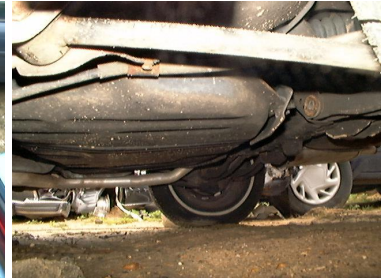
**Occupant: 1998-4-52-1-1**

| Fire Occurrence | Minor fire |

| Damage (C1-C6) | 1 24 31 24 11 0 |

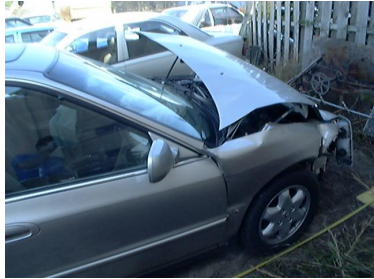
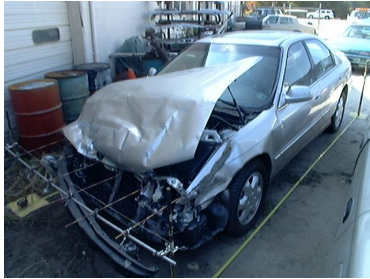
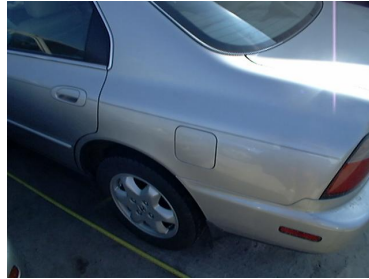
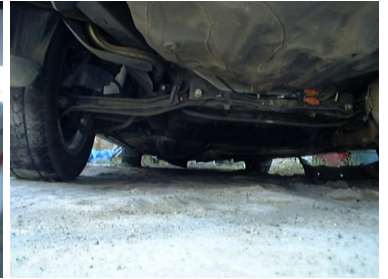
**Occupant: 1998-43-261-1-1**

| Fire Occurrence | No fire |
| Location of Fuel Leakage | No fuel leakage |
| Fuel Tank Damage | No damage |

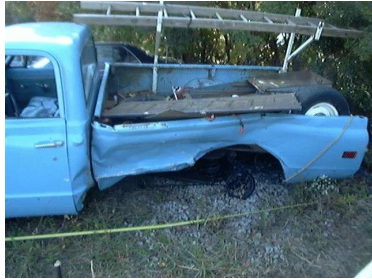
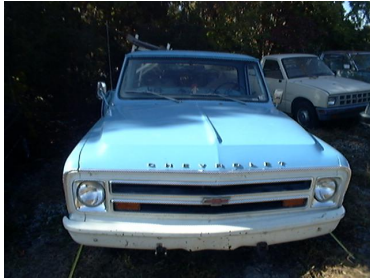
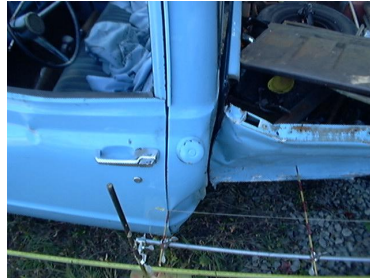
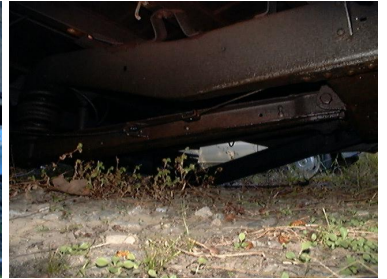
**Occupant: 1998-43-261-2-1**

| Fire Occurrence | No fire |
| Location of Fuel Leakage | Filler neck |
| Fuel Tank Damage | Other damage |

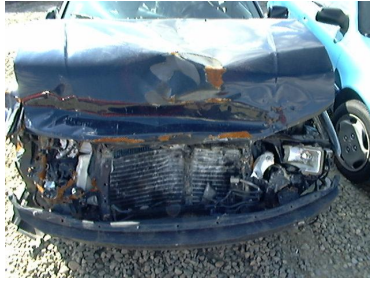
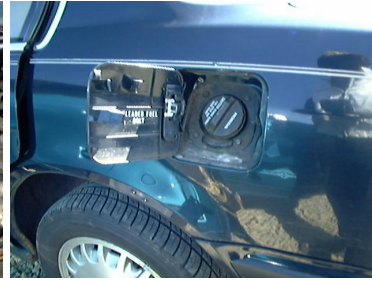
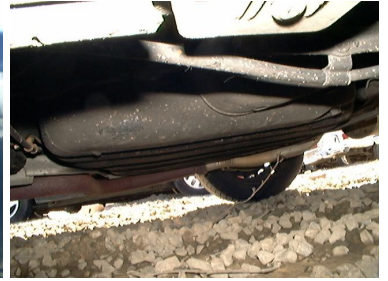
**Occupant: 1998-43-30-2-1**

| Fire Occurrence | Minor fire |
| Location of Fuel Leakage | No fuel leakage |
| Fuel Tank Damage | No damage |

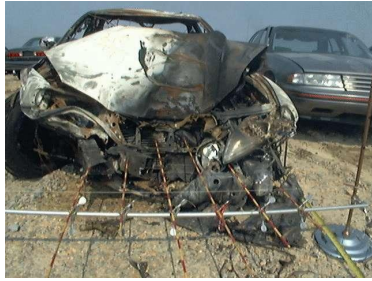
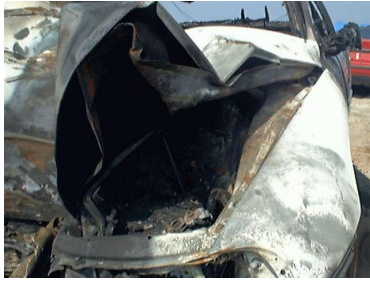
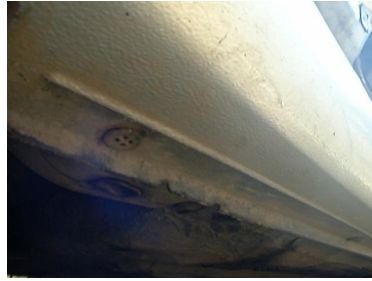
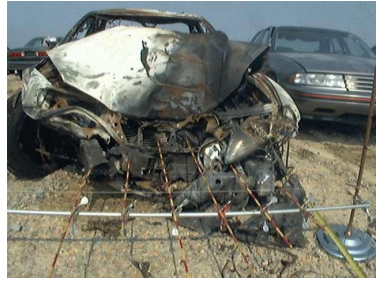
**Occupant: 1998-43-501-1-1**

| Fire Occurrence | Major fire |
| Location of Fuel Leakage | No fuel leakage |
| Fuel Tank Damage | No damage |

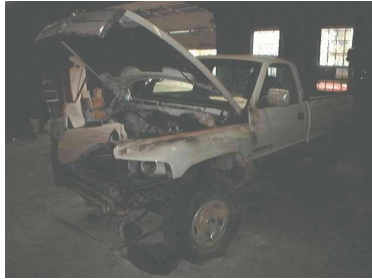
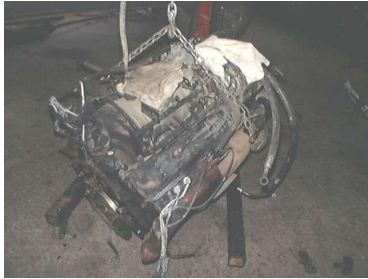
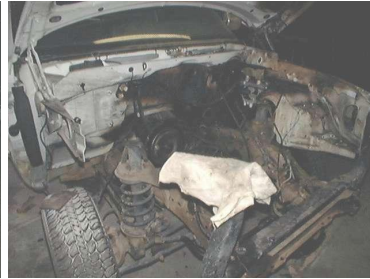
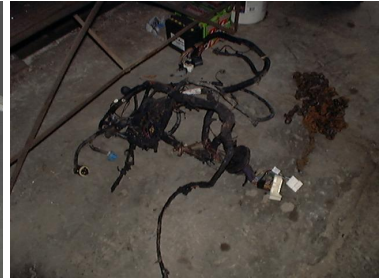
**Occupant: 1998-43-502-1-1**

| Fire Occurrence | Minor fire |
| Location of Fuel Leakage | No fuel leakage |
| Fuel Tank Damage | No damage |

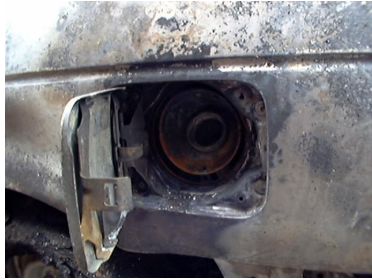
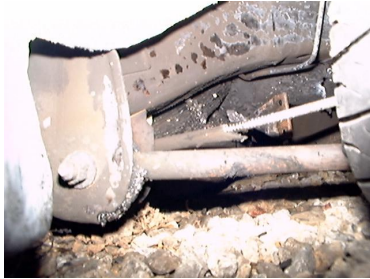
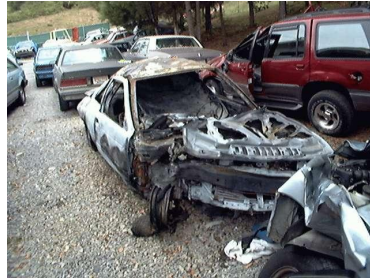
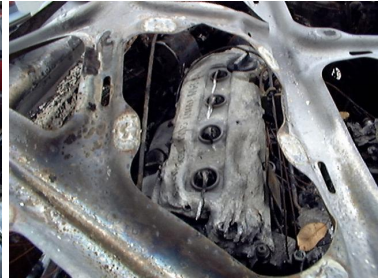
**Occupant: 1998-45-117-1-1**

| Fire Occurrence | Major fire |
| Location of Fuel Leakage | No fuel leakage |
| Fuel Tank Damage | Other damage |

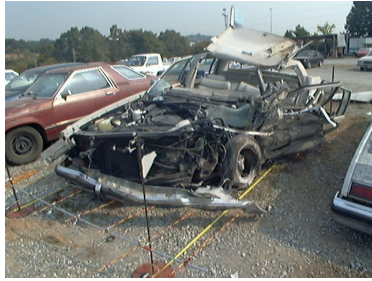
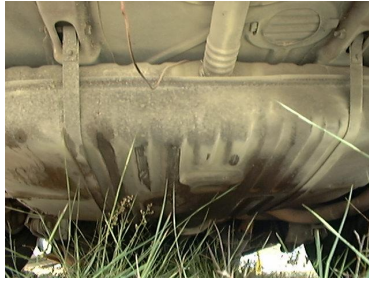
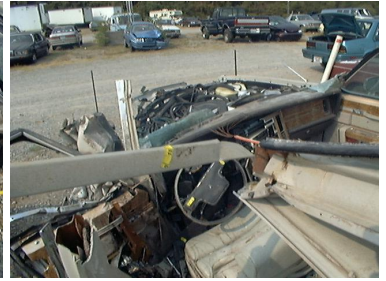
**Occupant: 1998-45-122-1-1**

| Fire Occurrence | Minor fire |
| Location of Fuel Leakage | No fuel leakage |
| Fuel Tank Damage | No damage |

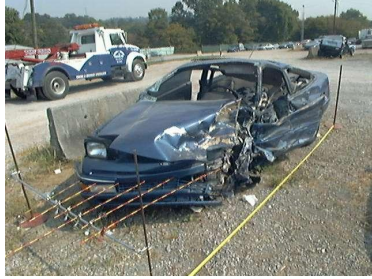
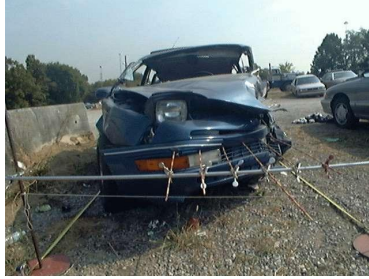
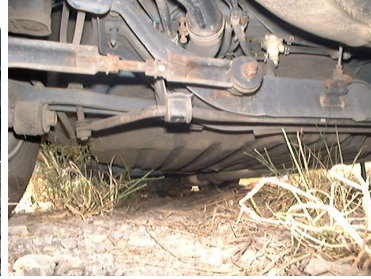
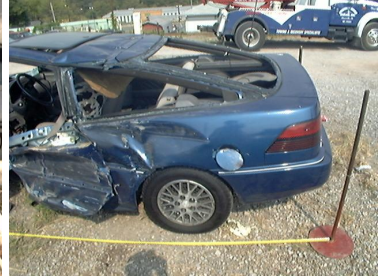
**Occupant: 1998-45-122-2-1**

| Fire Occurrence | No fire |
| Location of Fuel Leakage | No fuel leakage |
| Fuel Tank Damage | No damage |

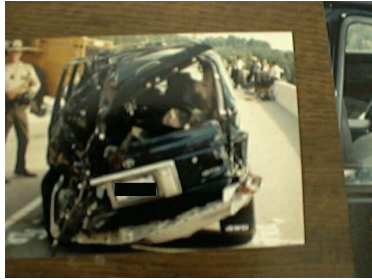
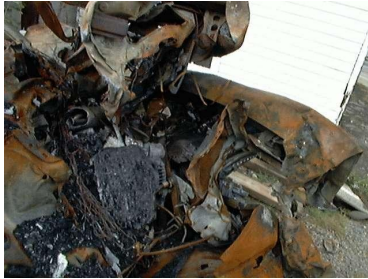
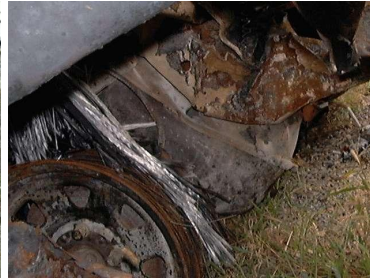
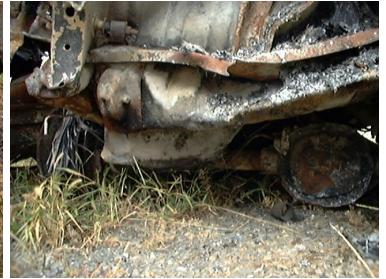
**Occupant: 1998-45-128-2-1**

| Fire Occurrence | Major fire |

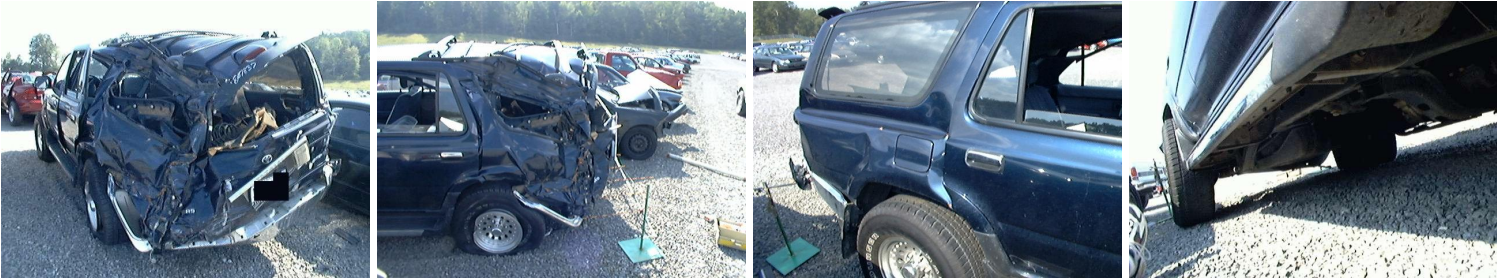
Occupant: 1998-45-128-4-1

| Fire Occurence | No fire |

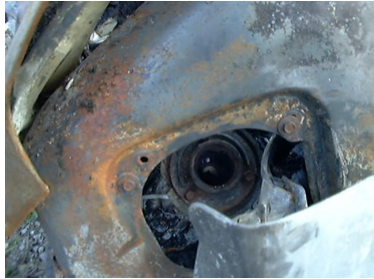
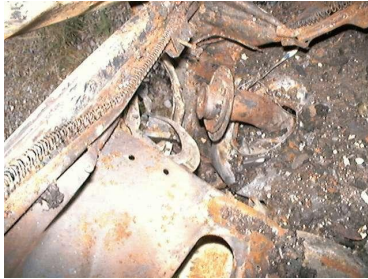
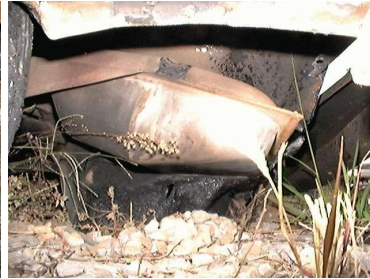
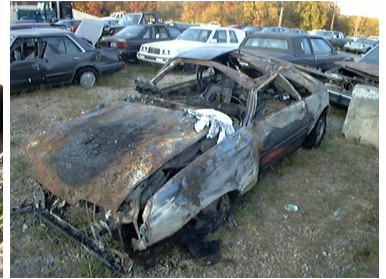
**Occupant: 1998-45-147-1-1**

| Fire Occurrence | Major fire |

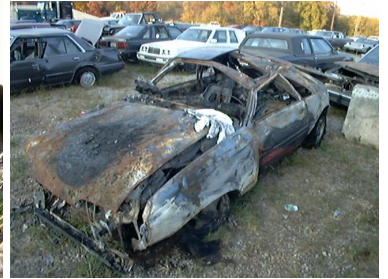
**Occupant: 1998-45-147-1-2**

| Fire Occurrence | Major fire |

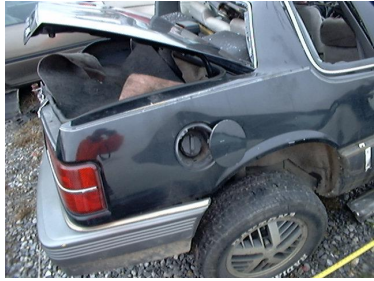
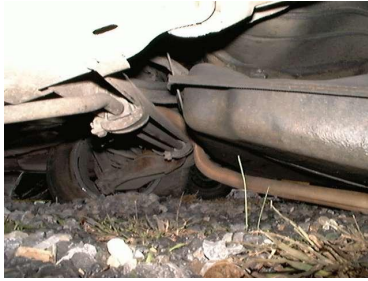
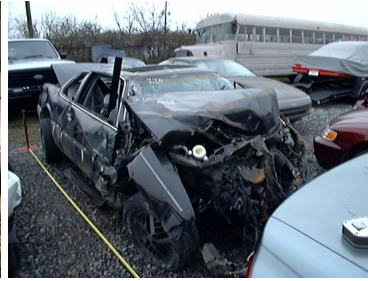
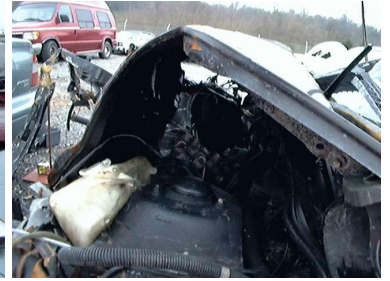
**Occupant: 1998-45-178-1-1**

| Fire Occurrence | Minor fire |
| Location of Fuel Leakage | No fuel leakage |
| Fuel Tank Damage | Deformed |

| Damage (C1-C6) | 58 60 72 70 55 49 |

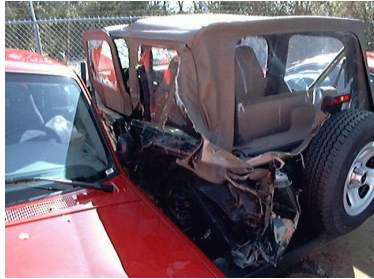
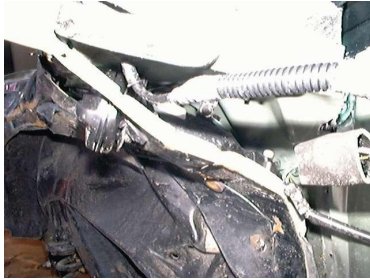
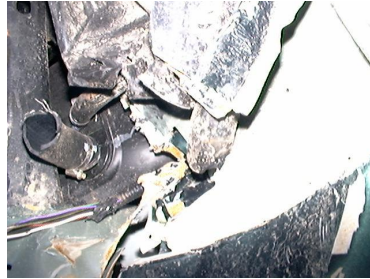
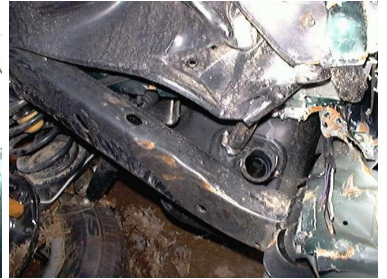
**Occupant: 1998-45-189-1-1**

| Fire Occurrence | No fire |
| Location of Fuel Leakage | Filler neck |
| Fuel Tank Damage | Fill neck separation |

| Damage (C1-C6) | 22 30 28 16 9 2 |

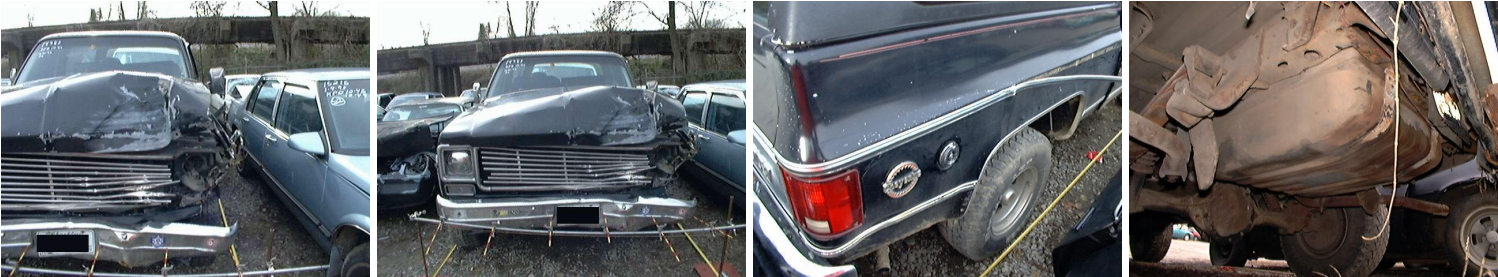
Occupant: 1998-45-189-2-1

| Fire Occurence | No fire |
| Location of Fuel Leakage | No fuel leakage |
| Fuel Tank Damage | No damage |

| Damage (C1-C6) | 18 12 11 7 0 0 |

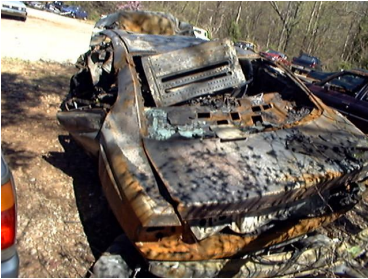
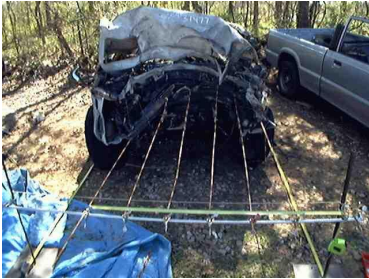
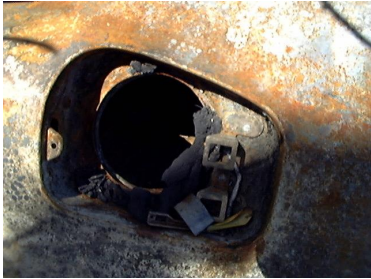
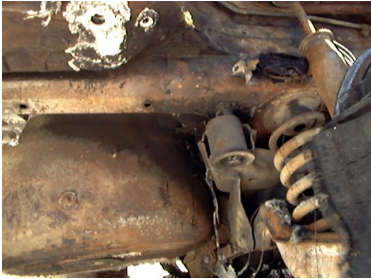
Occupant: 1998-45-28-1-1

| Fire Occurence | Major fire |
| Location of Fuel Leakage | Filler neck |
| Fuel Tank Damage | Fill neck separation |

| Damage (C1-C6) | 124 141 147 136 118 69 |

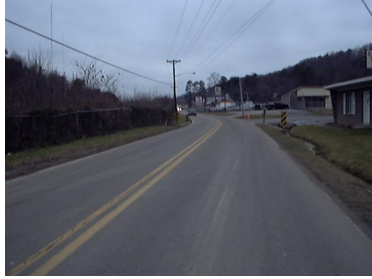
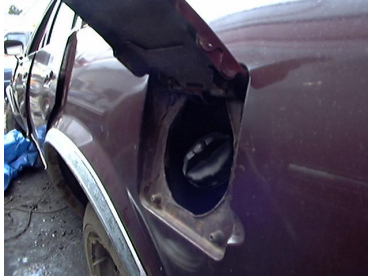
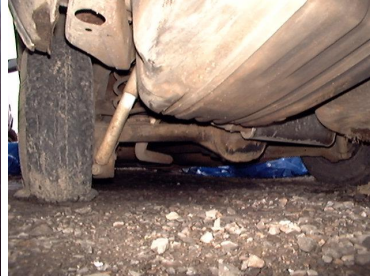
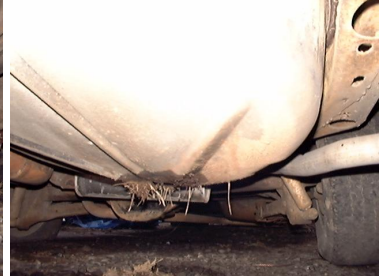
**Occupant: 1998-45-3-1-1**

| Fire Occurrence | No fire |
| Location of Fuel Leakage | Tank |
| Fuel Tank Damage | Punctured |

| Damage (C1-C6) | 10 12 14 15 12 4 |
