# Accident Data Analysis and Investigation Tools

## NASS Case Summaries (1998)

*FHWA/NHTSA National Crash Analysis Center  
The George Washington University*

*Motor Vehicle Fire Research Institute*

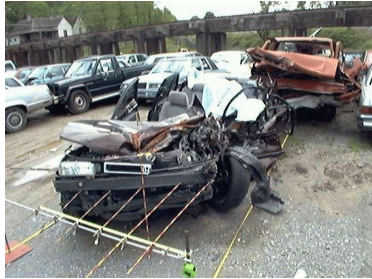
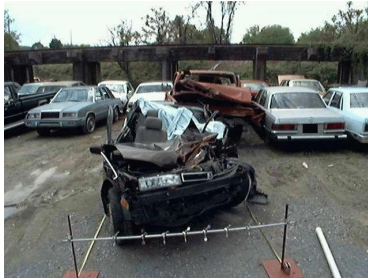
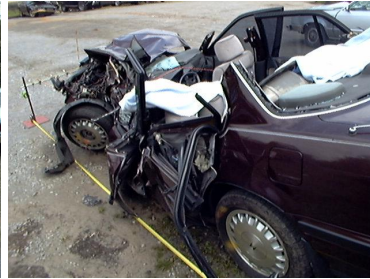
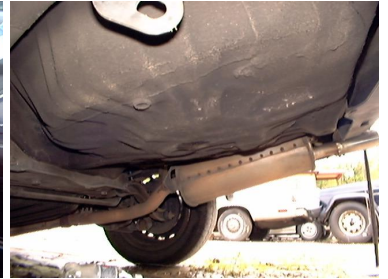
**Occupant: 1998-45-43-1-1**

| Fire Occurrence | No fire |
| Location of Fuel Leakage | No fuel leakage |
| Fuel Tank Damage | No damage |

| Damage (C1-C6) | 82 65 48 34 20 9 |

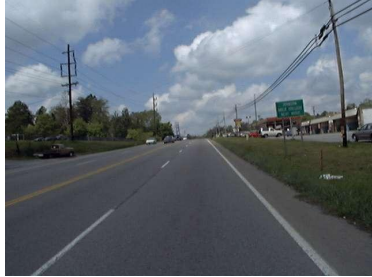
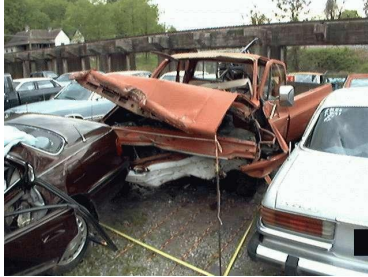
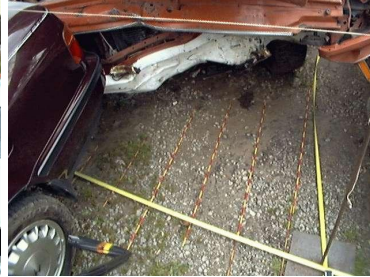
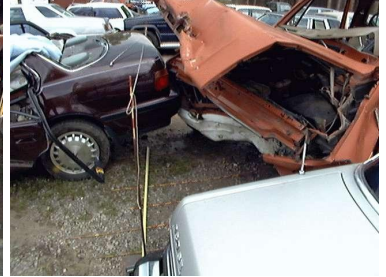
**Occupant: 1998-45-43-2-1**

| Fire Occurrence | No fire |
| Location of Fuel Leakage | Tank |
| Fuel Tank Damage | Deform+seam fail |

| Damage (C1-C6) | 143 121 107 92 47 28 |

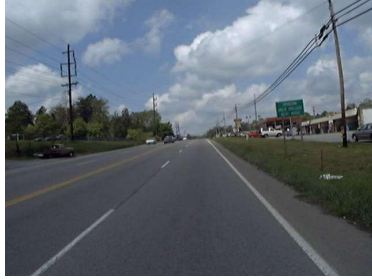
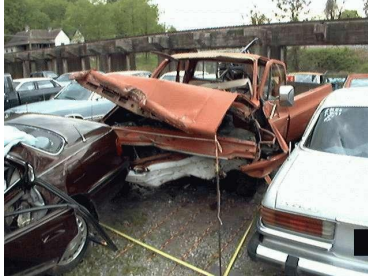
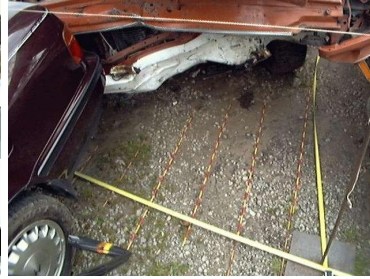
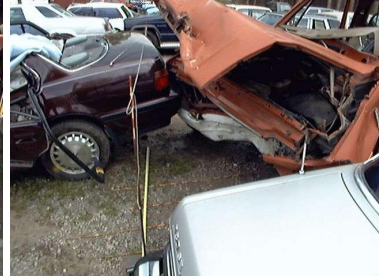
**Occupant: 1998-45-43-2-2**

| Fire Occurrence | No fire |

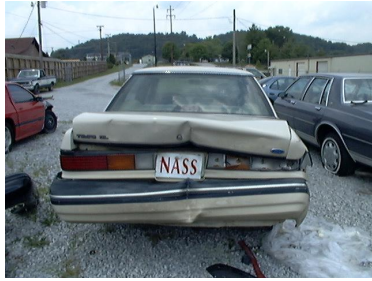
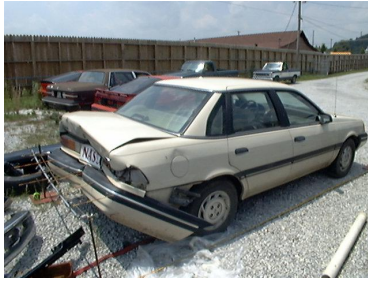
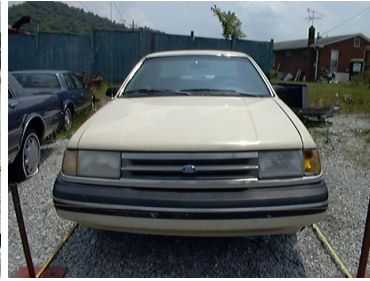
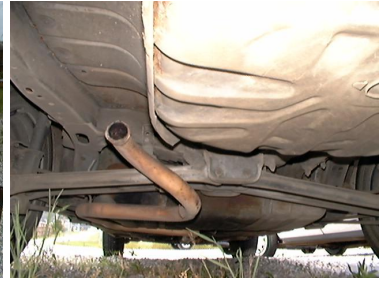
**Occupant: 1998-45-61-2-1**

| Fire Occurrence | No fire |

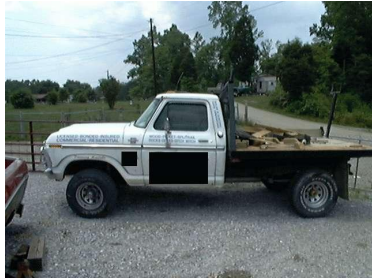
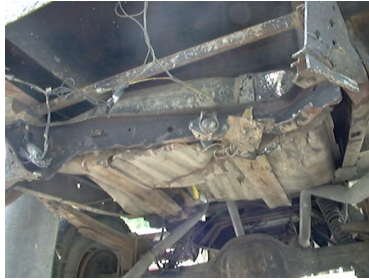
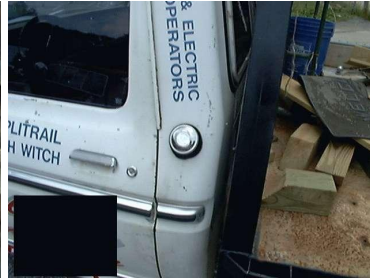
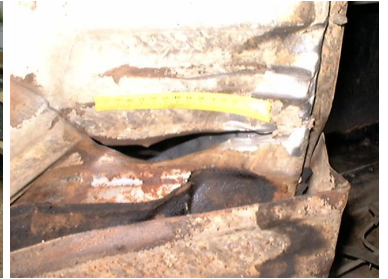
**Occupant: 1998-45-61-3-1**

| Fire Occurrence | No fire |

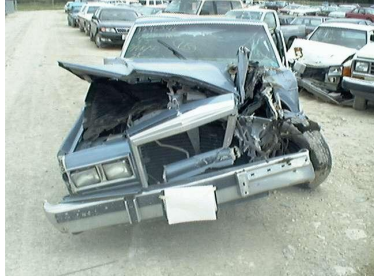
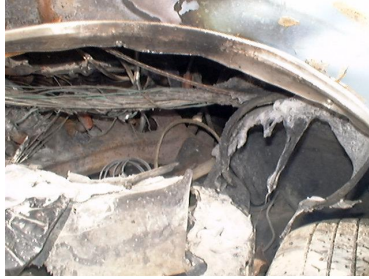
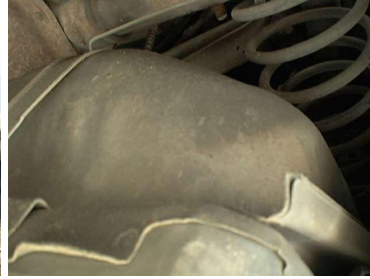
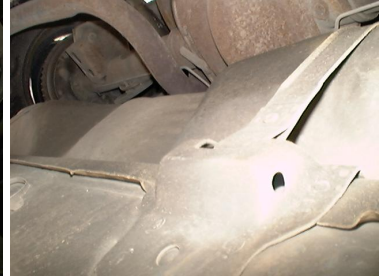
**Occupant: 1998-49-62-1-1**

Vehicle 1 was traveling NB in the 2nd lane of a dry 4-lane concrete undivided 2-way urban street, negotiating a curve just before an intersection. V1 went to the right, crossing the 1st lane and impacting a curb on the east side of the street. V1 continued northbound, across some grass, over the south curb of the cross street, over the north curb and across more grass. V1 then re-entered the street, began a CCW rotation, crossed all four lanes and impacted right front to a light pole on the west side of the street, where V1 came to rest and caught fire. The vehicle was towed due to damage and the driver and sole occupant was taken to the morgue where he was pronounced dead.

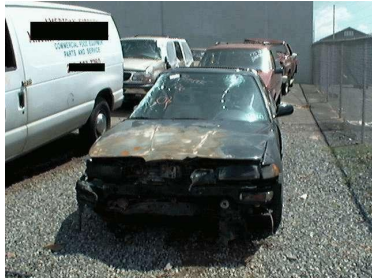
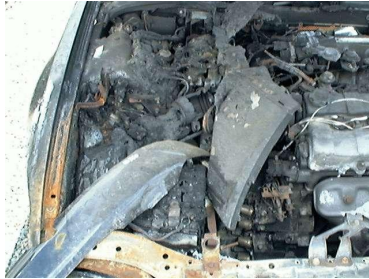
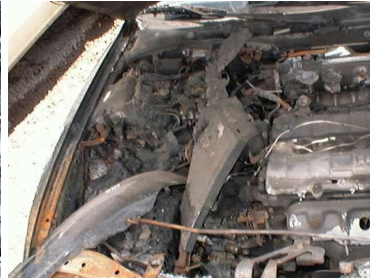
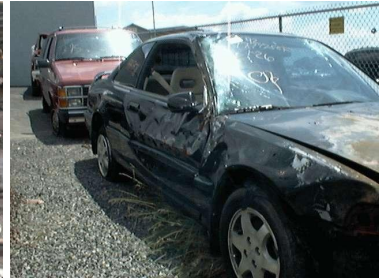
Occupant: 1998-5-62-1-1

V1 was travelling east on a two-lane, positively divided highway; approaching an exit ramp to an elevated street. V1 attempted to exit the highway and travelled onto a grassy, sloped median between the highway and the exit ramp. V1 began to rotate counter-clockwise while traversing the median and struck the end of a concrete retaining wall with it's right side. This impact cracked the frame of the vehicle behind the right front tire, causing the engine to separate from the vehicle. This impact also initiated a rollover to the right side. The engine and the vehicle travelled to the southeast through the air, across the exit ramp. Both objects then struck a chain-link fence, damaging the right side of the vehicle and knocking the fence over. The vehicle then struck a utility pole with it's right side while upside down. This impact changed the rotation of the vehicle to clockwise and ejected both occupants. The vehicle then came to rest on it's roof in the roadway. The engine travelled through the fence, struck a tree, then came to rest on a separate roadway, and caught fire. The vehicle required towing. One occupant sustained a serious injury, the other sustained a moderate injury. Both airbags deployed in the vehicle.

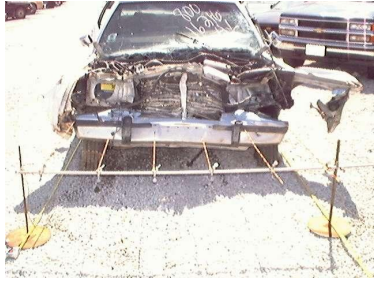
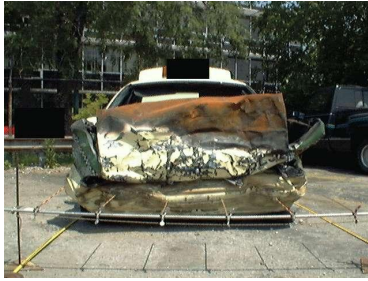
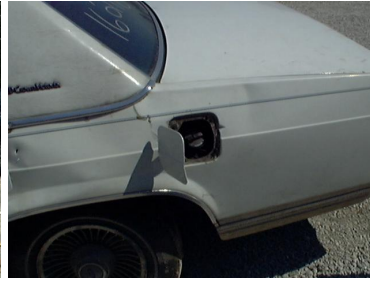
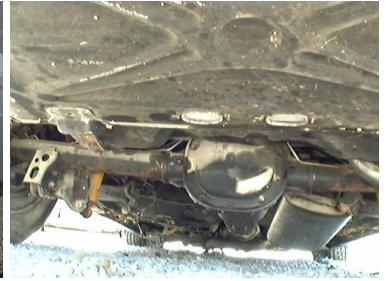
**Occupant: 1998-72-73-1-1**

| Fire Occurrence | No fire |
| Location of Fuel Leakage | No fuel leakage |
| Fuel Tank Damage | No damage |

| Damage (C1-C6) | 80 79 79 78 75 76 |

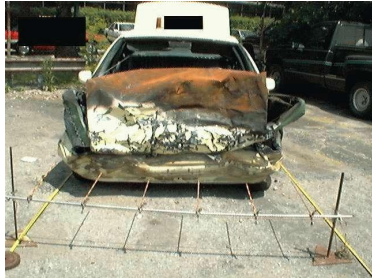
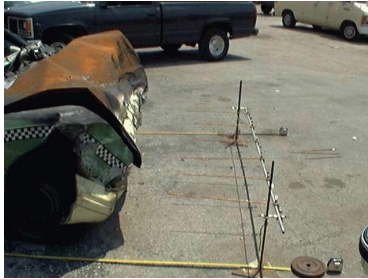
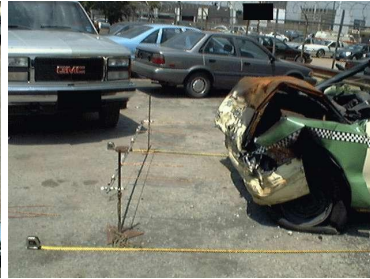
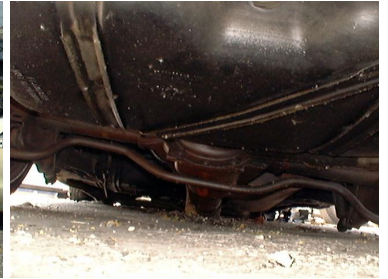
**Occupant: 1998-72-73-2-1**

| Fire Occurrence | Major fire |
| Location of Fuel Leakage | No fuel leakage |
| Fuel Tank Damage | No damage |

| Damage (C1-C6) | 88 90 88 85 81 78 |

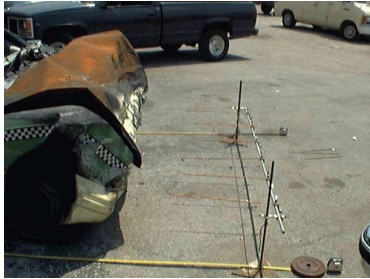
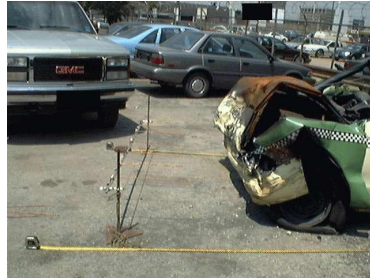
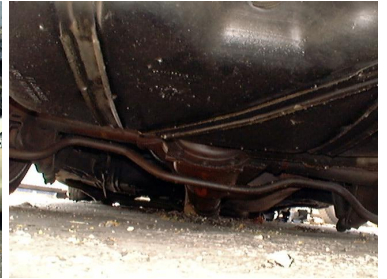
**Occupant: 1998-72-73-2-2**

| Fire Occurrence | Major fire |
| Location of Fuel Leakage | No fuel leakage |
| Fuel Tank Damage | No damage |

| Damage (C1-C6) | 88 90 88 85 81 78 |

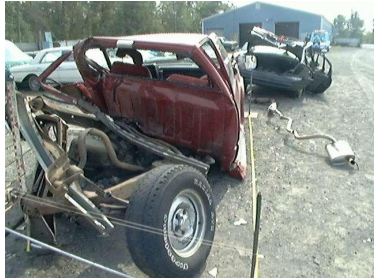
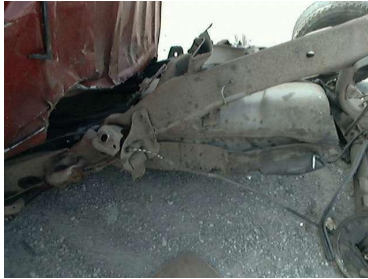
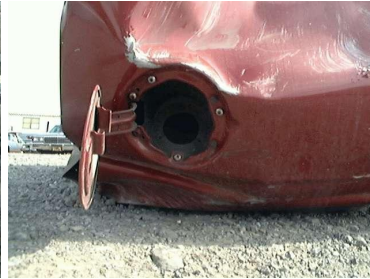
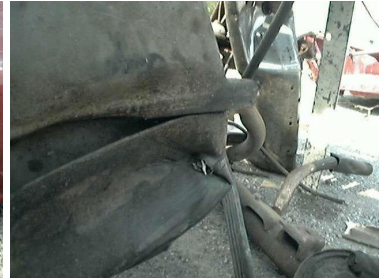
**Occupant: 1998-73-120-2-1**

| Fire Occurrence | No fire |
| Location of Fuel Leakage | Tank |
| Fuel Tank Damage | Punctured |

| Damage (C1-C6) | 86 B Y E W 9 |

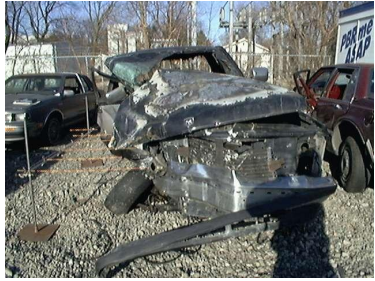
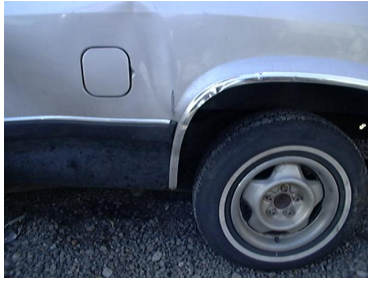
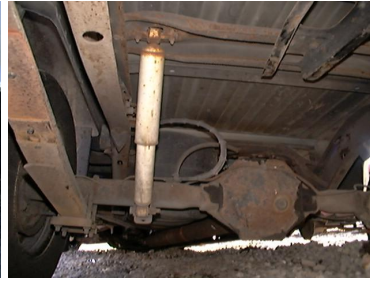
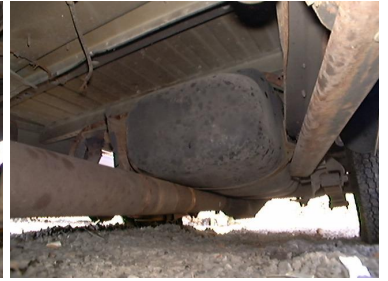
**Occupant: 1998-73-148-2-1**

| Fire Occurrence | Major fire |

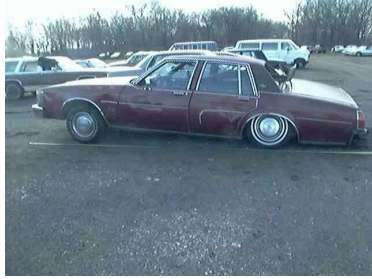
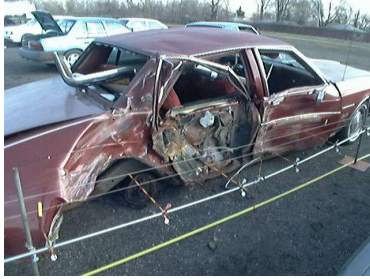
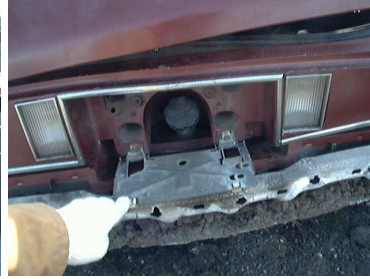
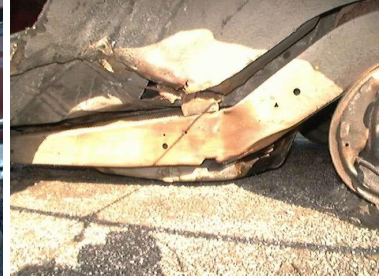
**Occupant: 1998-73-18-1-1**

| Location of Fuel Leakage | Tank |
| Fuel Tank Damage | Punctured |

| Damage (C1-C6) | 0 16 6 15 8 0 |

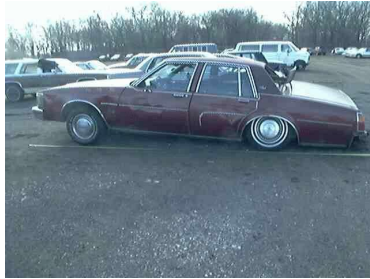
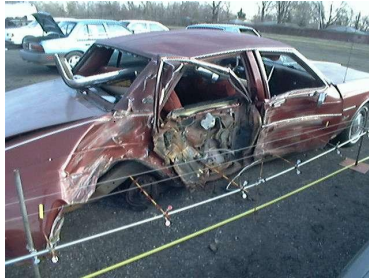
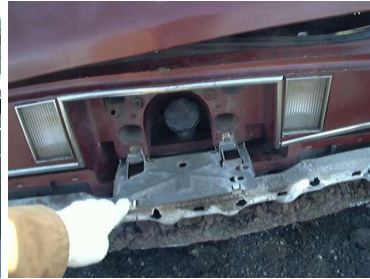
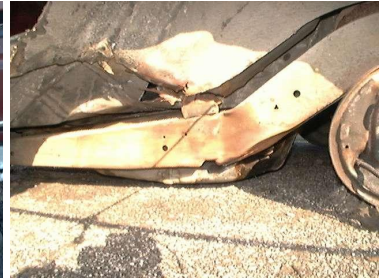
**Occupant: 1998-73-18-1-2**

| Location of Fuel Leakage | Tank |
| Fuel Tank Damage | Punctured |

| Damage (C1-C6) | 0 16 6 15 8 0 |

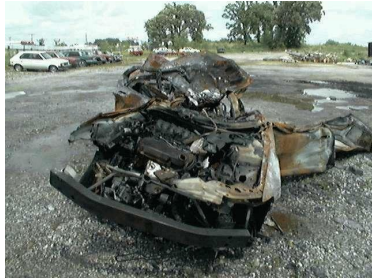
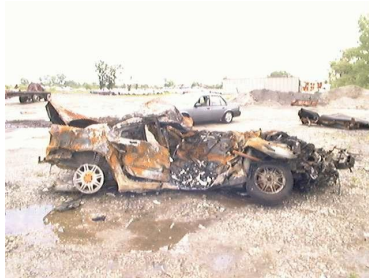
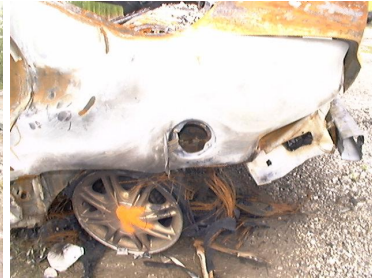
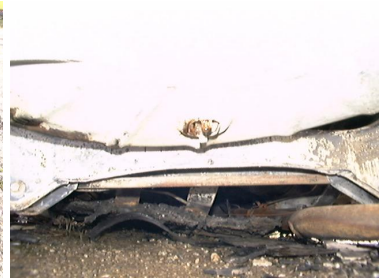
**Occupant: 1998-73-70-1-1**

| Fire Occurrence | Major fire |
| Location of Fuel Leakage | Other |
| Fuel Tank Damage | Other damage |

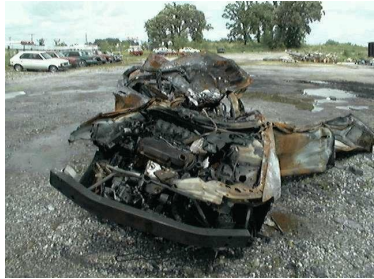
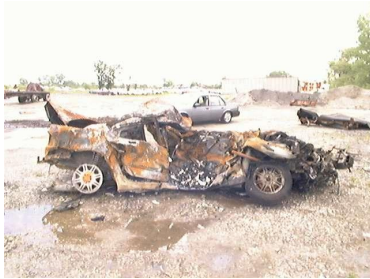
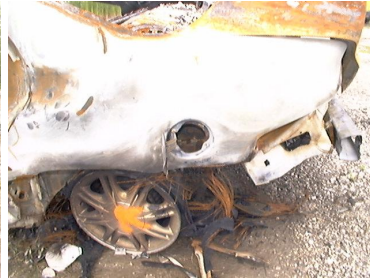
**Occupant: 1998-73-70-1-2**

| Fire Occurrence | Major fire |
| Location of Fuel Leakage | Other |
| Fuel Tank Damage | Other damage |

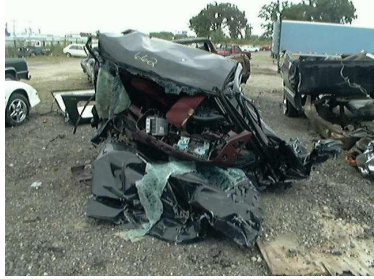
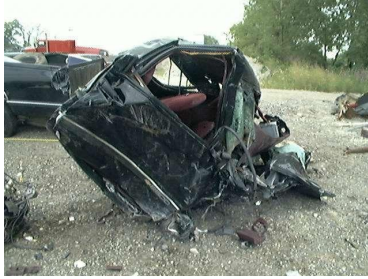
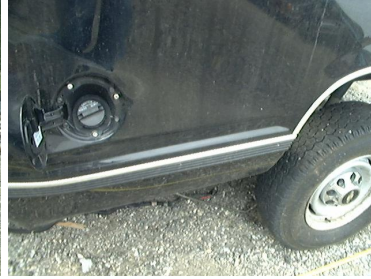
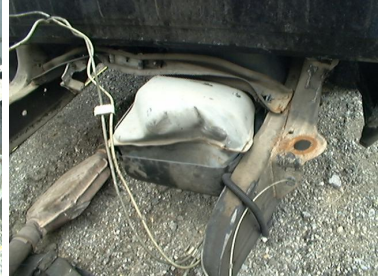
**Occupant: 1998-73-95-1-1**

| Location of Fuel Leakage | Other |
| Fuel Tank Damage | Deformed |

| Damage (C1-C6) | 44 46 46 56 62 86 |

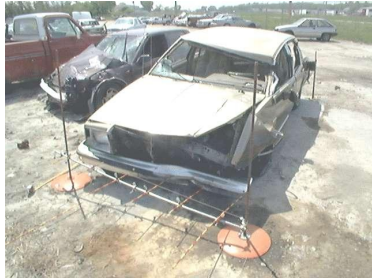
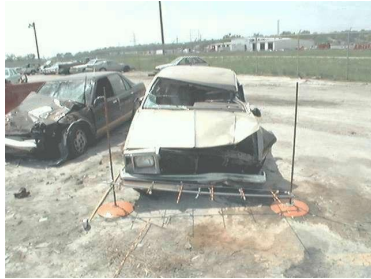
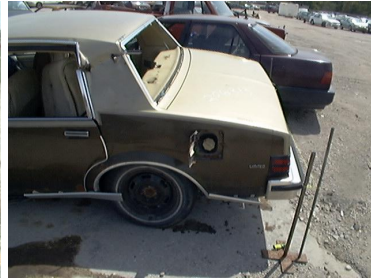
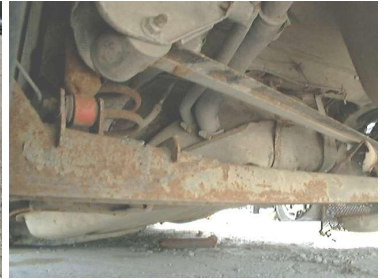
**Occupant: 1998-74-61-1-1**

| Fire Occurrence | Minor fire |
| Location of Fuel Leakage | No fuel leakage |
| Fuel Tank Damage | No damage |

| Damage (C1-C6) | 41 33 29 15 4 0 |

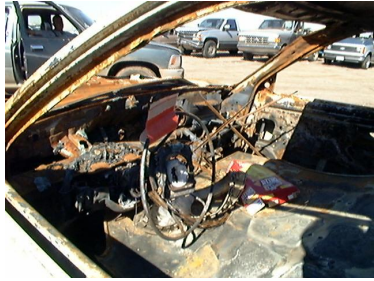
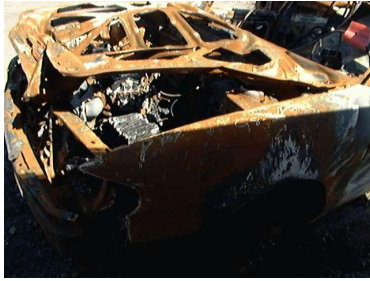
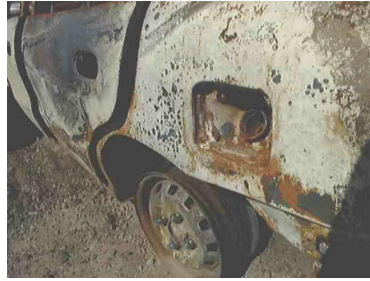
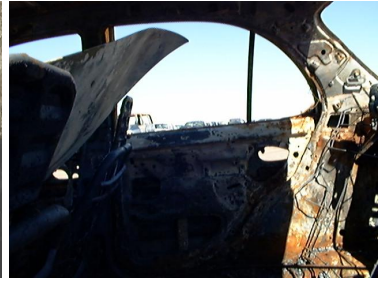
Occupant: 1998-78-501-1-1

| Fire Occurrence | Major fire |
| Location of Fuel Leakage | No fuel tank |
| Fuel Tank Damage | No fuel tank |

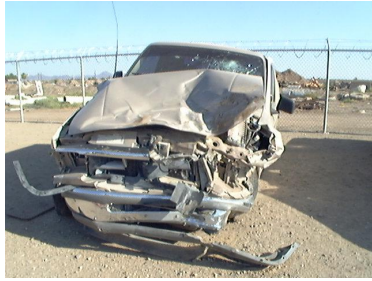
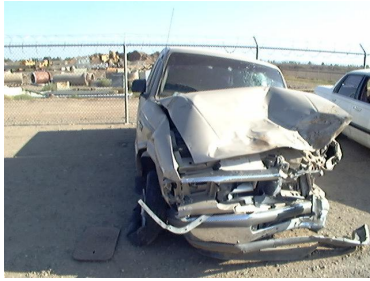
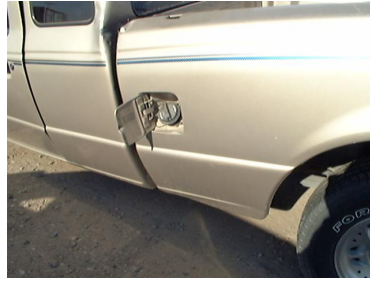
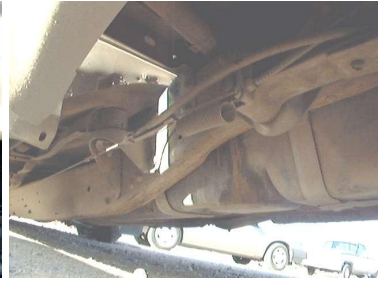
**Occupant: 1998-78-67-1-1**

| Fire Occurrence | No fire |
| Location of Fuel Leakage | No fuel leakage |
| Fuel Tank Damage | No damage |

| Damage (C1-C6) | 72 45 30 22 16 19 |

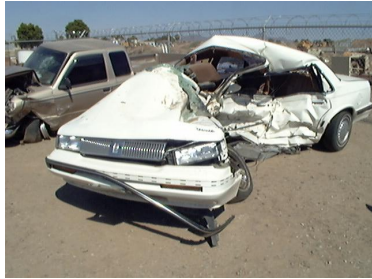
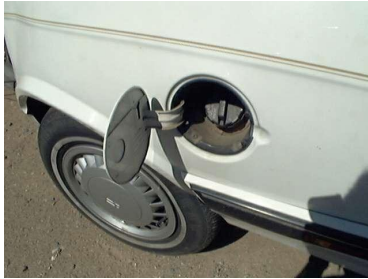
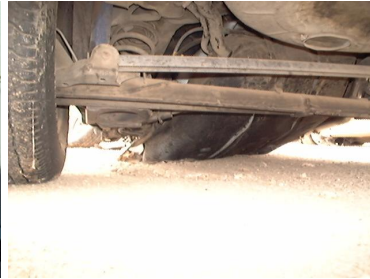
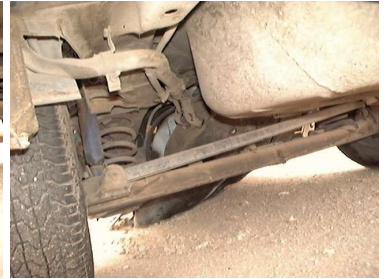
**Occupant: 1998-78-67-2-1**

| Fire Occurrence | No fire |
| Location of Fuel Leakage | Other |
| Fuel Tank Damage | Other damage |

| Damage (C1-C6) | 19 99 110 110 97 34 |

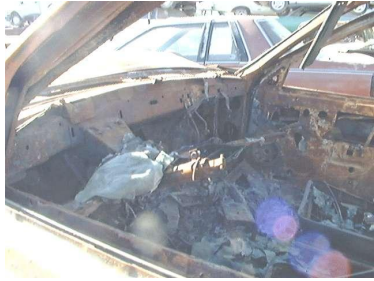
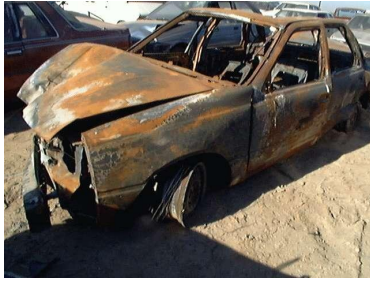
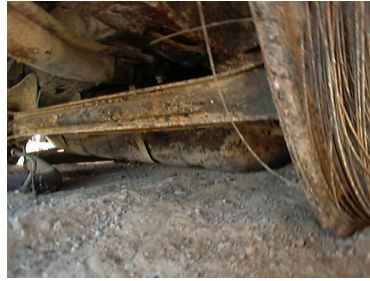
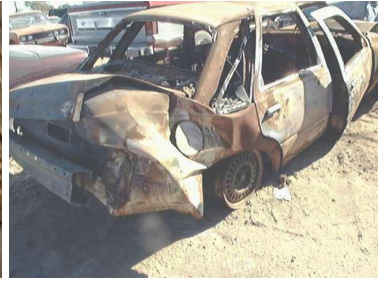
**Occupant: 1998-78-71-1-1**

| Fire Occurrence | Major fire |
| Location of Fuel Leakage | Filler neck |
| Fuel Tank Damage | Fill neck separation |

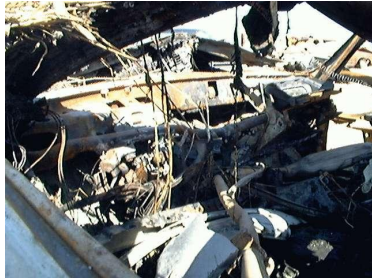
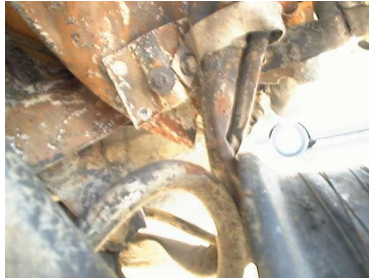
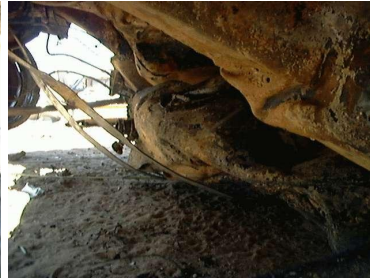
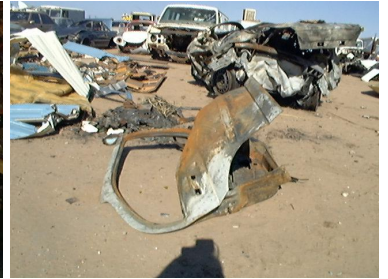
**Occupant: 1998-78-83-1-1**

| Fire Occurrence | Major fire |
| Location of Fuel Leakage | Filler neck |
| Fuel Tank Damage | Fill neck separation |

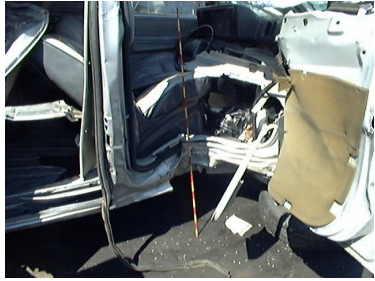
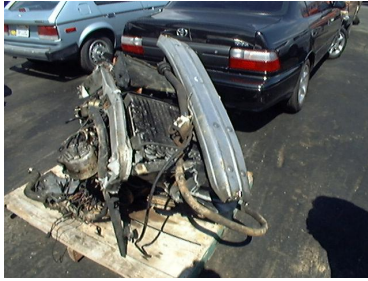
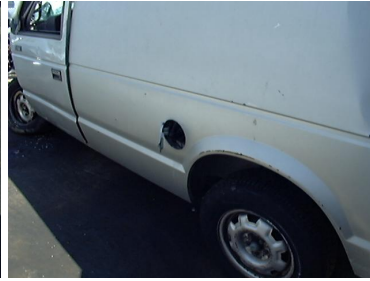
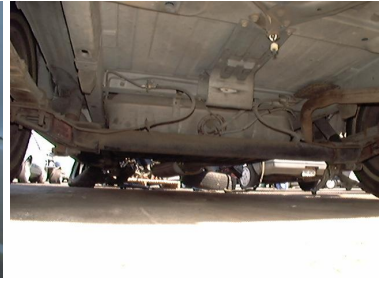
**Occupant: 1998-79-58-1-1**

| Fire Occurrence | No fire |
| Location of Fuel Leakage | Line/pump/filter |
| Fuel Tank Damage | No damage |

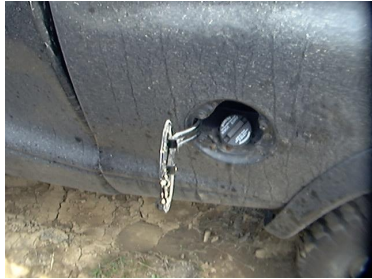
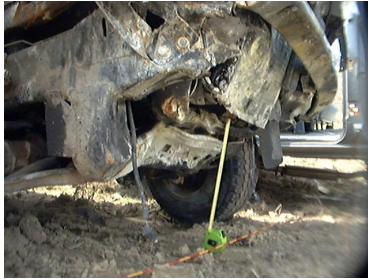
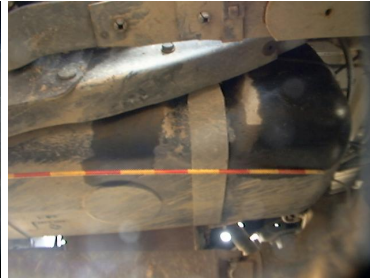
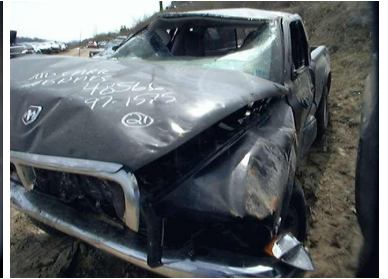
**Occupant: 1998-8-24-1-1**

| Fire Occurrence | Minor fire |

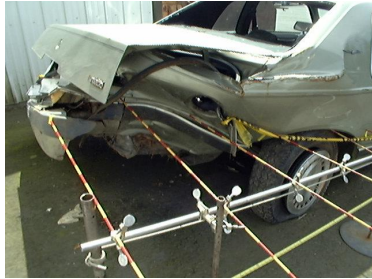
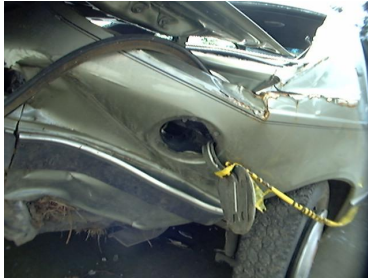
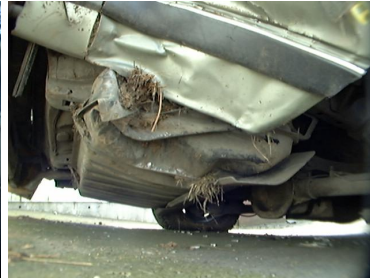
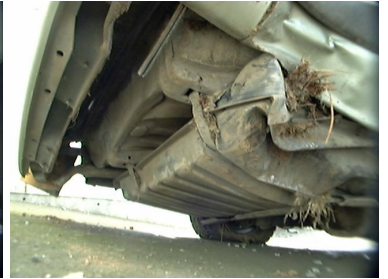
**Occupant: 1998-81-34-1-1**

| Location of Fuel Leakage | Other |
| Fuel Tank Damage | Deformed |

| Damage (C1-C6) | 45 59 48 23 14 6 |

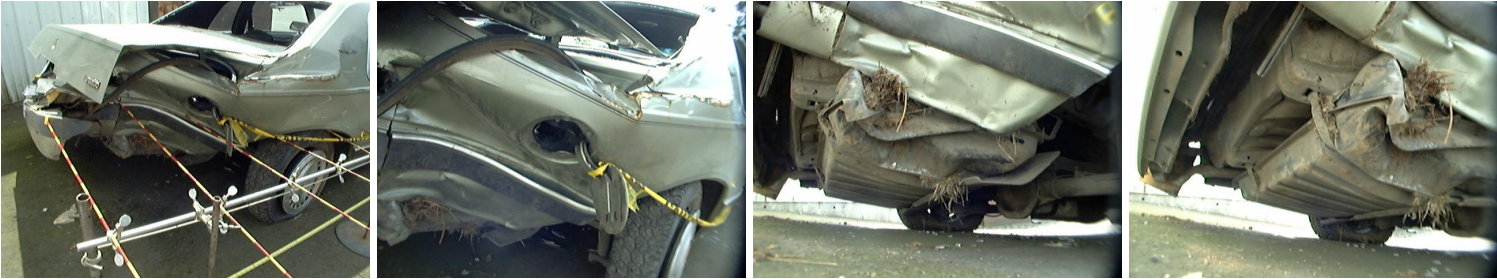
Occupant: 1998-81-34-1-2

| Location of Fuel Leakage | Other |
| Fuel Tank Damage | Deformed |

| Damage (C1-C6) | 45 59 48 23 14 6 |

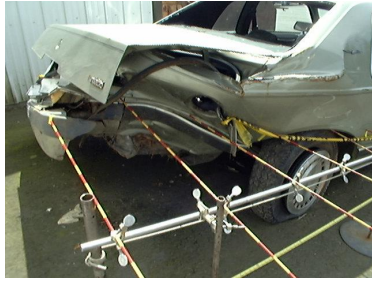
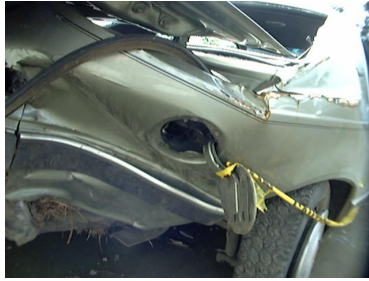
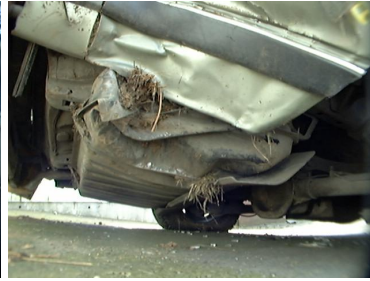
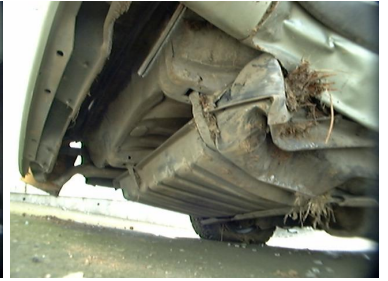
**Occupant: 1998-81-34-1-3**

| Location of Fuel Leakage | Other |
| Fuel Tank Damage | Deformed |

| Damage (C1-C6) | 45 59 48 23 14 6 |

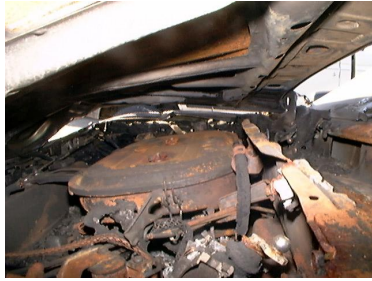
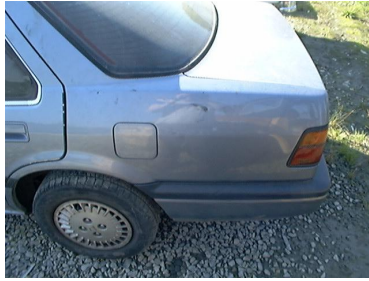
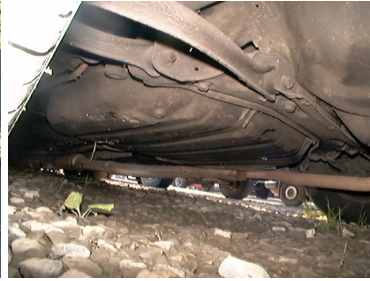
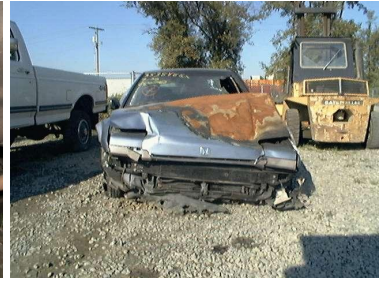
**Occupant: 1998-81-74-1-1**

| Fire Occurrence | Major fire |

| Damage (C1-C6) | 20 15 18 19 18 22 |

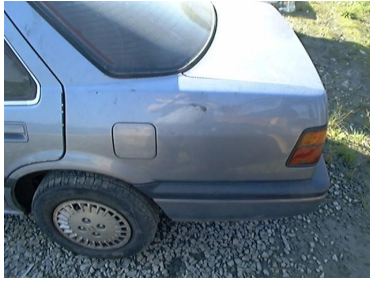
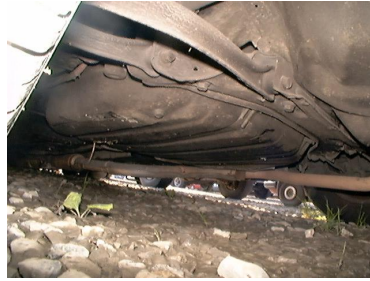
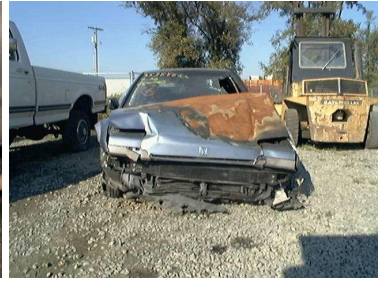
**Occupant: 1998-81-74-1-3**

| Fire Occurrence | Major fire |

| Damage (C1-C6) | 20 15 18 19 18 22 |
