DOT HS 800 624

# **AN ASSESSMENT OF AUTOMOTIVE FUEL SYSTEM FIRE HAZARDS**

**Dynamic Science  
A Division of Marshall Industries  
1800 West Deer Valley Drive  
Phoenix, Arizona 85027**

**Contract No. DOT FH 11 7579  
December 1971  
Final Report**

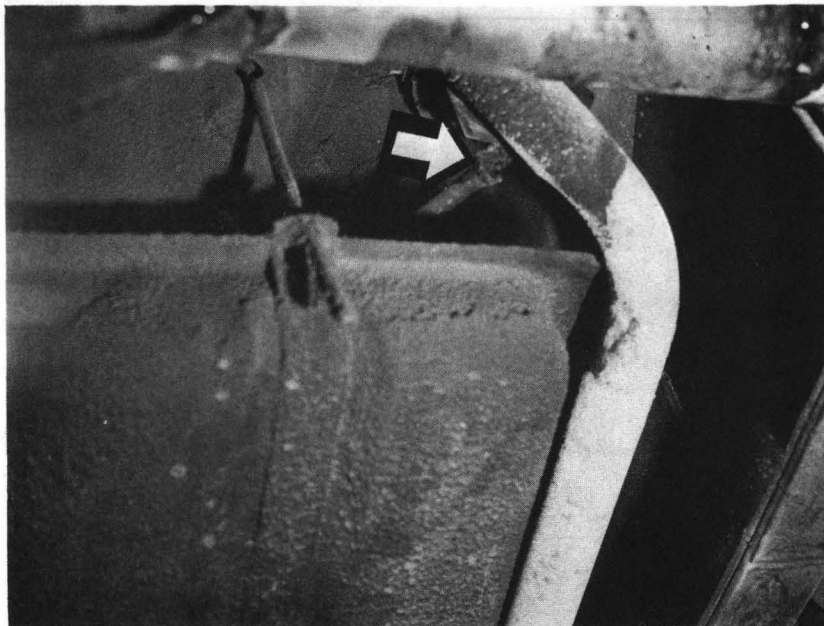
The other instance of material degradation noted was found in a 1971 AMC Hornet. The vapor hose leading from the fuel tank to the liquid check valve had been burned almost through where it had come in contact with the tail pipe, as shown in Figure 5-4. (The vehicle odometer registered 4,281 miles at this time.) In addition to the loss of vapor through this line, liquid fuel could also be lost since the break occurred between the liquid check valve and the fuel tank.

This vehicle was one that had been selected to undergo the pitch tests conducted during this program (Appendix D). No fuel was lost until the vehicle was pitched more than the operational limit of 30 degrees, but there was evidence from the condition of the vehicle undercoating that fuel had been forced through the hose during sudden braking maneuvers. Although the tail pipe temperature would not be sufficiently high to ignite the fuel or vapor, the possibility of an outside ignition source must always be considered.

Figure 5-4. Burned Vapor Hose in 1971 AMC Hornet.

An inspection of the rubber vapor hose showed that it had been burned almost through where it had come in contact with the tail pipe, as shown in Figure 5-4. (The odometer of the vehicle registered 4,281 miles at the time of the test.) Raising the rear end of the vehicle allowed fuel to enter the hose and consequently flow from the damaged line.

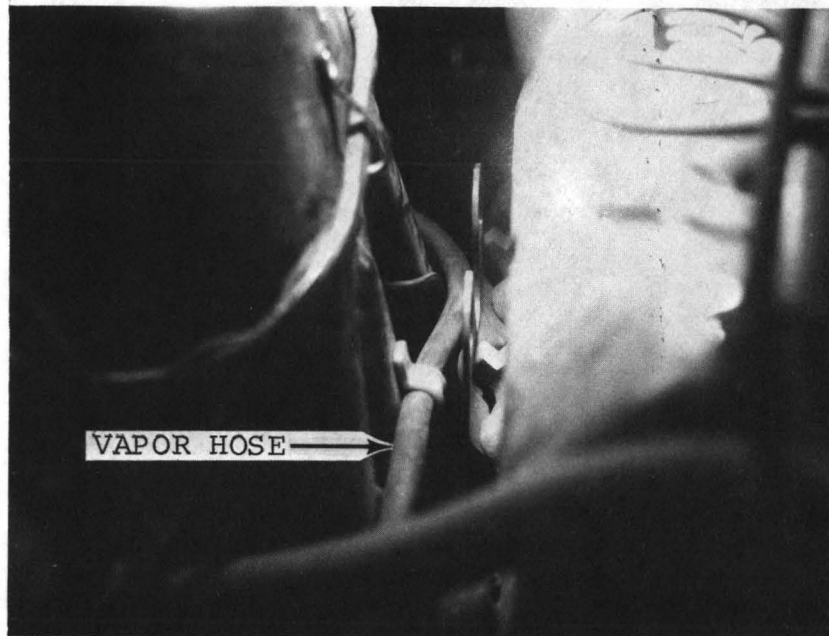
line from the control valve to the canister was routed approximately 1 inch away from the exhaust manifold in the engine compartment. This line actually came in contact with a bracket mounted on the manifold, as may be seen in Figure 5-5. In this same vehicle the plastic vapor line from the liquid-vapor separator to the three-way control valve was routed only 2 inches away from the exhaust pipe.

Figure 5-5. Vapor Hose in Engine Compartment of 1970 Ford Mustang.

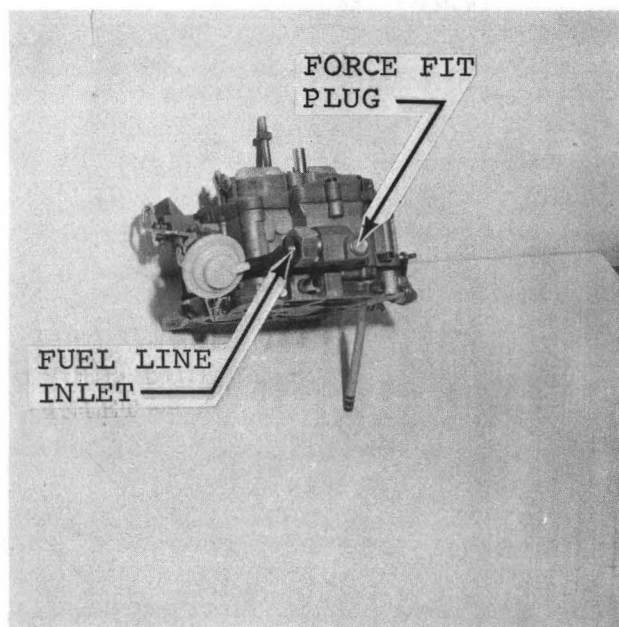
No evidence of fatigue failure or attachment loosening was evident in any of the vehicles analyzed. This is not surprising due to the newness of the vehicles. In general, the components and their attachments seem adequate from the standpoint of fatigue or vibration failure. However, one potential problem does exist that should be studied in further detail. Vehicle fires have been started in the past when force-fit plugs located in the carburetor body have been forced out due to vibration, allowing fuel to spill on the hot engine and thus start an engine compartment fire. The problem of the force-fit plugs still exists as they are used in the 1970 and 1971 carburetors. This problem is particularly aggravated if a fairly large force-fit plug is located next to the fuel line inlet, as shown in Figure 5-6. Pressure from the incoming fuel can force the loosened plug out, allowing fuel to be pumped through the opening and onto the hot engine before the vehicle driver is aware of the problem.

Figure 5-6. 1970 Carburetor Containing Force Fit Plug.

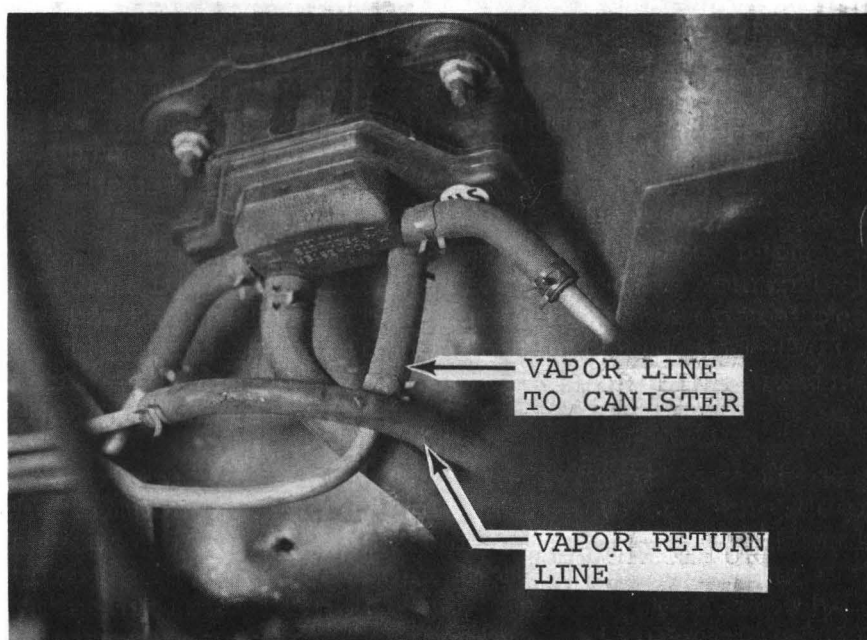
Although the failure of a component due to chafing is also a long term process, careful examination of the vehicle can disclose areas where chafing could occur and thus present a problem. Damage which had already occurred because of chafing was found in the 1970 Pontiac Catalina. In this vehicle, which had an odometer reading of 15,198 miles, chafing of the vapor emission hose from the liquid-vapor separator to the canister and of the vapor return line from the fuel pump to the fuel tank was readily apparent, as shown in Figure 5-7. The serious wear of these lines was caused by the chafing of the lines on the differential gear housing. Another potential chafing problem was found in the same vehicle in the engine compartment where the hose from the carbon canister to the carburetor came in contact with the air conditioner compressor bracket, as seen in Figure 5-8. This line is supported only by being taped to another line in the engine compartment. After the vehicle had been driven for this many miles, the tape had dried and come off. The tape marks may still be seen in Figure 5-8.

Figure 5-7. Chafing of Vapor Hoses in 1970 Pontiac Catalina.

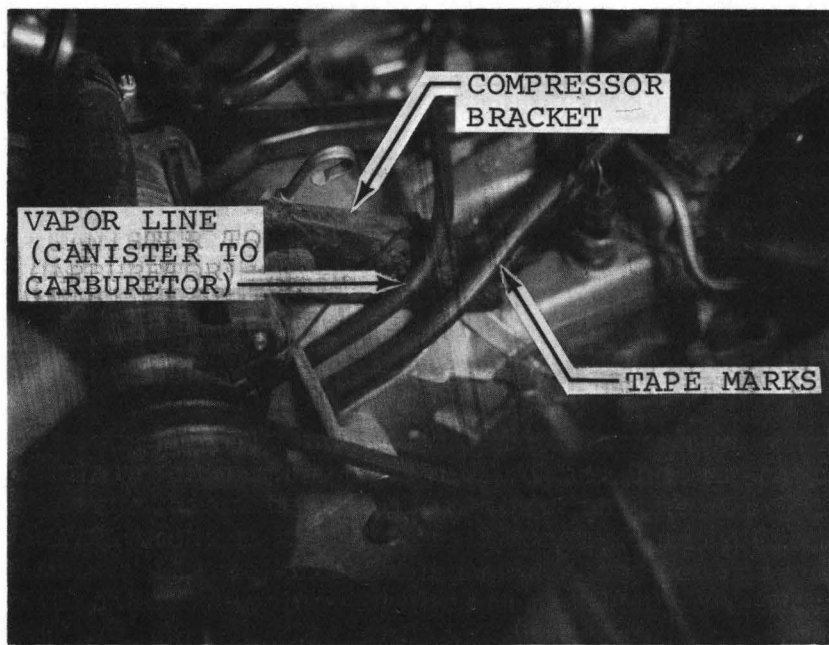
Figure 5-8. Engine Compartment Vapor Hose Routing in 1970 Pontiac Catalina.

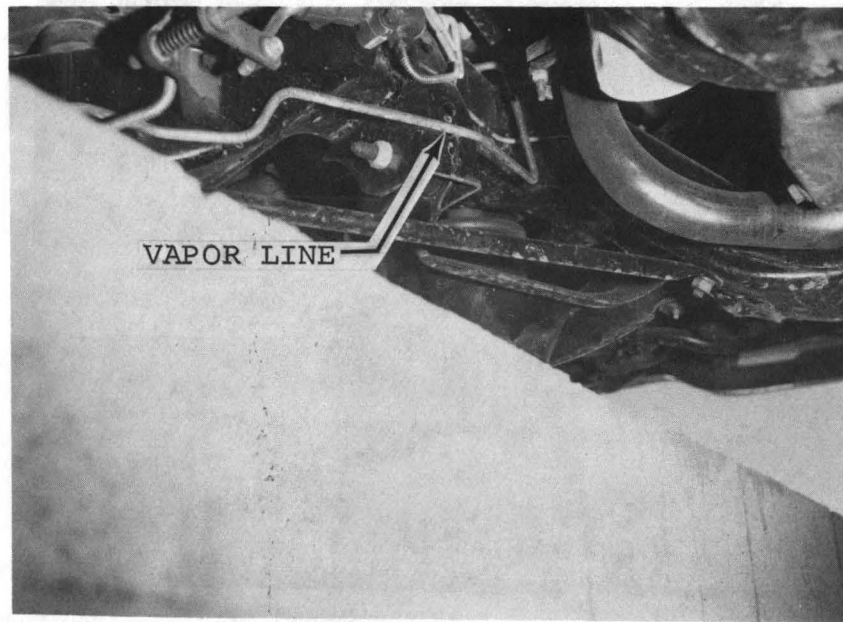
Figure 5-9. Vapor Line in 1971 Chevrolet Impala.

Several other potential chafing hazards were discovered during the analyses. One of these exists in the 1971 VW Super Beetle where the vapor line in the luggage compartment is routed over and rides on the luggage compartment lid hinge. In the 1971 Impala the vapor line from the liquid vapor separator to the canister rubs along the front lower control arm mount, as shown in Figure 5-9.

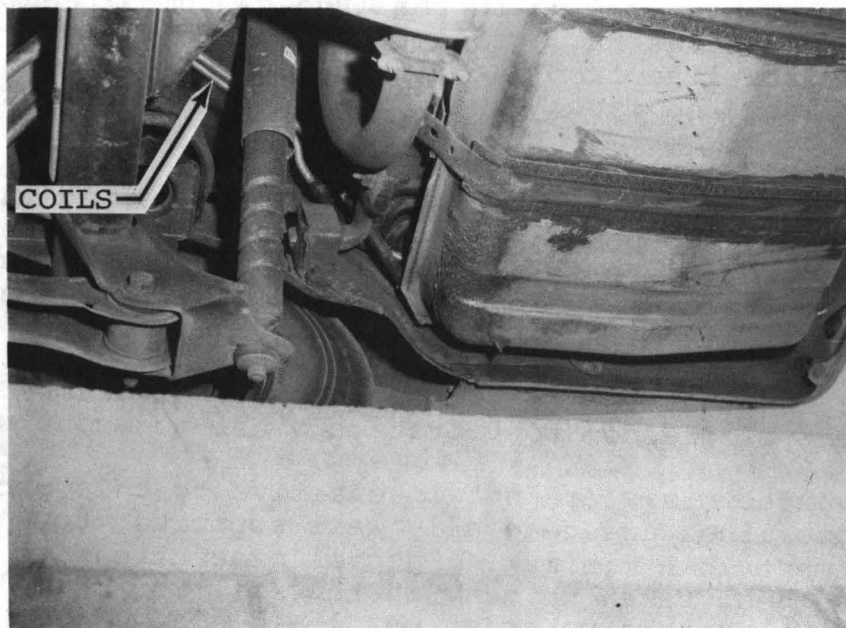
Figure 5-10. Metal Coil Protection on 1971 Vega Vapor and Fuel Lines.

The manufacturers are not insensitive to this problem, however, and the lines are generally well supported to reduce vibrational movement to a minimum. Special precautions to prevent chafing have been taken in many instances. For example, in several General Motors vehicles metal coils have been wrapped around the line, as shown in Figure 5-10, to protect the line in potential chafing areas. Another example of such protection is found in the Ford Pinto where the reinforced paper purge line from the canister to the air cleaner is stabilized by a loose clamp on the radiator, as seen in Figure 5-11. The chafing

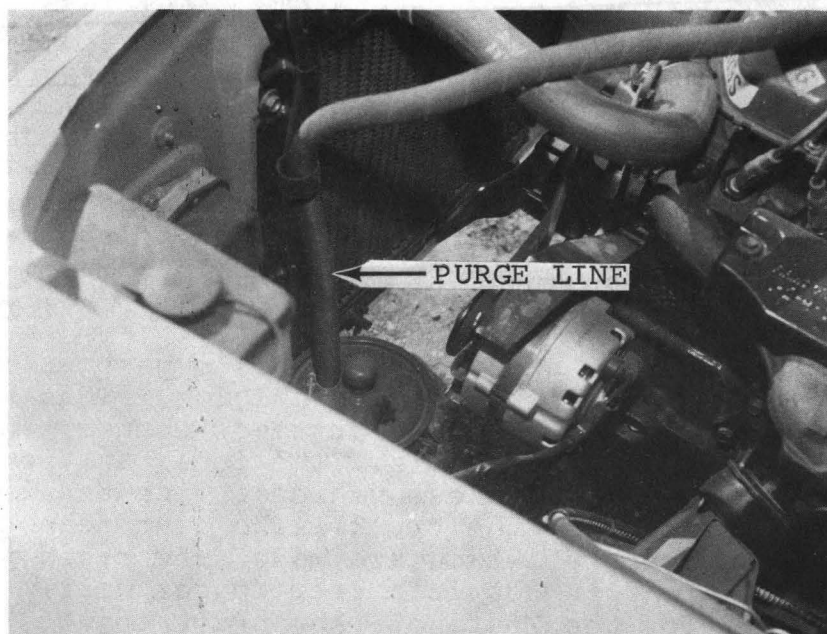
Figure 5-11. Vapor Purge Line Installation in 1971 Pinto.

hazard of this design has been reduced to a minimum by coating the clamp with a smooth synthetic material to eliminate any sharp edges.

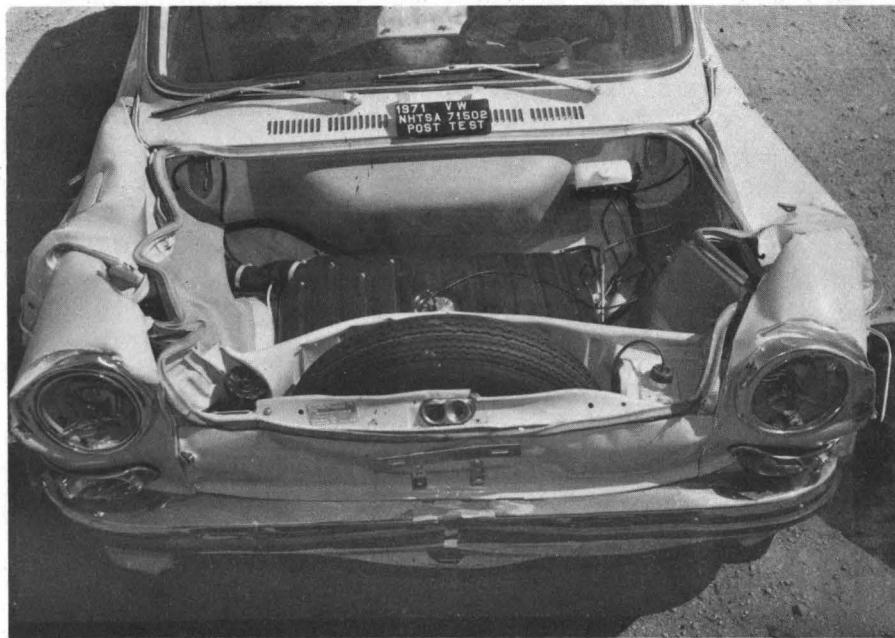
Figure 5-14. 1971 Volkswagen Squareback After a 30-mph Barrier Impact.

None of the components were damaged during any of the tests. The only attachment failure occurred in the Volkswagen subsystem sled test when the fuel tank slipped completely out of the clips holding the tank to the vehicle structure. Complete separation from the structure was prevented by the filler neck. It is unlikely that the fuel tank would behave in this manner during a front end collision since the vehicle structure would be pushed back against the fuel tank, trapping it in the structure; this happened during a subsequent barrier impact with a 1971 Volkswagen Squareback sedan. In this test the fuel tank was buckled and pushed rearward approximately 3 inches (see Figure 5-14), but no leakage occurred either during or after impact. The strong flexible filler neck which held the fuel tank in the structure during the sled test undoubtedly contributed to the absence of leakage during the barrier test by moving with the deforming structure rather than exerting high stresses on the filler cap or fuel tank connections.

There was a small amount of leakage when the vent line from the Volkswagen tank pulled loose as the tank left its structural attachment during the sled test. However, this leakage can be discounted as a hazard since the Volkswagen fuel tank did not separate during the barrier test. The only other leakage which occurred was a small amount of fuel sprayed from around the Ford and General Motors filler caps during the sled tests. Figure 5-15 shows the fuel spray from the Chevelle filler during the front impact test. Although only a small volume of fuel was lost, the spray could travel some distance to an ignition source and must therefore be considered a potential fire hazard.

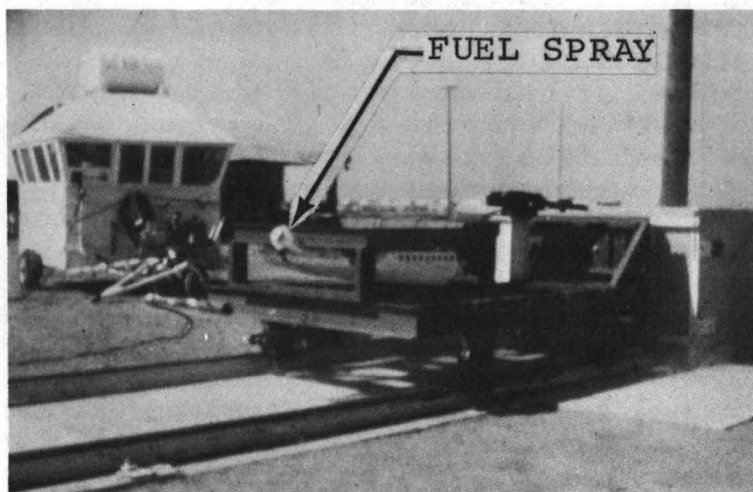
Figure 5-15. Fuel Spray During Sled Test of 1971 Chevelle Fuel System.

Toyota consisted of a fluid spray. The Chevelle spillage consisted of a short spurt of fluid which apparently was forced through the pressure relief valve in the filler cap (see Figure 5-15). The amount of fluid spilled in all cases was small.

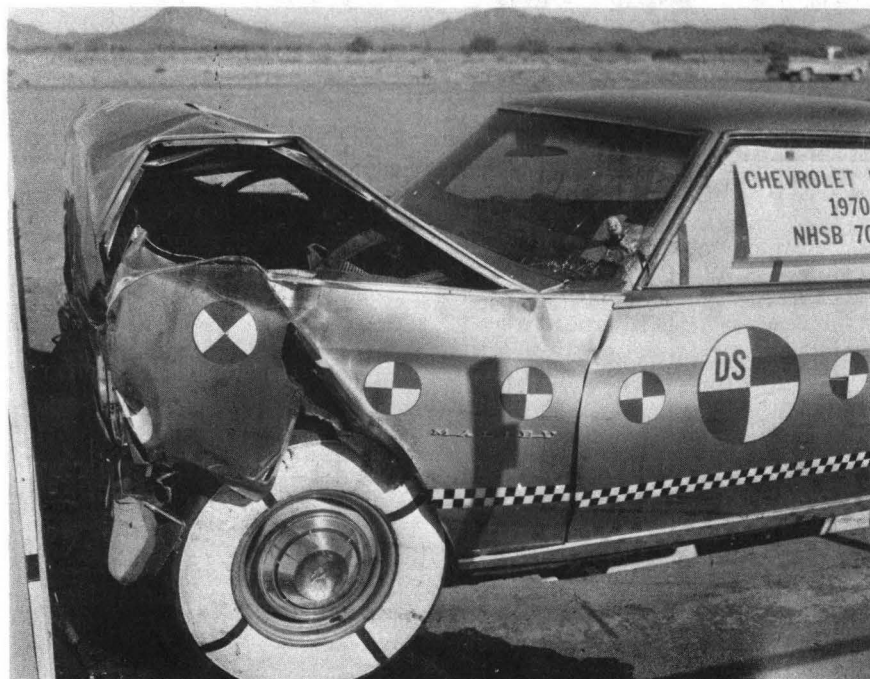
Figure 5-18. 1970 Chevelle Malibu After  
30-mph Barrier Test.

the damage to the canister. The canister in the Chevelle was broken near the bottom, allowing the carbon to drop to the ground. This canister is also mounted at the front of the car, ahead of the engine block. While the Fiat and Capri canisters were made of metal, the Chevelle canister is made of plastic. It is

possible that the Chevelle canister might not have broken had it also been made of metal.

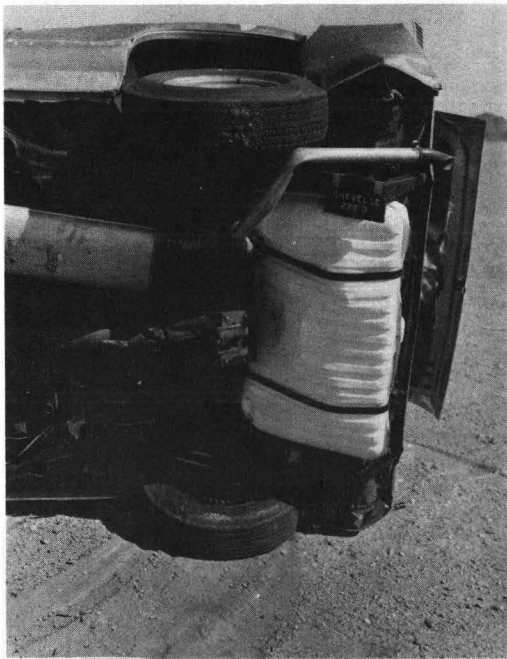
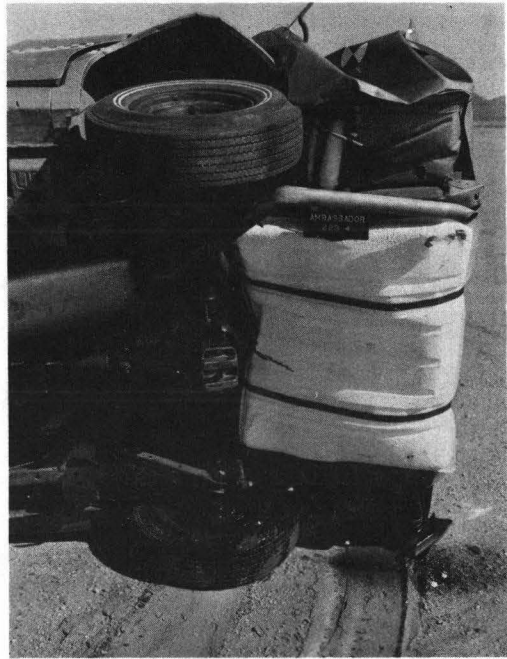
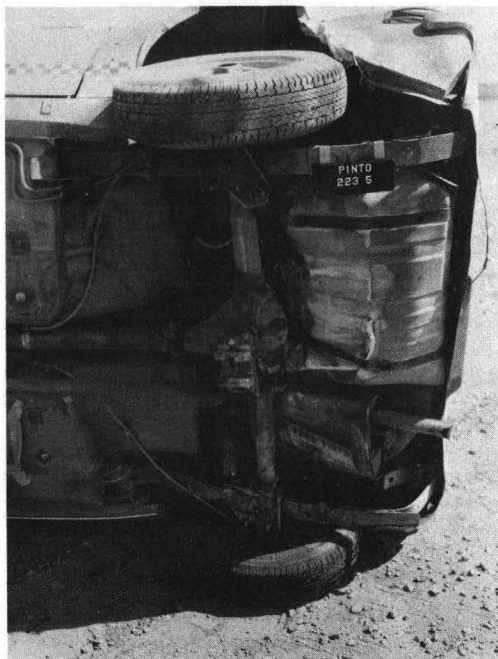
Figure 5-39. Fuel Tank Damage Caused by Rear End Barrier Impacts.

As expected, all of the rear underfloor tanks suffered extensive damage during the barrier tests. All of the tanks were crushed between the rear of the vehicle structure and the differential gear housing as shown in Figure 5-39. The high-speed test film showed that the differential hit the fuel tank between 33 and 42 msec after impact. Maximum penetration of the fuel tank by the differential housing and maximum dynamic crush of the vehicle occurred simultaneously. The fuel tanks were flexible and withstood well the physical crushing and hydraulic forces of the test fluid within the tank. The resilience of the tanks may be seen by comparing the dynamic crush of the tanks

with the static crush (Table 5-IV). Although leakage did occur in the Chevelle and Pinto systems, none of the failures were due to splitting of the tank metal or the welded tank seams.

the tank as vehicle crushing continued, puncturing the tank at maximum crush and rotation. The asymmetrical position of the fuel tank with respect to the differential housing (see view of Pinto in Figure 5-39) probably contributed to the failure by allowing the tank to wrap around the edge of the housing. Although the fuel tank in the Chevelle and Ambassador were also struck by the differential housing, the symmetrical position of the tanks with respect to the differentials prevented the tanks from wrapping around the edge of the housings and the tanks were not punctured. However, even in this symmetrical position, a severe rear end collision can result in puncture by the differential as in the case of the Chevelle Malibu shown in Figure 5-44. Two tears in the front of the fuel tank, one approximately 6 inches long and the other 2 inches long (see Figure 5-45) resulted when the tank was pushed against the differential housing. A failure of this type can lead to very rapid loss of a large quantity of fuel which, if ignited, would result in a catastrophic fire.

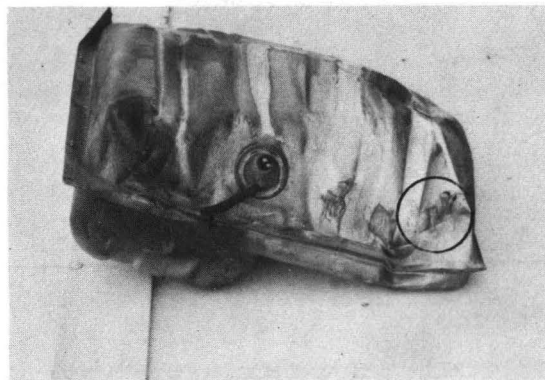
Figure 5-43. Punctures in Barrier Crashed Pinto Fuel Tank.

Another mode of fuel tank failure during rear end collisions was illustrated during the barrier test of the Pinto. During impact, the right front part of the fuel tank was struck by the differential housing, puncturing two holes in the tank (see Figure 5-43) which resulted in a spillage rate of 18 ounces per minute. One hole was caused by a nut on the differential housing and the other by the edge of the housing adjacent to the nut. The imprint of the nut is clearly visible in Figure 5-43. The high-speed test film showed that the differential first struck the tank in the right front center and then rotated upward into

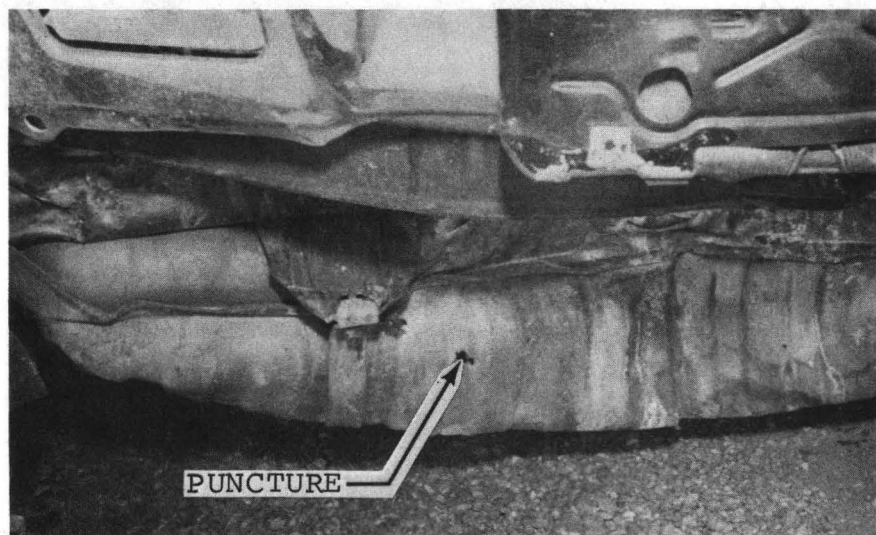
Figure 5-46. Fuel Tank Puncture Caused by Striking Vehicle During Severe Rear End Collision.

Another type of fuel tank failure which can occur during a rear end collision is the puncturing of the fuel tank by the structure of the striking car, as shown in Figure 5-46. This tear, which also occurred in the Malibu discussed above, measured

approximately 1-inch x 1-1/2 inches. Again, failure of this type would lead to rapid loss of fuel. It should be noted that in this particular vehicle both side frame rails were buckled and the doors were jammed. If a fire had started, the chances for occupant escape would have been very slim.

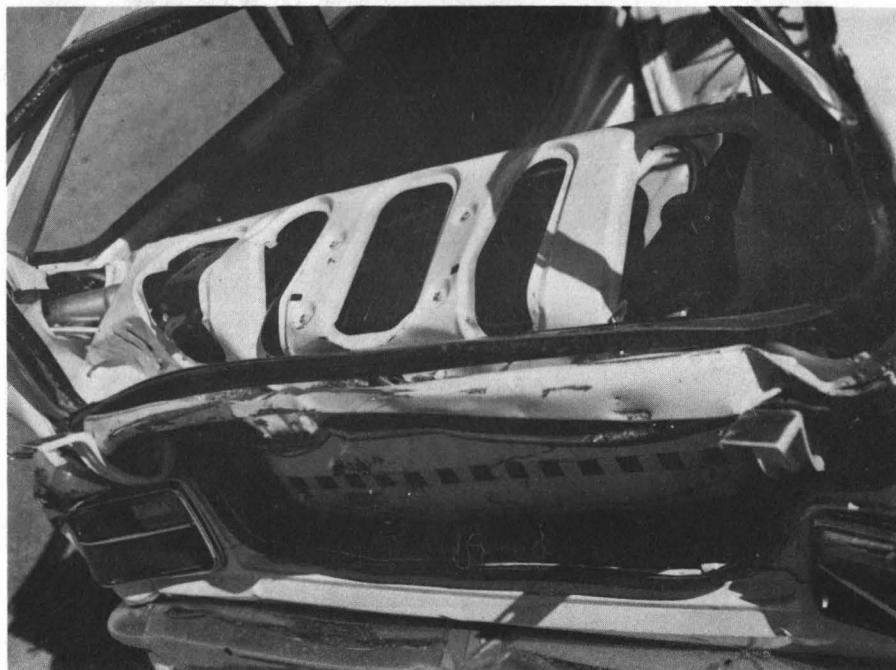
Figure 5-47. Toyota Fuel Tank Following 30-mph Barrier Test.

The mid-tank in the barrier-tested Toyota, due to its forward location above the rear axle, was not directly impacted during the test although the dynamic crush of the vehicle measured 32 inches. The post-test view in Figure 5-47 shows the fuel tank relative to the crushed vehicle structure.

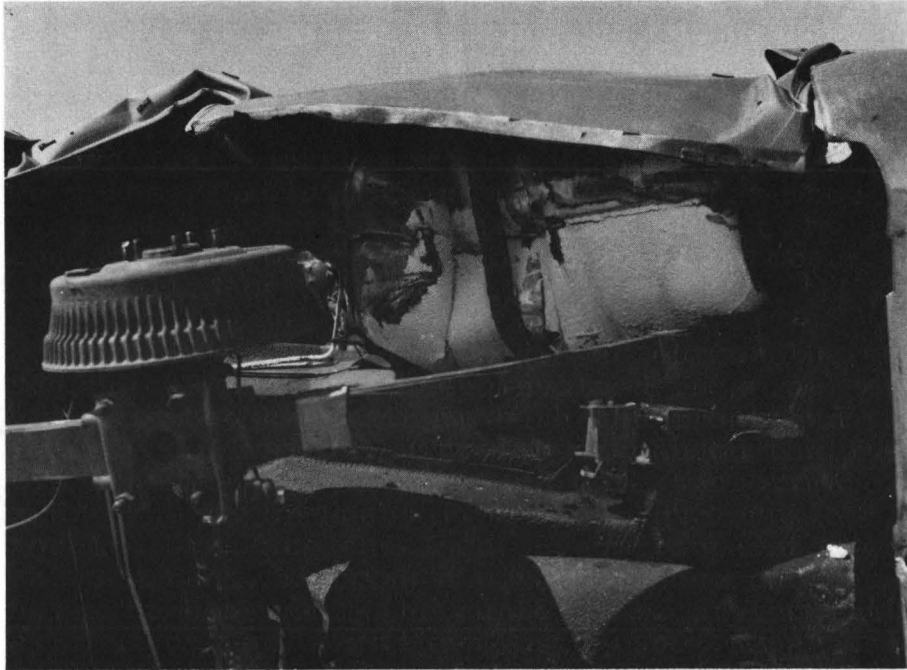
Figure 5-49. Fuel Tank in Dodge Station Wagon Following Barrier Test.

Although the fuel tank in the barrier crashed Dodge station wagon was severely distorted and crushed as shown in Figure 5-49, no failure occurred in the tank. The fuel tank was compressed between the rear structure of the vehicle and the left rear tire during impact, but fortunately there were no structural protrusions near the tank which could puncture it.

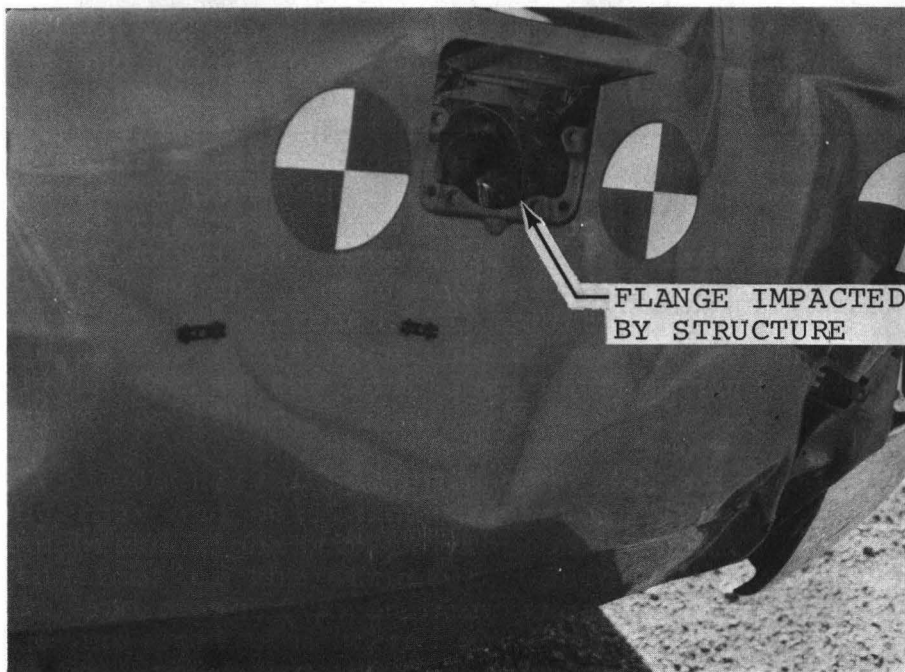
Figure 5-50. Post-test View of Dodge Station Wagon Filler Cap.

Although the Dodge fuel tank was not damaged, a fuel surge sufficient to wet approximately 1 square foot of ground near the left rear wheel occurred upon impact. Examination of the vehicle disclosed that the projecting flange on the filler cap had been struck by the rear filler well structure as shown in Figure 5-50, loosening the cap and allowing fuel to surge from the filler at impact. Although the amount of spillage was small, it should be considered hazardous since vapor spray could easily form a flammable fuel/air mixture. This mixture could travel to potential outside ignition sources in the area.

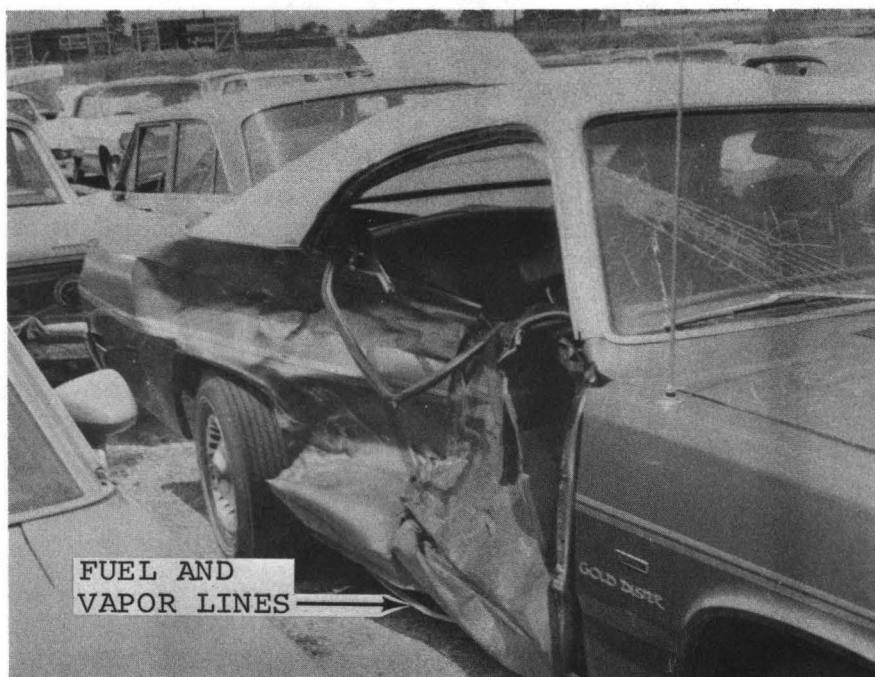
Figure 5-53. Typical Side Impact Damage.

5.3.3 Side Impacts. Several vehicles involved in moderate to severe side impact collisions were examined and no fuel system damage was found in any of the vehicles. Figure 5-53 shows typical damage sustained in these collisions. This vehicle received a severe impact at the right front door which pushed the vehicle structure completely away from the fuel and vapor lines routed under the right side of the car. The lines were not damaged because of the common tendency of the striking car to override the bottom structure of the struck car.

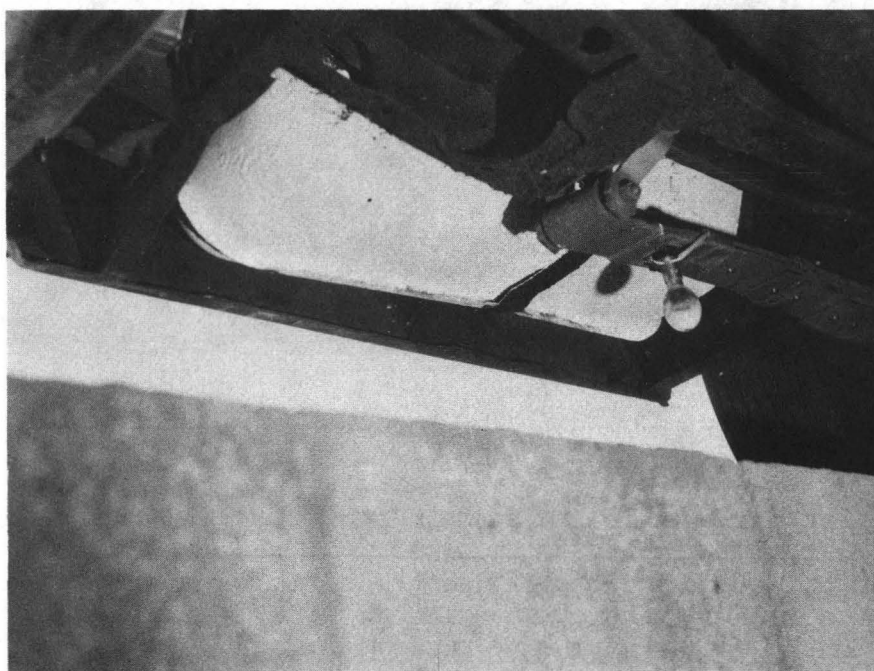
Figure 5-54. Typical Station Wagon Fuel Tank Installation.

Side impacts in the front or rear quarter panels of a vehicle, however, can often lead to fuel system damage depending on the location of the fuel system components within the vehicle. Most station wagon fuel tanks, for instance, are susceptible to extensive damage from a rear quarter impact due to their location in the rear quarter panel. Figure 5-54, a typical station wagon

fuel tank installation, shows that no protection other than the body sheet metal is available to help reduce damage to the fuel tank during an impact in this area.

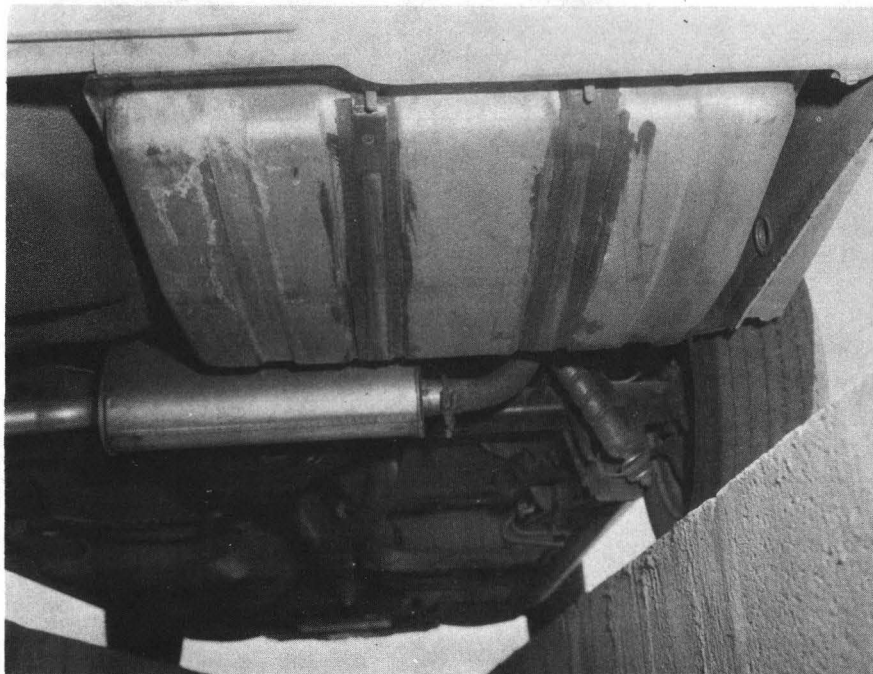
Figure 5-55. Chevrolet Vega Fuel Tank Installation.

Most fuel tanks located under the rear of the vehicle are somewhat protected from side impact damage by their central location and a fairly severe rear quarter impact would be necessary to damage them to any great extent. The Chevrolet Vega fuel tank, however, is located behind the rear tire and axle very close to the right side of the vehicle (see Figure 5-55). Damage to the tank could be expected to be quite extensive during a moderate to severe right rear quarter impact as the tank would be crushed between the impacting vehicle and the body structure to the left of the fuel tank.

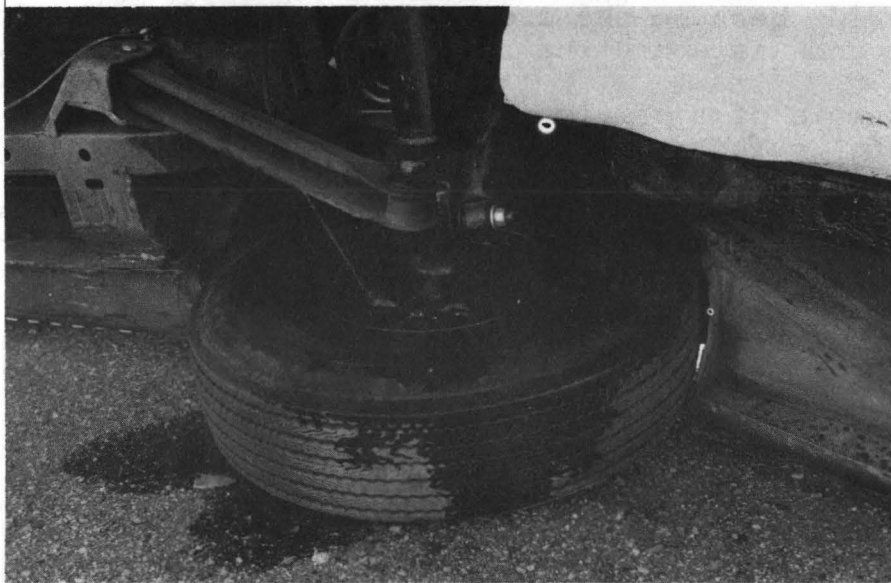
As in the case of roll-overs after front impacts, roll-overs following rear end impacts may produce spillage from damaged components which did not leak when the vehicle remained upright. This was demonstrated when the Ambassador and the Toyota were rolled on their left sides following the barrier impact. Fuel spillage at a rate of 14.4 ounces per minute was observed from a broken vapor line in the Ambassador (Figure 5-60). The rubber section of the vapor line leaving the right front corner of the tank had been torn where it connects to the metal portion of the line leading to the liquid check valve (see Figure 5-61). This tear occurred approximately 6 inches from the tank outlet and was apparently caused by the hose being caught between the crushed vehicle structure and the right rear shock absorber or spring. Most of the fuel in the tank eventually flowed out through this broken line.

Figure 5-60. Fuel Spillage From Damaged Vapor Hose in AMC Ambassador.

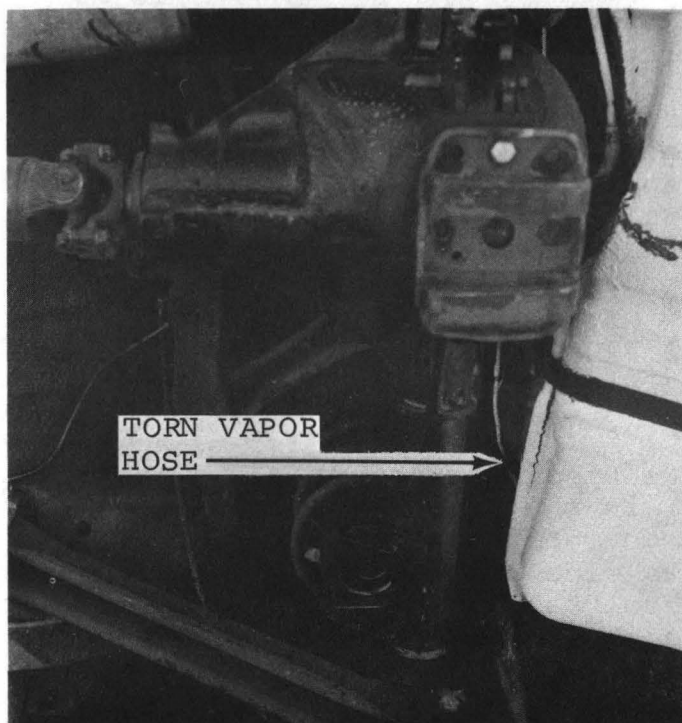
Figure 5-61. Vapor Hose Damage in Ambassador From Rear Barrier Test.

Examination of the vehicle disclosed that the rubber section of the vapor line leaving the right front corner of the tank had been torn where it connects to the metal portion of the line leading to the liquid check valve (see Figure 5-61). This tear occurred approximately 6 inches from the tank outlet and was apparently caused by the hose being caught between the crushed vehicle structure and the right rear shock absorber or spring.

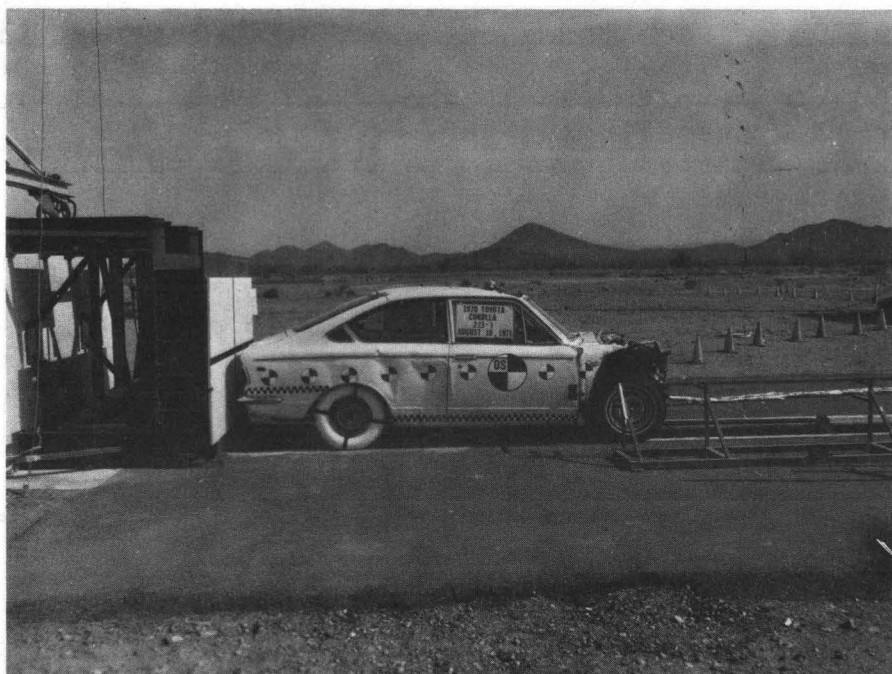
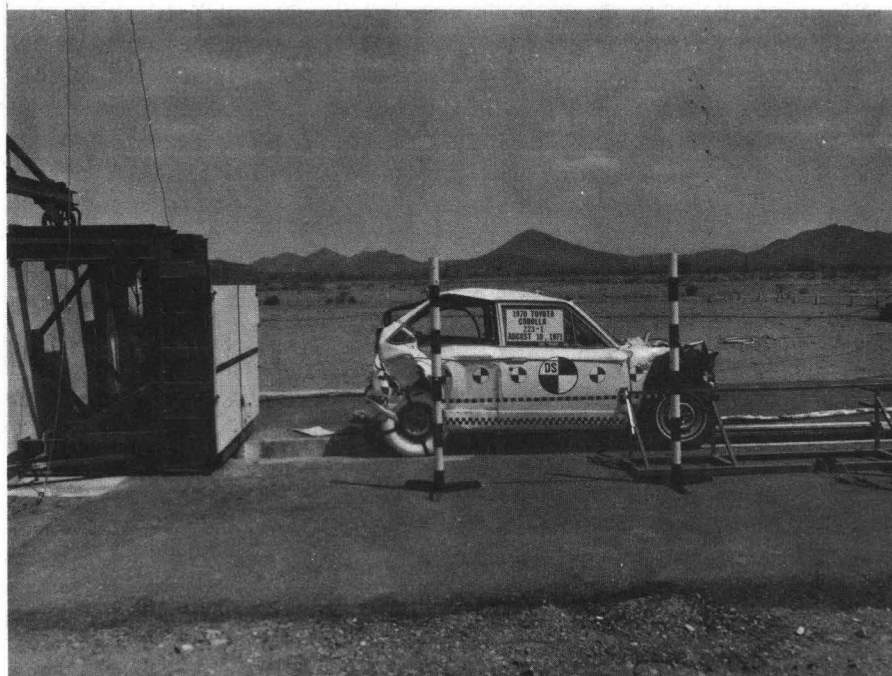
Examination of the vehicle disclosed that approximately 0.3 ounce (by weight) of fluid surged through the broken filler neck-fuel tank vapor line connection on top of the fuel tank (see Figure 5-48). This soldered connection had been broken by the impact of the vapor storage tank (located above the fuel tank). The fuel tank itself was not impacted by either the barrier or the crushed vehicle structure due to its forward location above the rear axle. There was no post-impact fluid leakage.

The deformation of the vehicle structure did pull the fuel feed hose from the tank off of the metal feed line leading to the engine compartment as shown in Figure 5-48. No fluid leakage occurred from the separated line on impact or thereafter.

Figure G-2. Pre- and Post-test Views of Toyota Corolla.

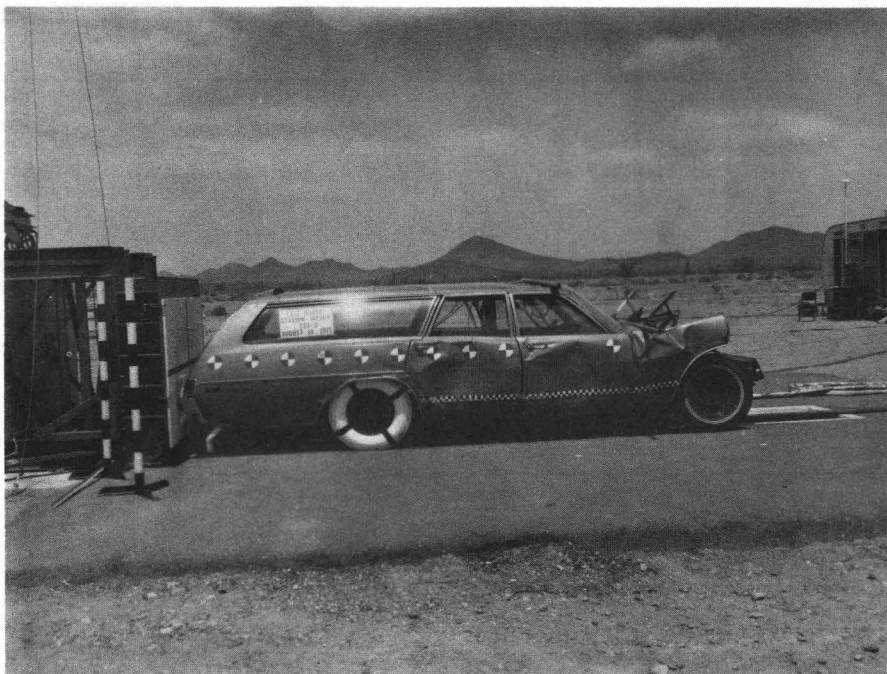
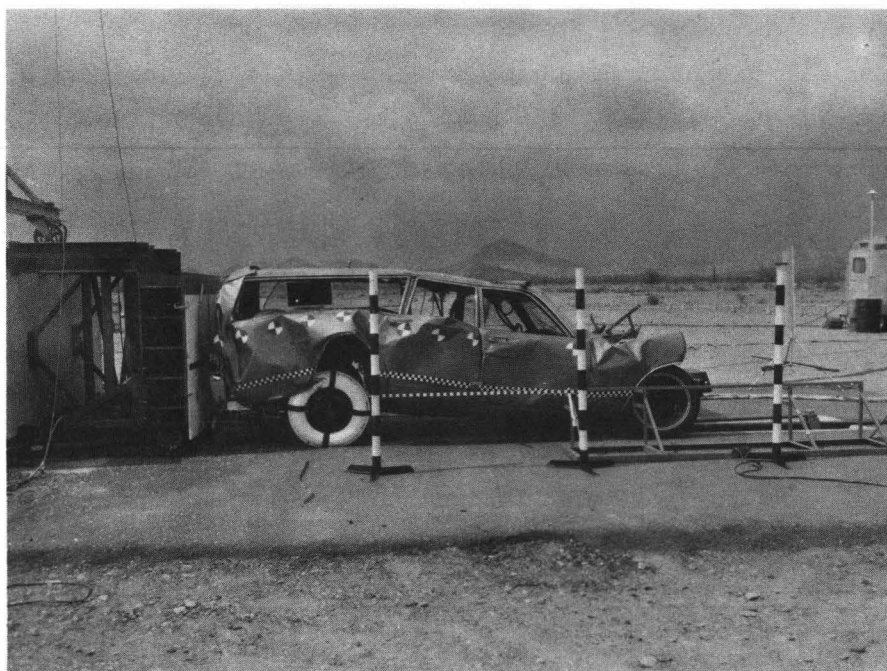
G.4.2 Dodge Station Wagon. Pre- and post-test views of the vehicle are shown in Figure G-3. The impact caused the rear frame to buckle up extensively above and immediately forward of the rear axle, thus allowing the whole rear body structure to move forward. The passenger compartment was buckled badly in the rear seat back area.

A fluid surge sufficient to wet approximately 1 square foot of ground near the left rear wheel occurred upon impact. Post-impact spillage of 1/4 oz/min from the left rear fender area stopped completely within 3 minutes. Examination of the vehicle disclosed that the projecting flange on the filler cap had been struck by the rear filler well structure, loosening the cap and allowing fluid to surge from the filler at impact. No other spillage occurred.

Figure G-3. Pre- and Post-test Views of Dodge Station Wagon.

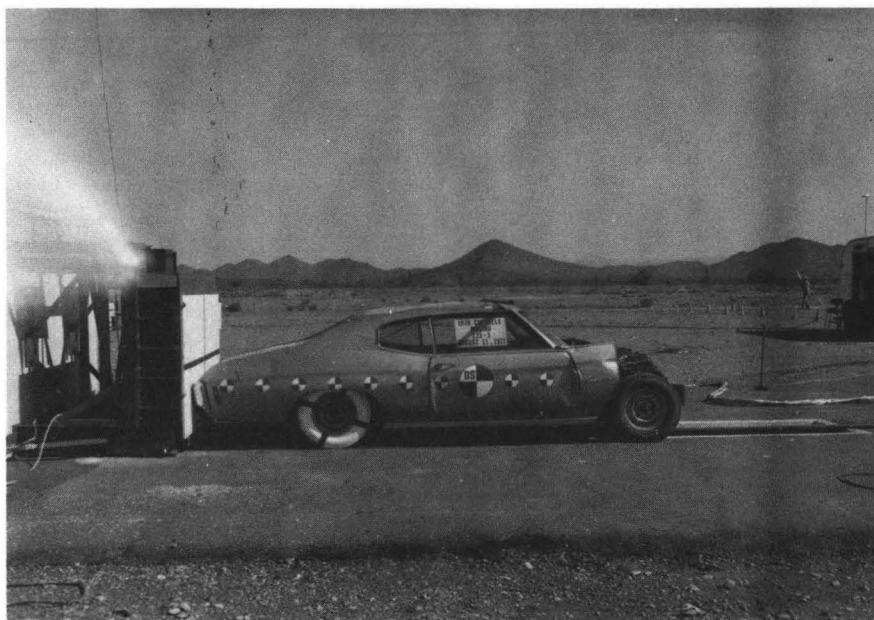
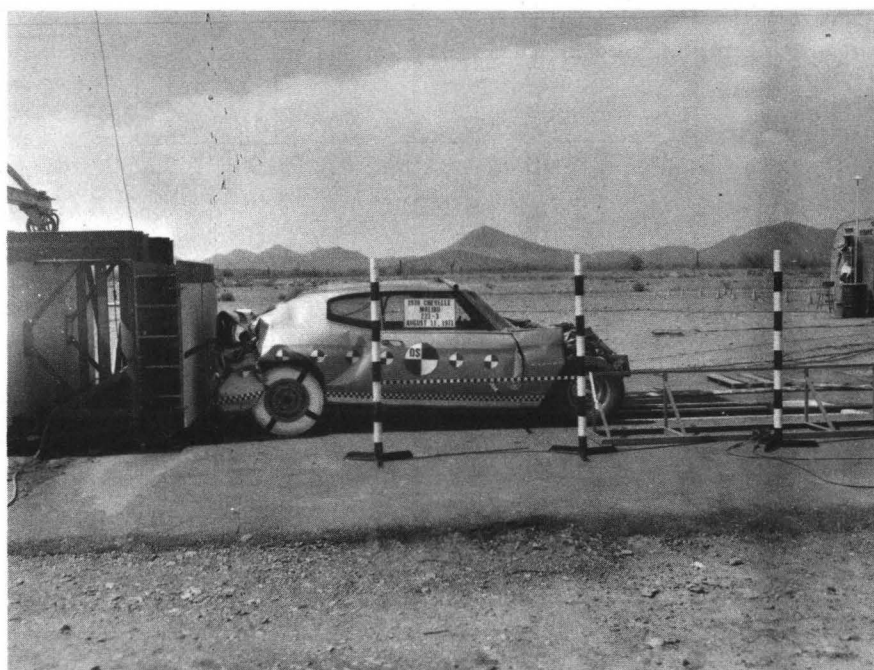
G.4.3 Chevelle Malibu. Pre- and post-test views of the vehicle are shown in Figure G-12. Examination revealed that the frame buckled downward approximately 1 foot forward of the rear frame cross member and buckled upward above the rear axle, allowing the whole rear structure behind the axle to move forward.

Post-test fluid spillage averaged 2.2 oz/min between the second and fifth minute after impact. This spillage occurred at the filler pipe-fuel tank connection. During impact, the filler pipe was trapped between the rear frame cross member (which moved up as the frame buckled) and the trunk floor pan, crushing the pipe and partially pulling it from the soldered connection in the tank. At the same time, the film analysis revealed that the fuel tank, which was first crushed in the front center by the differential housing, rode partially up and over the differential, pulling the rear of the tank downward and further pulling on the filler pipe-tank connection. Although the fuel tank was badly deformed, the only spillage occurred at the filler pipe-tank connection.

Figure G-12. Pre- and Post-test Views of Chevelle Malibu.

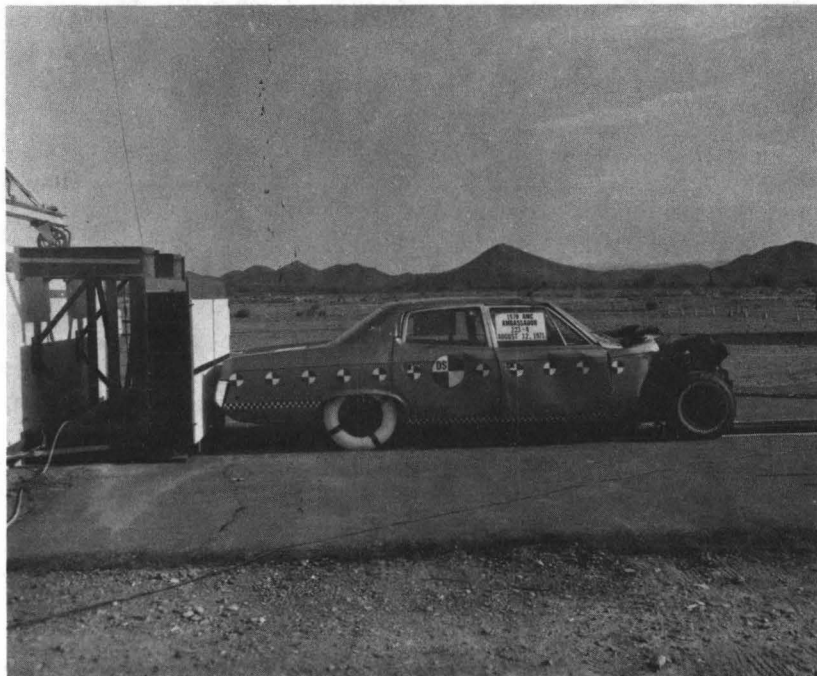
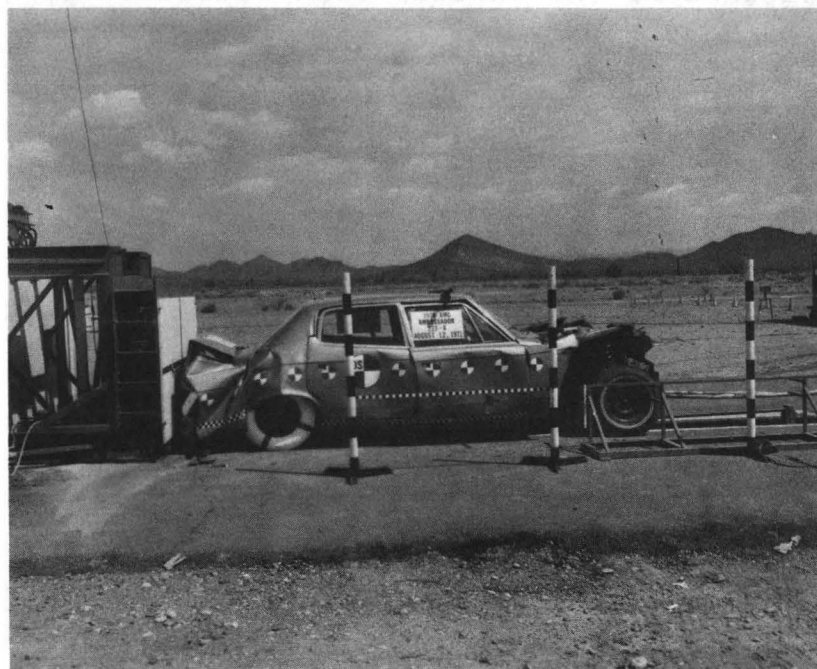
Figure G-22. Pre- and Post-test Views of AMC Ambassador.

There was no impact or post-impact leakage although the differential housing struck the front center of the fuel tank and crushed it inward 4 inches. The high-speed film showed that the differential housing also struck the fuel feed line at the front of the tank, bending it rearward but not breaking it.
