DOT HS 800 624

# **AN ASSESSMENT OF AUTOMOTIVE FUEL SYSTEM FIRE HAZARDS**

**Dynamic Science  
A Division of Marshall Industries  
1800 West Deer Valley Drive  
Phoenix, Arizona 85027**

**Contract No. DOT FH 11 7579  
December 1971  
Final Report**

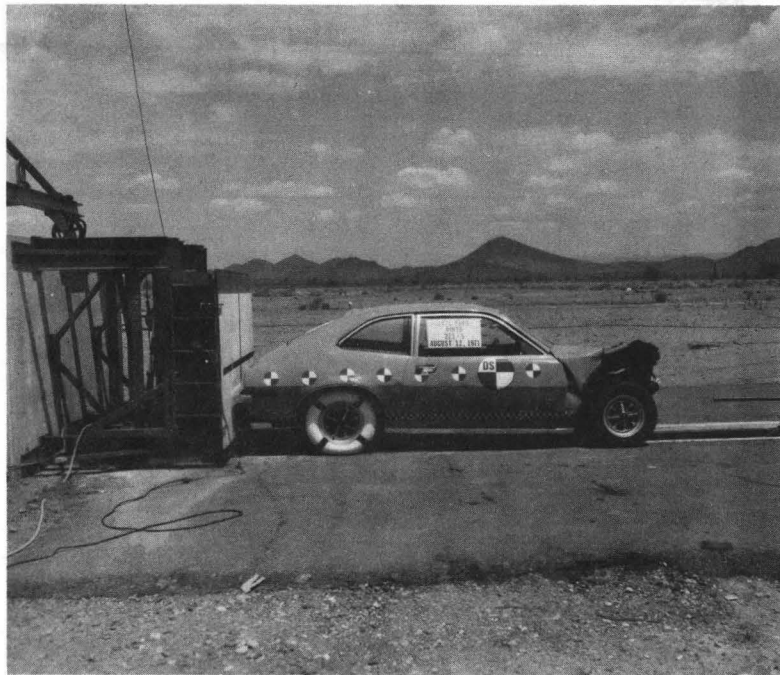
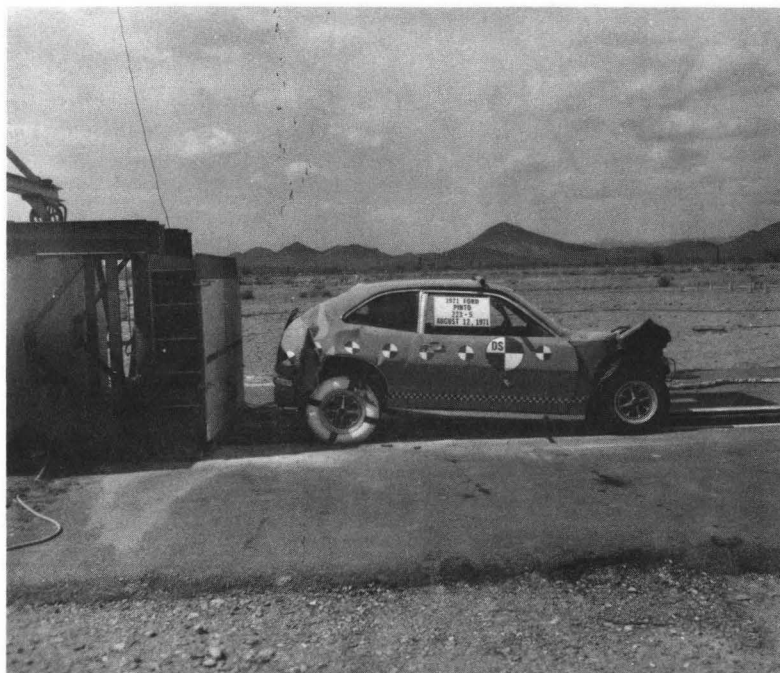
Figure G-30. Pre- and Post-test Views of Ford Pinto.

Fluid spillage from the fuel tank resulted in a post-impact fire in the camera pit. This fire was quickly extinguished and no fire damage was incurred by the test vehicle. The high-speed film revealed that the leaking test fluid was ignited approximately 1 second after impact by the hot filament of a broken pit camera light.

Fluid spillage samples taken 6 to 8 minutes after impact established a minimum spillage rate of 18.1 oz/min. Post-test examination of the vehicle revealed that the right front part of the fuel tank had been struck by the differential housing, tearing two holes in the tank (see Figure 5-43). One hole was caused by a nut on the differential housing and the other by the edge of the housing adjacent to the nut.

The high-speed film showed that the differential first struck the tank in the right front center and then rotated upward into the tank as crushing continued, puncturing the tank at maximum crush and rotation. Dynamic crushing of the tank was evident

and measured 4-1/2 inches. Permanent crush was 3 inches. Tank deformation resulted in the tank bulging downward and also creasing at the right side where the punctures occurred.
